HISTORICAL CHRONOLOGY

The purpose of this report is to review the existing conditions of several significant structures within the Bridge Street Cemetery in the City of Northampton, Massachusetts.

Existing Conditions of Structures

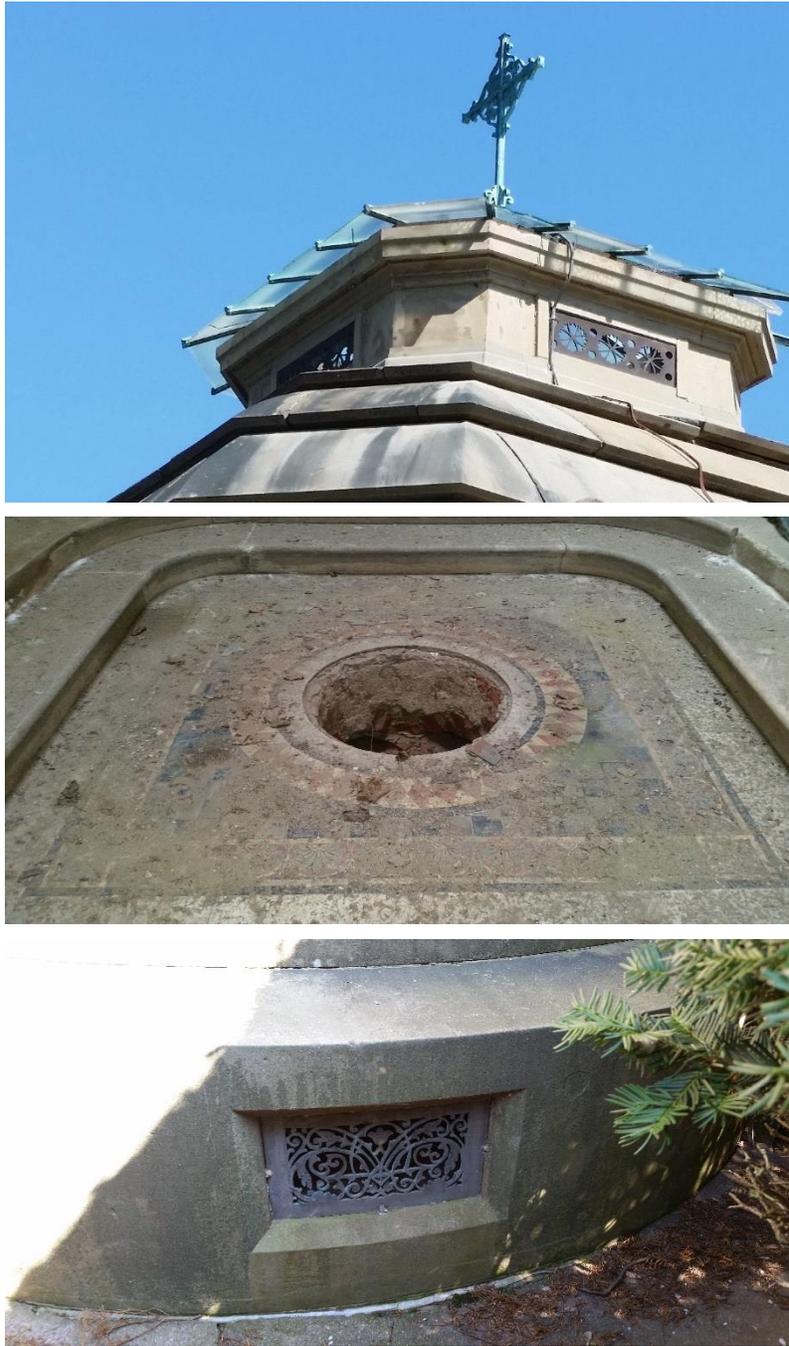
Ventilation features in the Mausoleum

The structure has a fairly sophisticated natural ventilation system. There are ventilation grates in the corners of the building near ground level. These vents appear to be connected to horizontal brick shafts that converge in the center floor of the structure. Another integral part of the ventilation system is the roof vents near the skylight, which permit air to pass through. The combination of the floor vents and roof vents allow interior hot air to rise and draw relatively cool air in from the base. The photos on the following page show the exterior vent and the floor vent. During the inspection, a steady flow of air was noted through the ventilation pit in the center of the floor. The grate on the ventilation pit is missing. It is assumed that this vent was most likely a bronze casting.

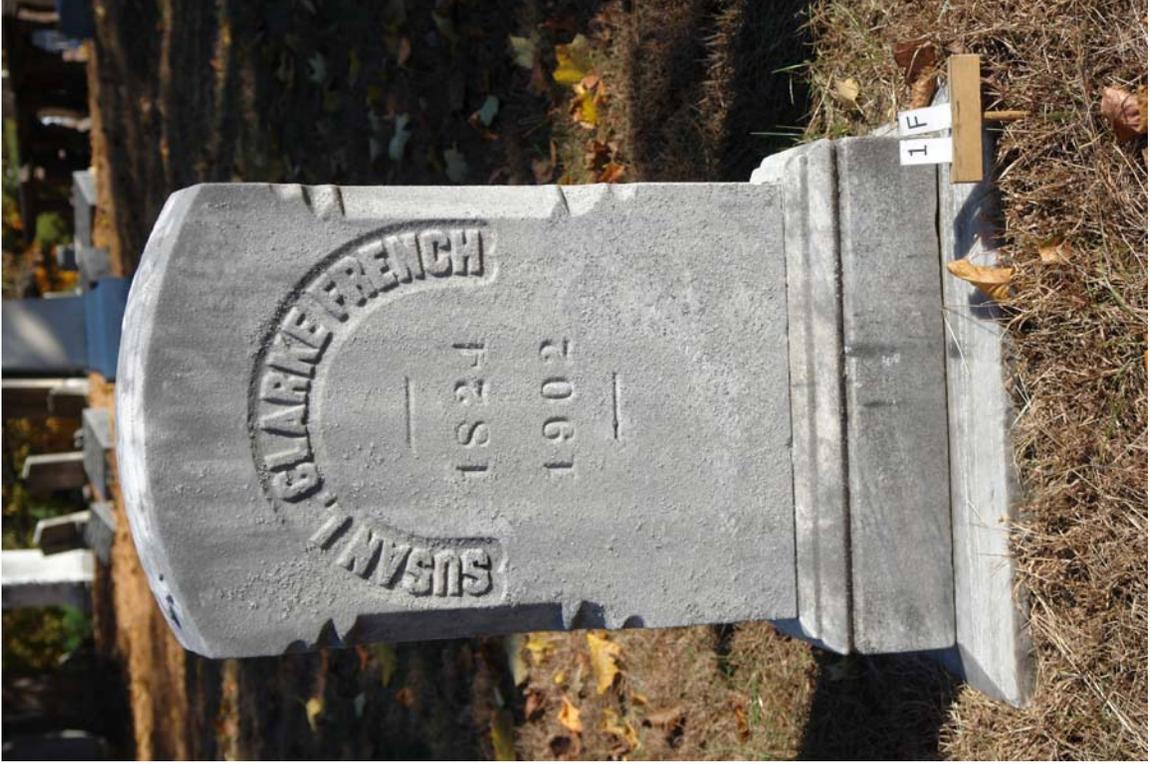
Cond. of Inscription: Legible Material: Marble

EXISTING CONDITIONS	CONSERVATION STRATEGY
Unstable	Level base Reset all elements
<p>CONSERVATION PRIORITY 1</p> <p>1) Hazardous, immediate action 2) Unstable--asap 3) Ongoing deterioration, treat 2-5 years</p> <p>RECOMMENDED TREATMENT</p> <ol style="list-style-type: none"> 1. Inspect soundness of setting joint of marker to base, if unstable, remove all units from in ground base. 2. Excavate area around existing base. 3. Align base with adjacent markers and re-set level. 4. Backfill with tamped gravel and re-grade with existing topsoil 5. If setting joint was unsound, remove failed setting mortar and, if required, replace setting pins with threaded stainless pins. 6. Prime setting surfaces with Acryl 60 diluted 1:3 with water. 7. Re-set marker plumb onto base/s with a cement/lime mortar (3/2/9) with 000 sand 8. Brace marker until cured and remove excess mortar.

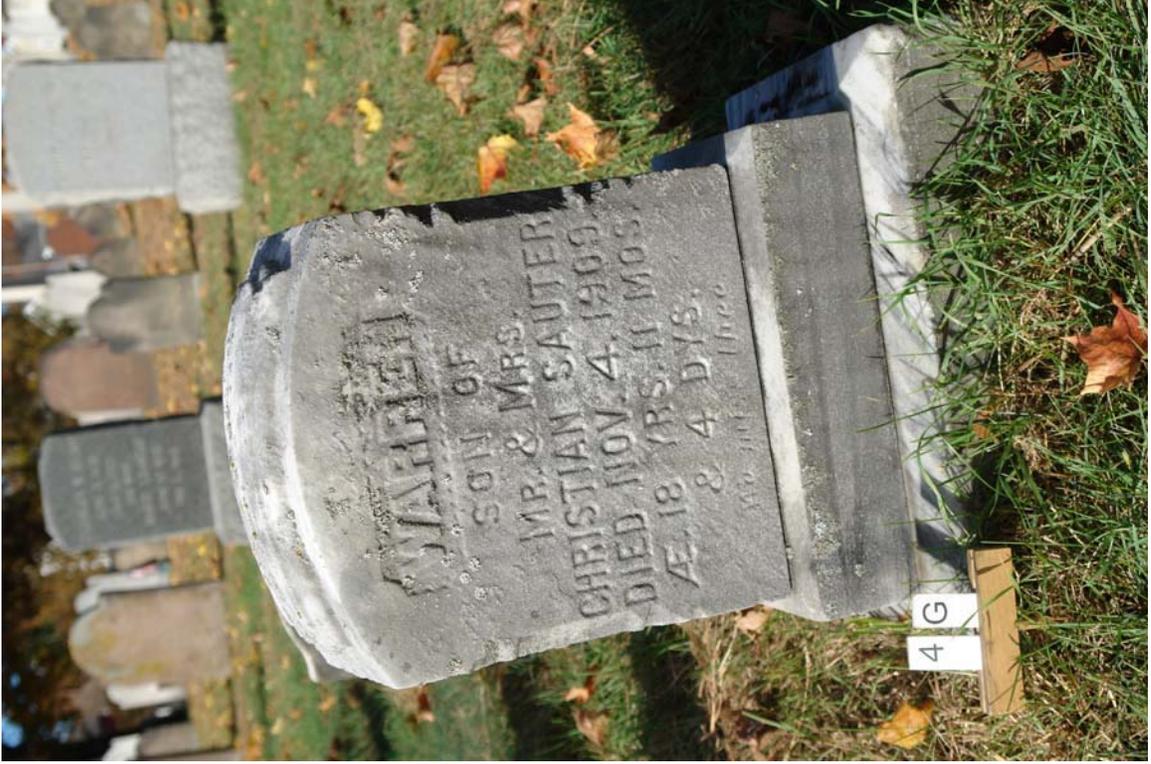
Cond. of Inscription: Legible Material: Marble

EXISTING CONDITIONS	CONSERVATION STRATEGY
Unstable	Level base Reset all elements

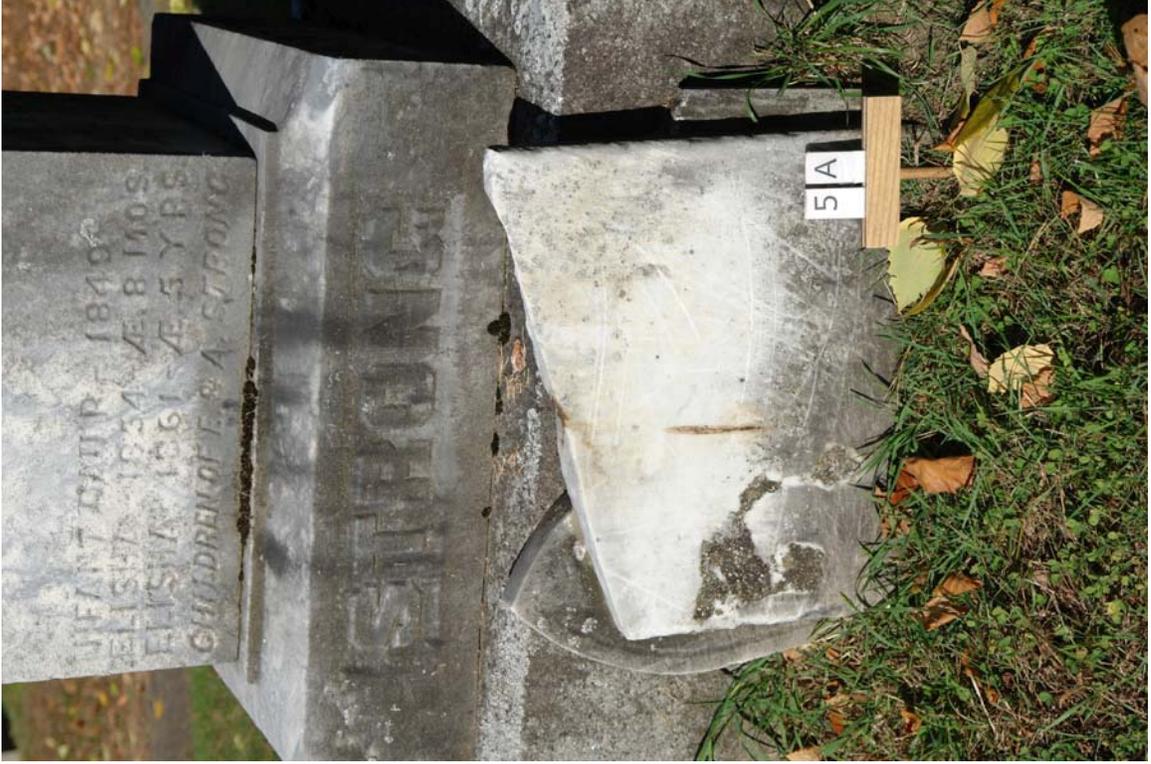
Cond. of Inscription: n.a. Material: Marble

EXISTING CONDITIONS	CONSERVATION STRATEGY
Fragmented	Evaluate

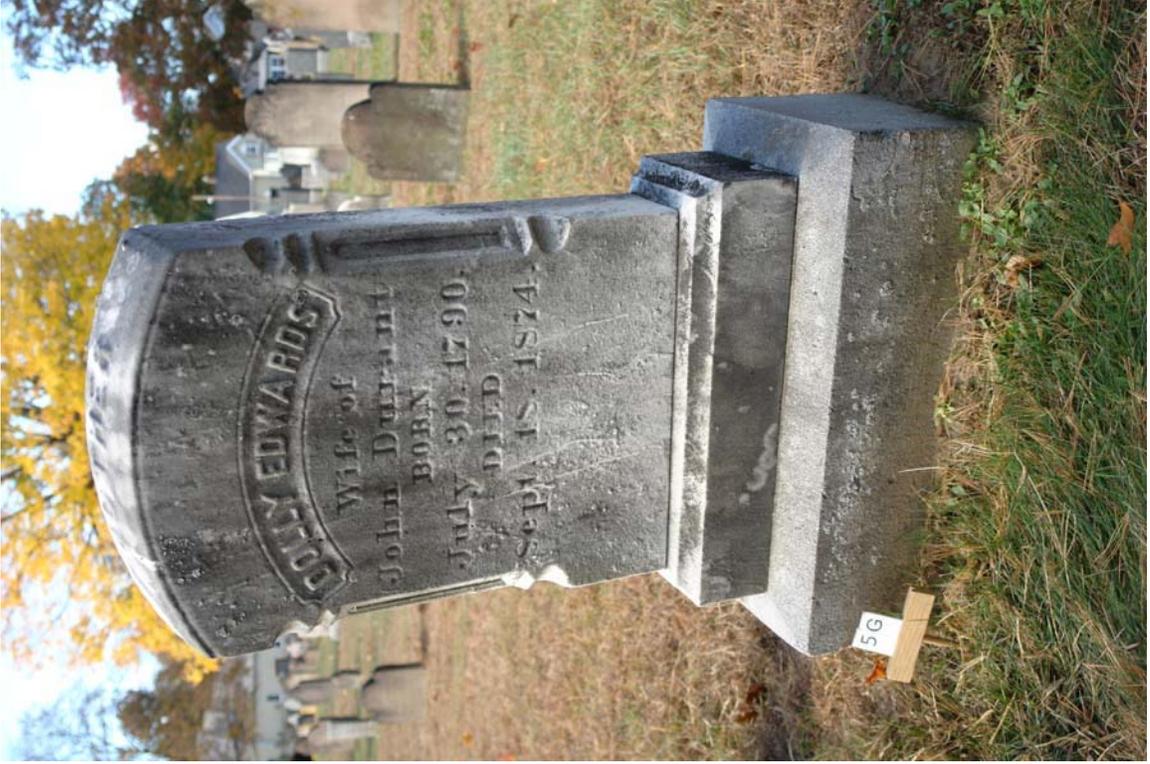
Cond. of Inscription: Legible Material: Marble

EXISTING CONDITIONS	CONSERVATION STRATEGY
Unstable	Level base Reset all elements

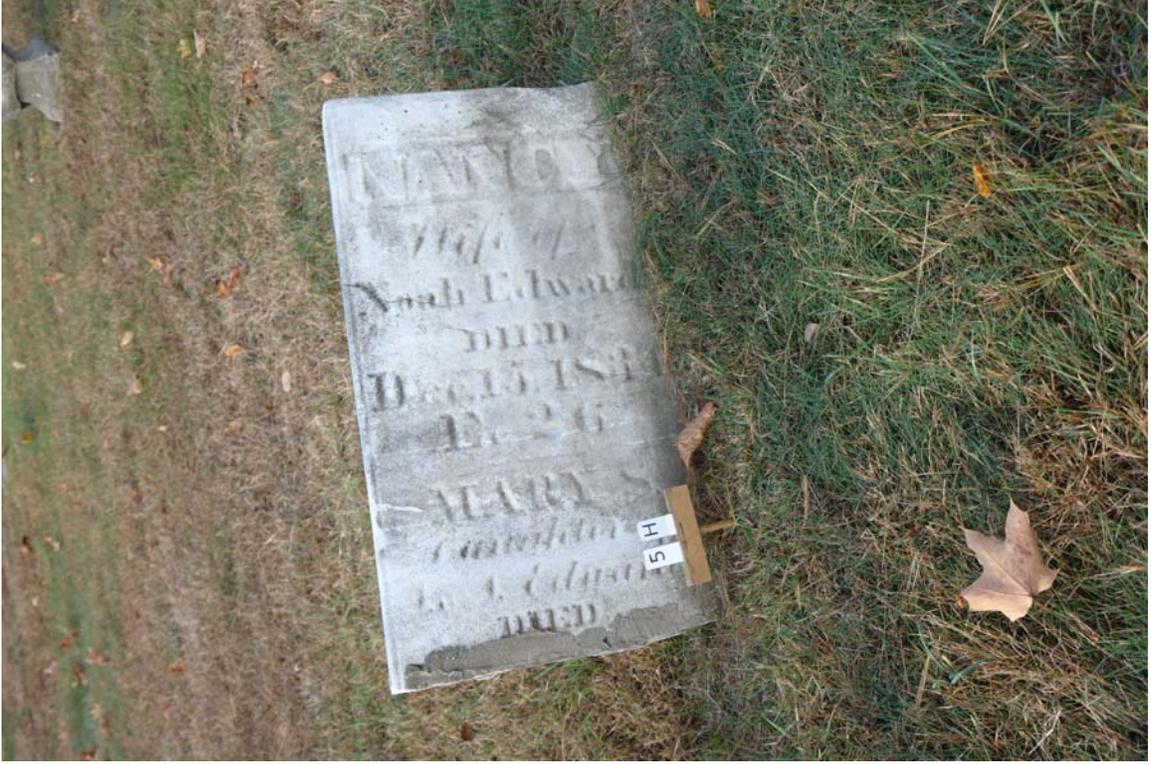
Cond. of Inscription: Legible Material: Marble

EXISTING CONDITIONS	CONSERVATION STRATEGY
Fractured at grade Fallen	Reset into new below grade base

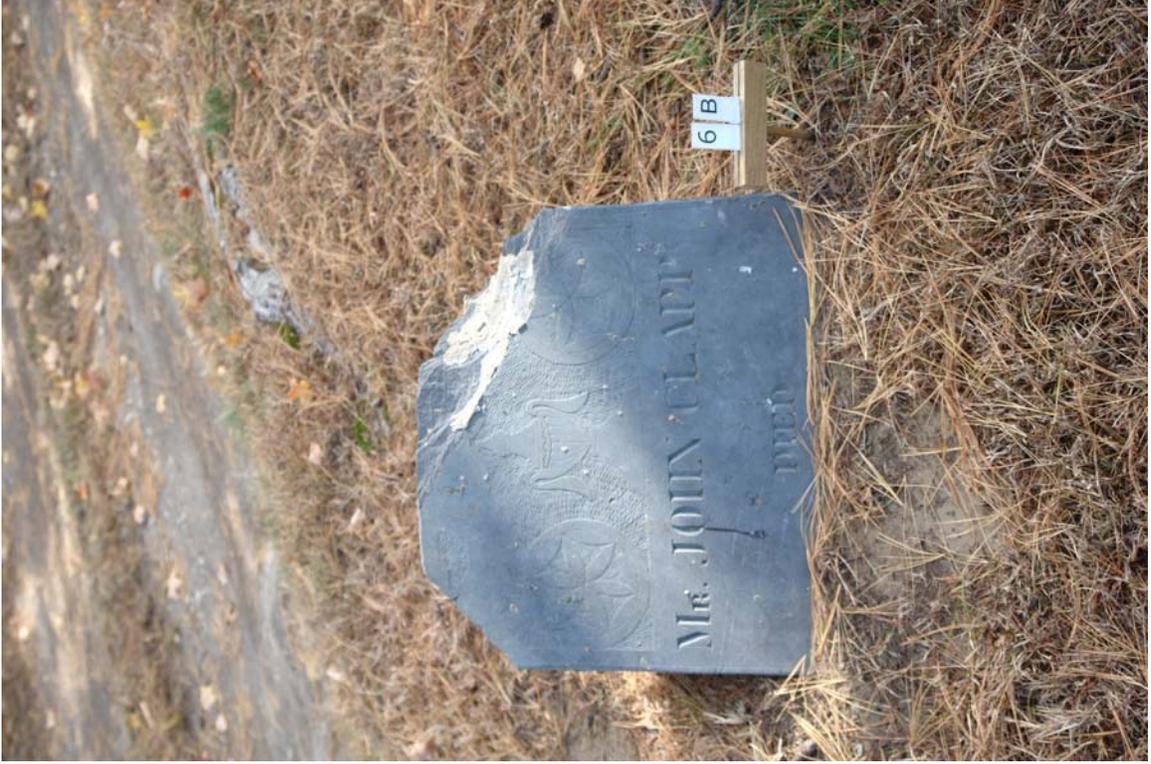
Cond. of Inscription: Legible Material: slate

EXISTING CONDITIONS	CONSERVATION STRATEGY
Fractured	Attach fragments with structural adhesive

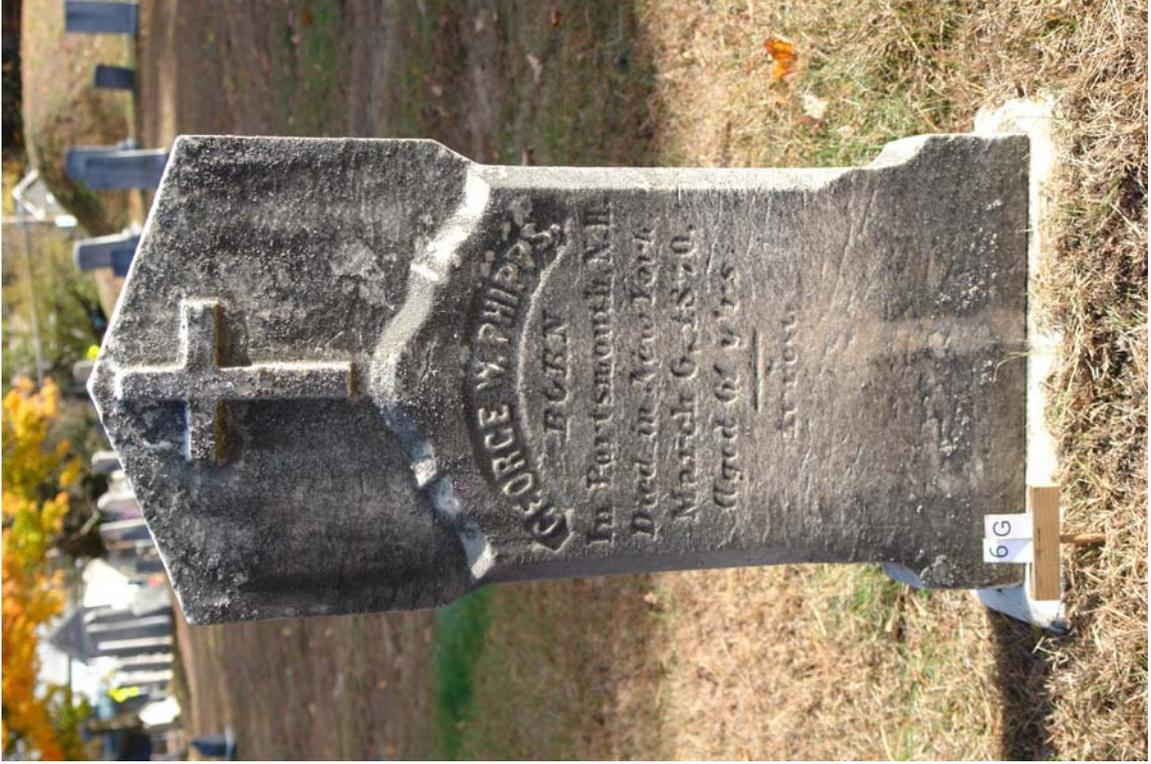
Cond. of Inscription: Legible Material: Marble

EXISTING CONDITIONS	CONSERVATION STRATEGY
Unstable	Level base Reset all elements

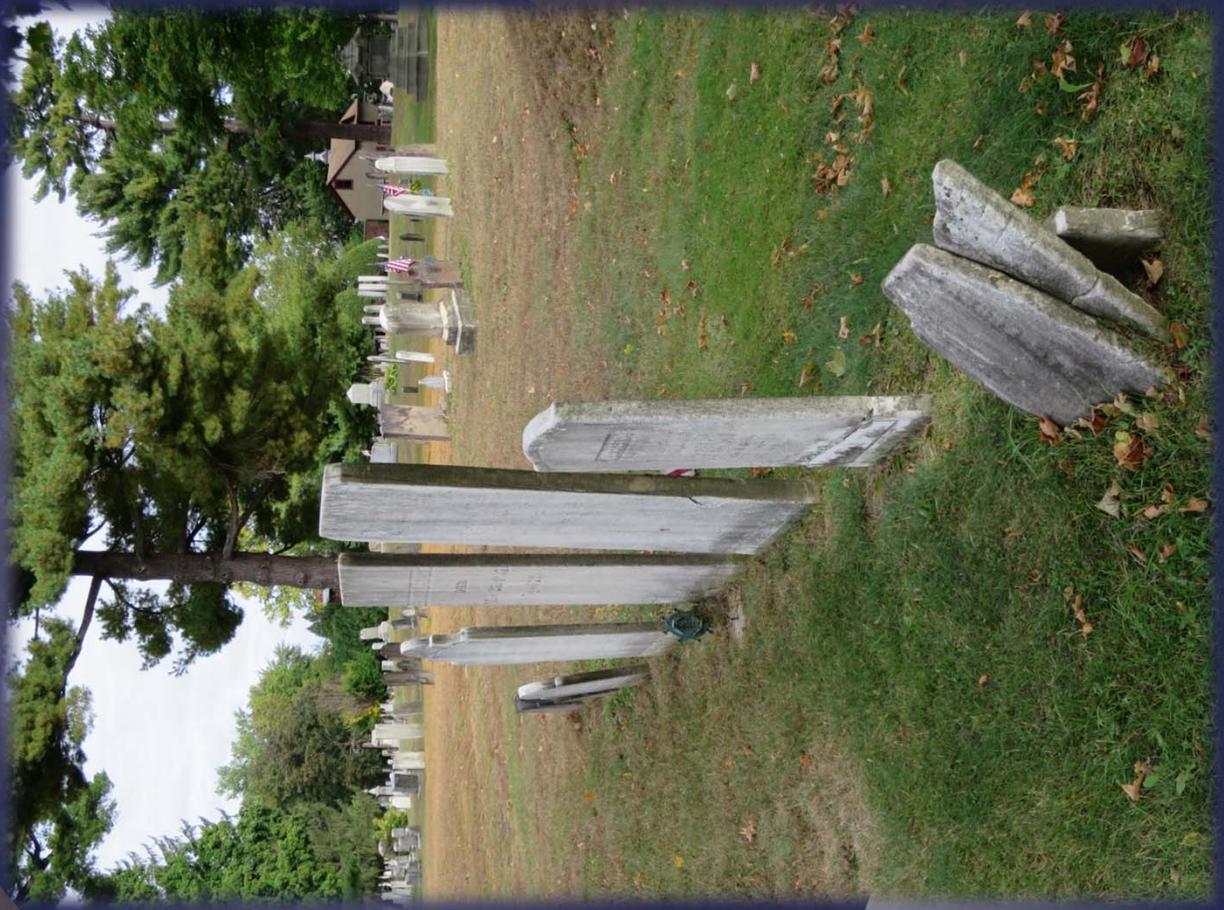
- In hazardous condition
- Located throughout the cemetery
- 85 stones
- Will require the services of a professional stone conservator
