A Preliminary Report on the
Shepherd Barn

Historic Northampton
66 Bridge Street, Northampton, MA
May 1, 2020

By
Jack A. Sobon: Architect

Addendum Report on the **Shepherd Barn**

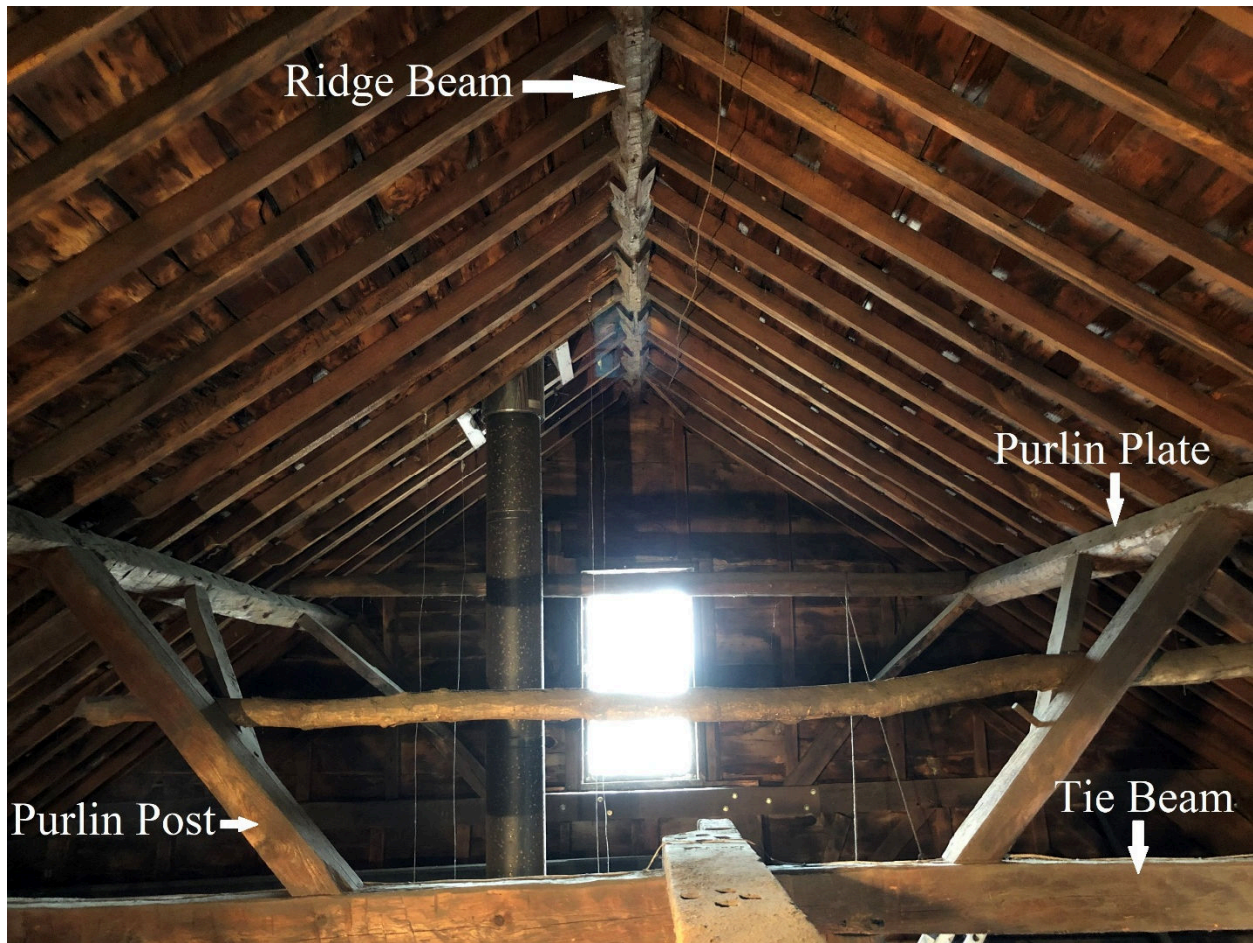
Fig. 1

Looking East above the tie beams, one can see the ridge beam at the peak and the purlin plates supporting the rafters at their mid-span. The braces from the inclined purlin posts up to the purlin plate are only in the end bays. The purpose of the poles laid across is unknown at this point.

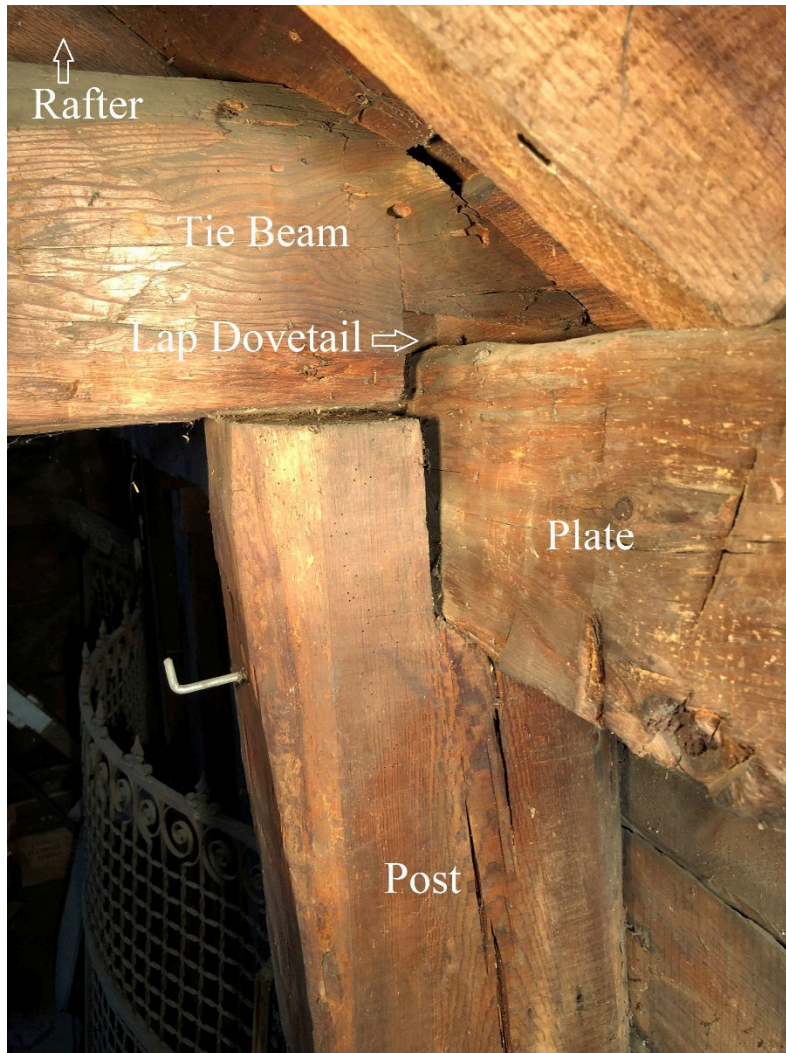
Fig. 2

The English tying joint occurs at the top of each wall post (8) and cleverly joins the post-tie beam-plate-rafter. Seasoning and shrinkage have partially revealed the lap half dovetail joint where the bottom two inches of the tie beam laps over the plate. The 8x8 post flares out at its upper end to 10-1/2", providing room for two tenons: one into the plate and a higher one into the tie beam.

While once typical of houses and barns prior to about 1815, English tying joints are rarely seen today. They are usually concealed in house framing and 18th century barns are rare in the area. Here are examples that can be seen by the public up close and should be taken advantage of. Perhaps a graphic poster with an exploded view would help point it out to the public.

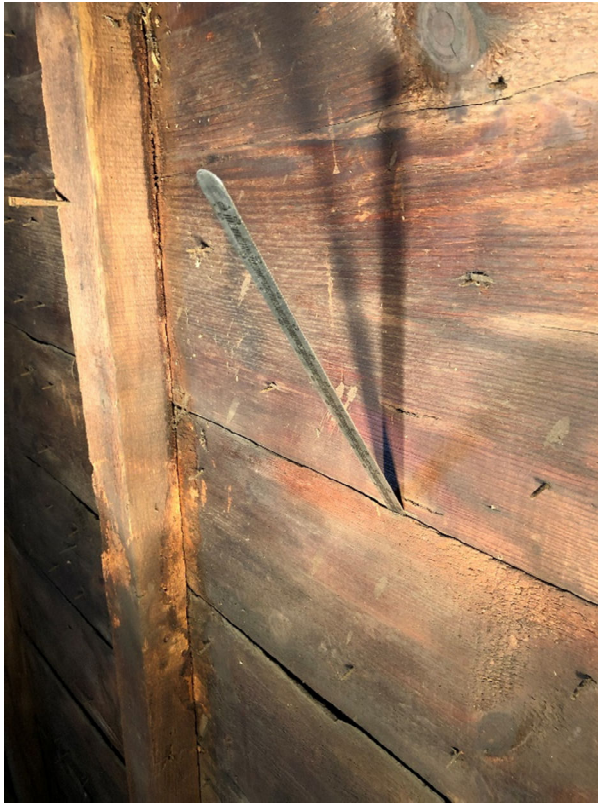
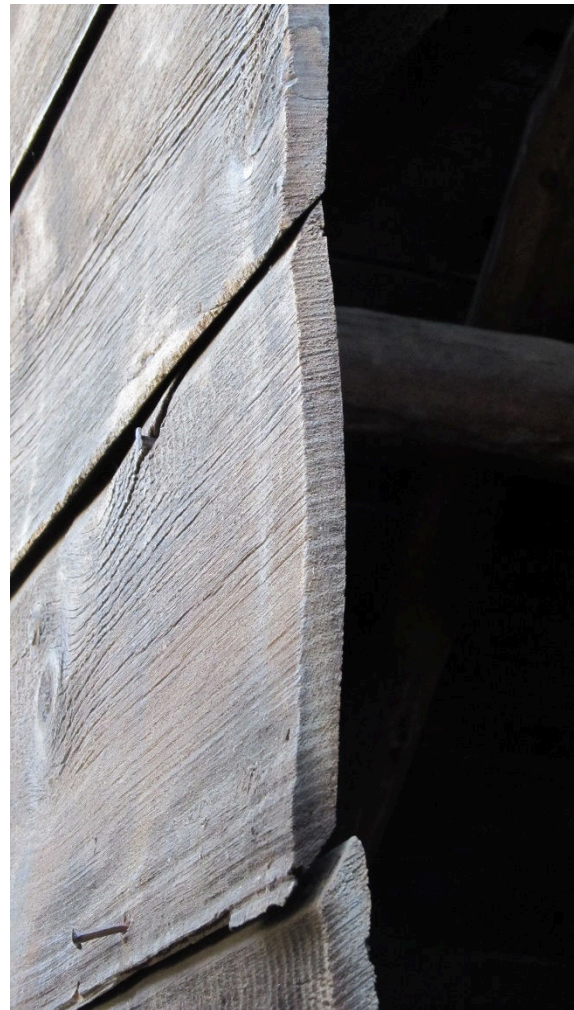
Fig. 3,4 Bevel Edge Weatherboarding

At left, a steel rule inserted in the siding lap illustrates the bevel angle. At right, similar bevel edged weatherboarding on a 1791 barn in Whately, Massachusetts.

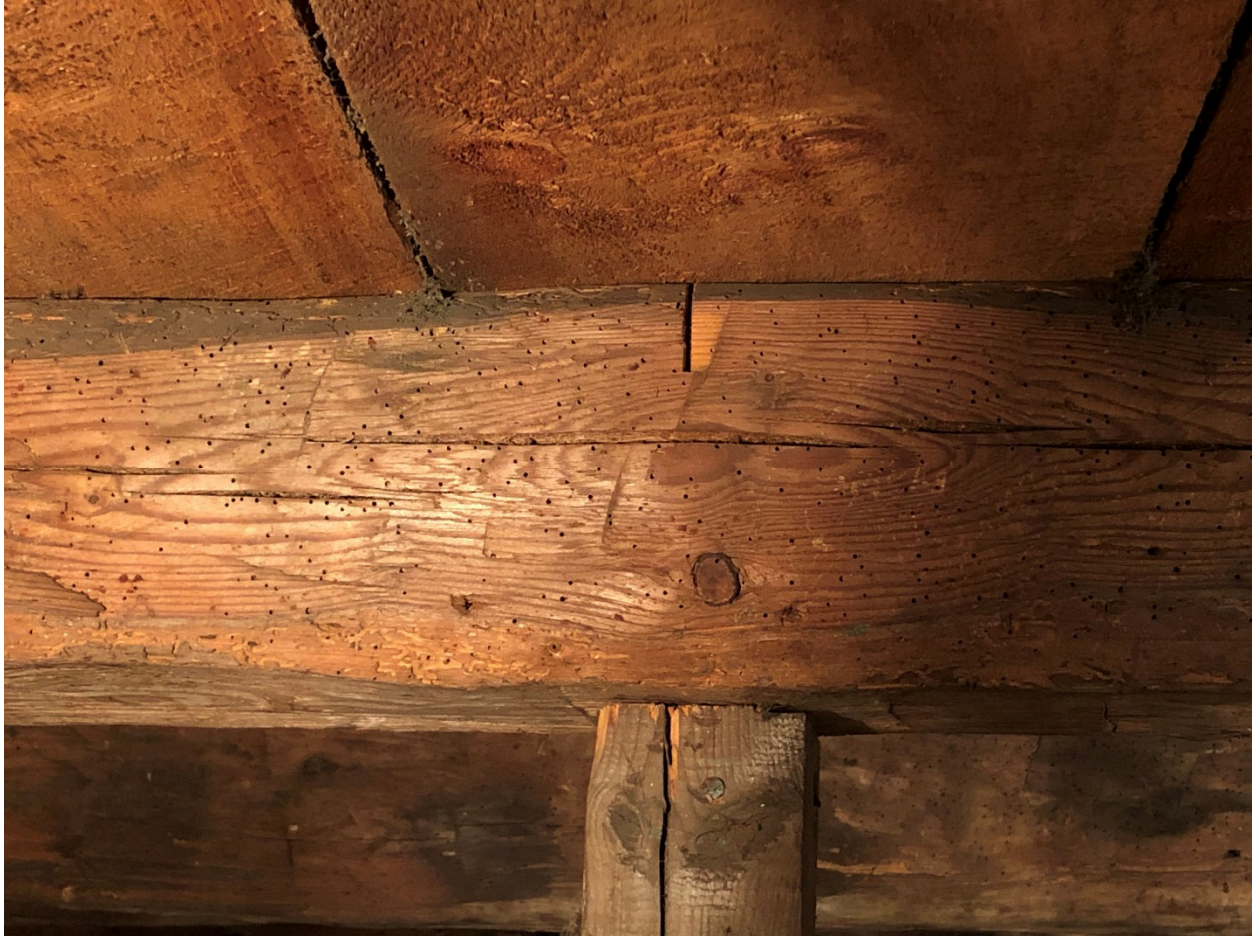
Fig. 5 Upper Loft Joist Notching

This sixteen-foot long hewn loft joist has been cut on its top edge near mid-span so it could be jacked up, creating a more level floor. The joist is supported with a stud.

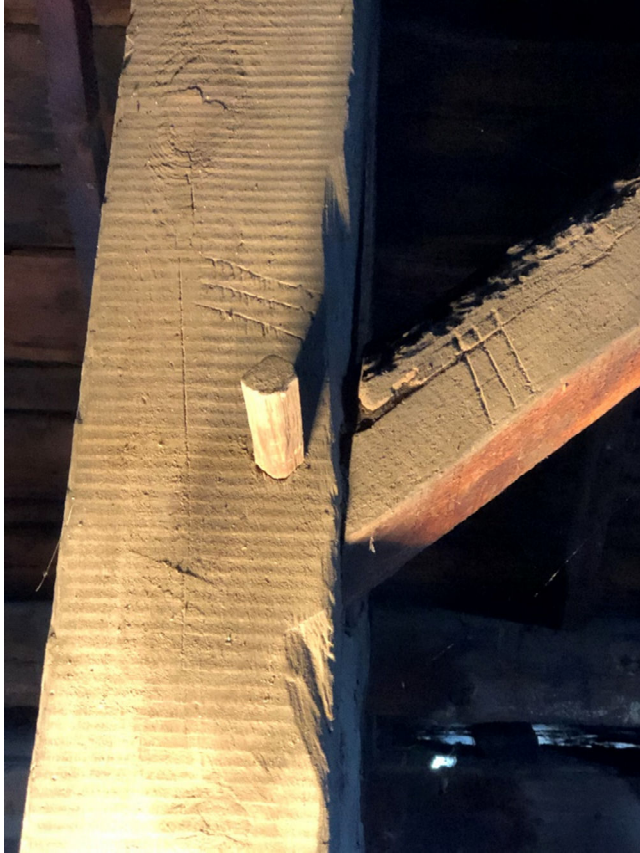
Fig. 6

This purlin plate brace and its corresponding purlin post is marked #3 with a race knife. When the purlin plate assembly was set out flat for framing, it was numbered from left to right.

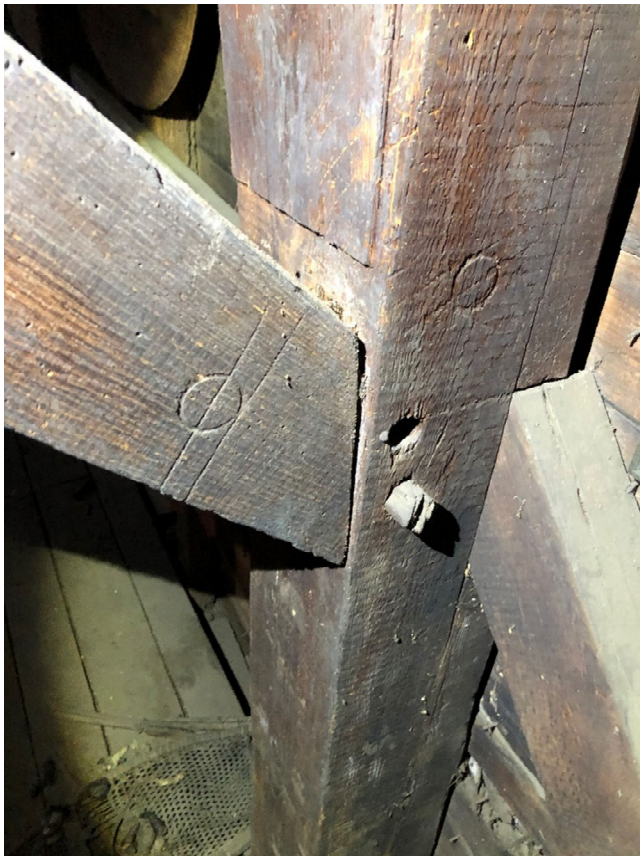
Fig. 7

This post to tie beam brace is number 2 but with a circle added using the compass point on the race knife. In this building it appears that the circles were used in cross framing and non-circles in longitudinal framing. Since most of the marks are on faces concealed by sheathing, it is difficult to understand the carpenter's exact system. Interestingly, there is a mistake in the carpentry shown here. The peg hole for the brace was first bored at the wrong end of the mortice. Peg hole diameter is 15/16" to 1"

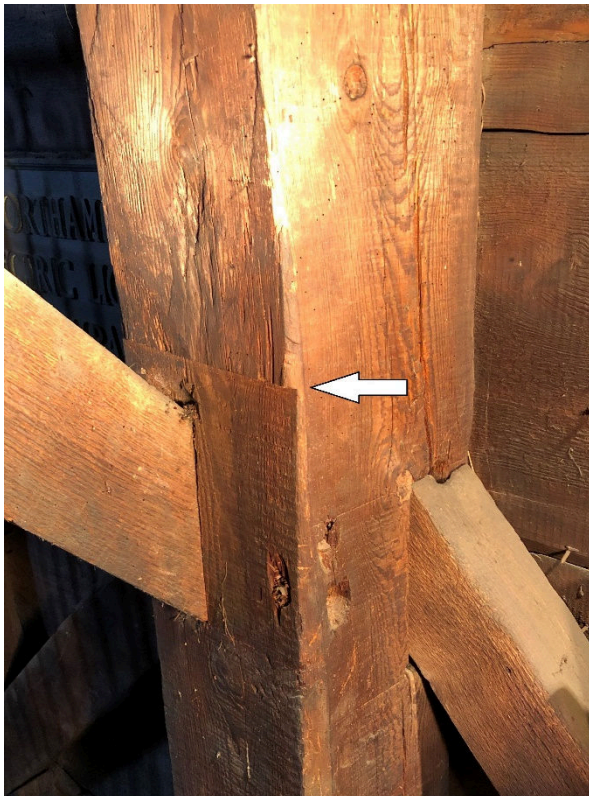
Fig. 9

On this post, the sawing stopped just above where the brace would enter. The tapered portion above is hand hewn.

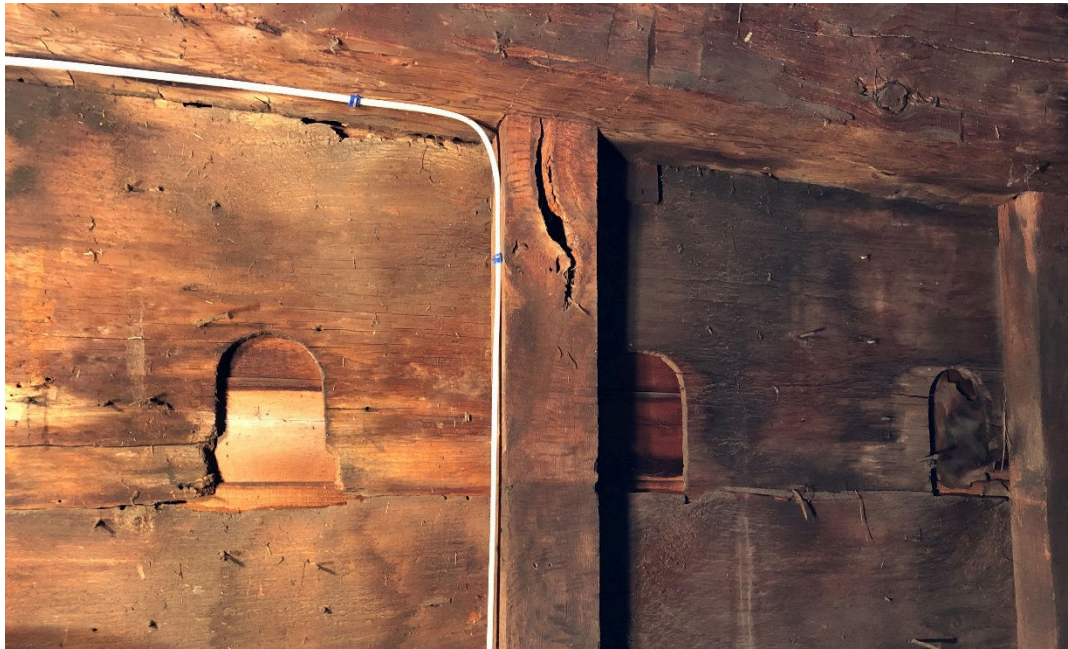
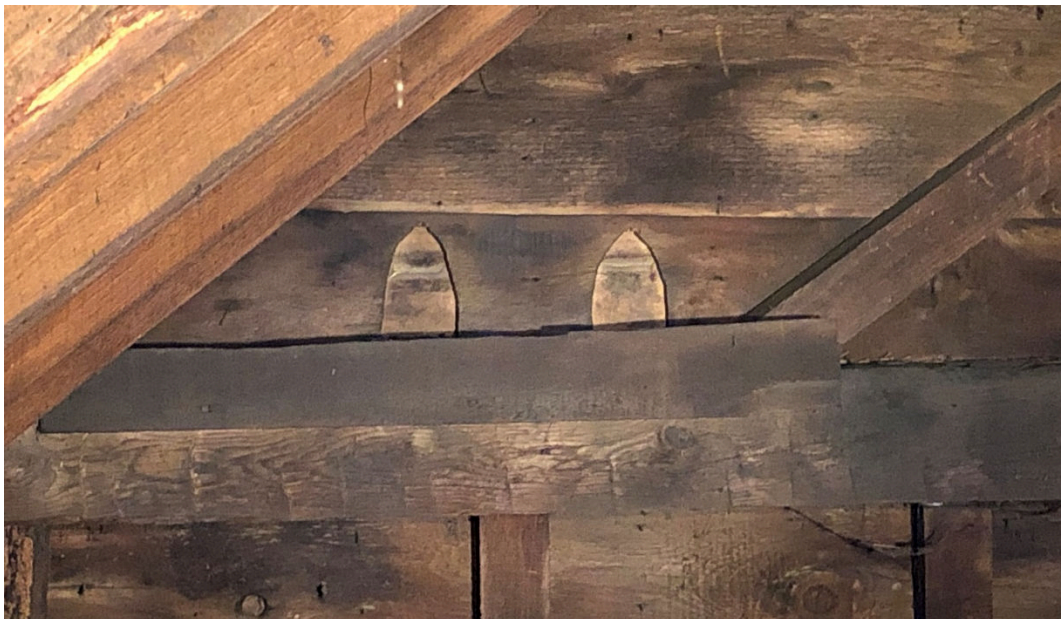
Fig. 10 & 11

Dovecote openings in the West gable just below the tie beam (photo above) and those in the East gable just above the tie (below).

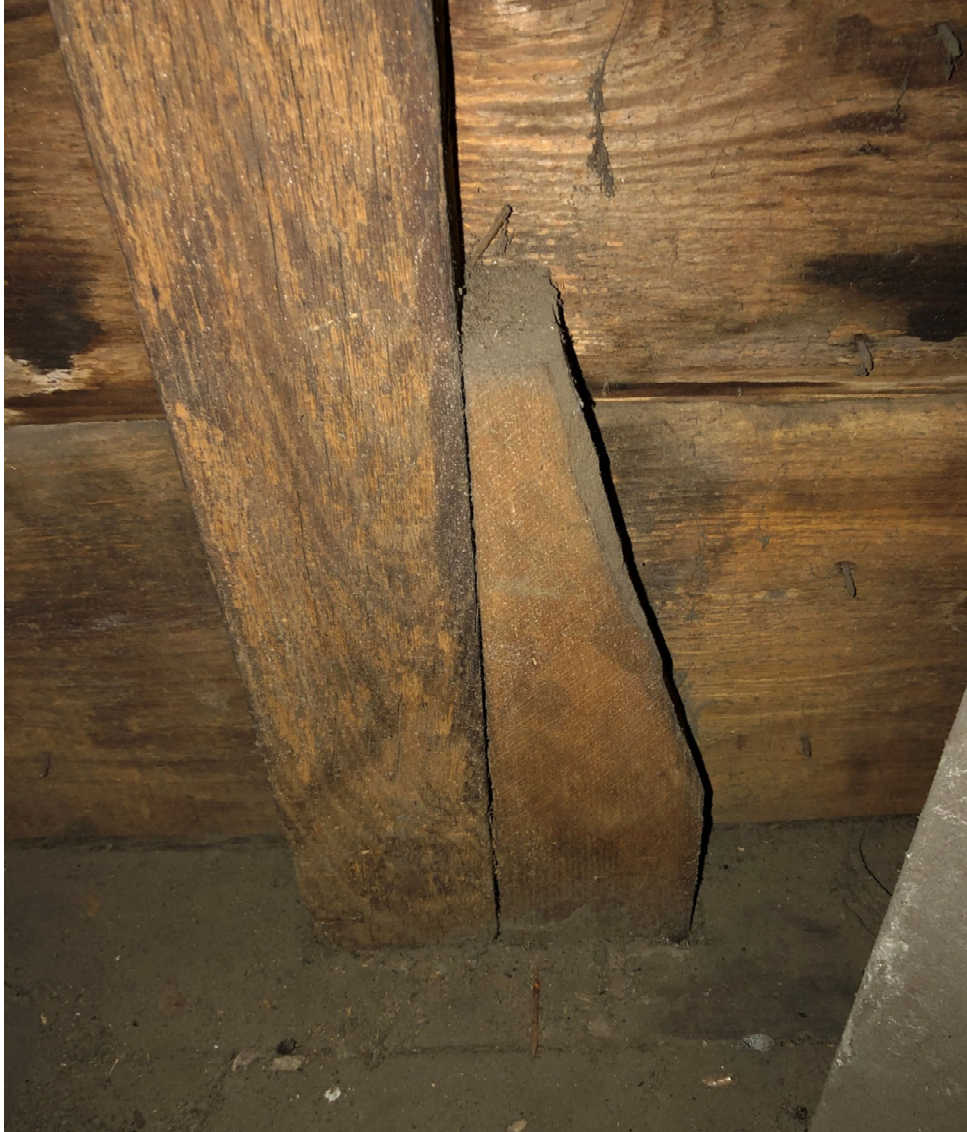
Fig. 12

There is also evidence that the structure underwent some restoration work early on, perhaps prior to moving it. Some stud bottoms visible behind the stairs have had their bottoms repaired with a nailed-on section that is probably tenoned in to the sill. This type of repair suggests decayed stud bottom tenons and a replaced sill beam. If the building was to be moved

**Stud Bottom
Repair**

The replacement piece on the right, which is likely tenoned into the sill, is tapered to permit nailing into the existing stud.

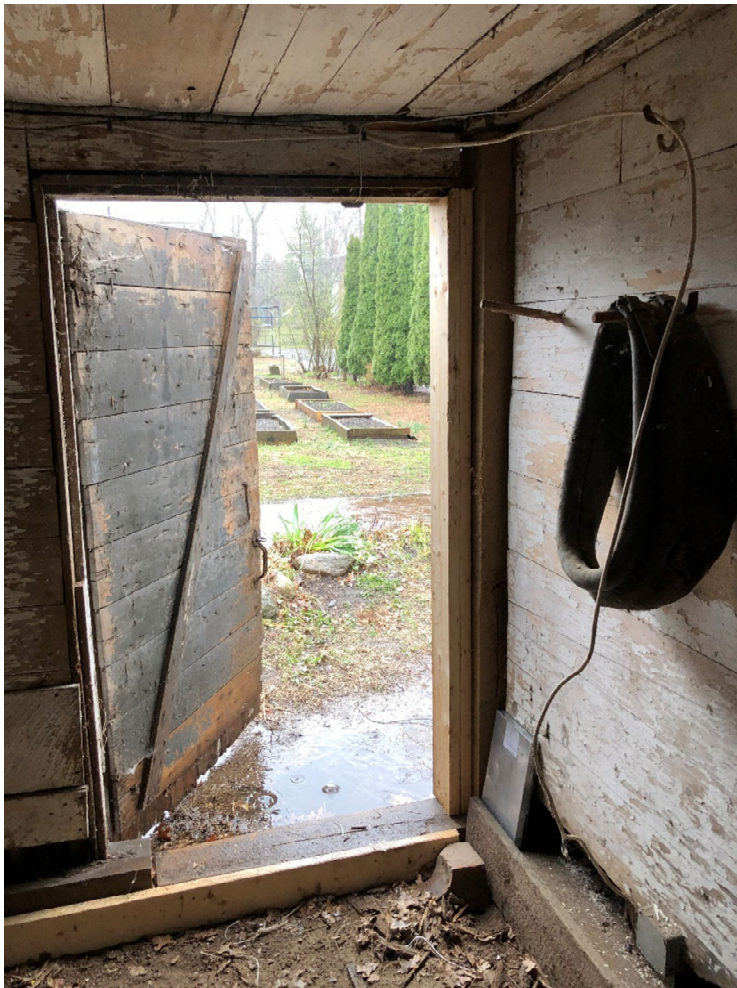
Fig. 13

future use, the flooring should be lifted up and this area examined. When originally constructed, the building's sill beams would have sat on a stone foundation wall along its perimeter and under interior posts, the sills would have borne on stone piers. Over the building's lifetime, these stones have sunken into the earth and the exterior ground has also risen so now the building appears to sit right on the ground. Wood, even preservative treated wood, does not last when on the ground.

Southwest corner horse stall doorway illustrates the at-grade condition of the barn. Note that much of this framing has already been replaced and some of it recently.

For permanence, wood needs to be elevated above the ground. Per the building code, untreated wood sills must be a minimum of 8" above grade, floor joists must be 18" above earth, and floor timbers 12" above earth. Preservative treated members can be used, but their life expectancy is only 20 or 30 years longer than untreated if exposed to ground and dampness. That is too short a time frame for such an important component to last before replacing. Thus, there are two basic options for this barn:

1. Repair or replace the floor structure as necessary, elevate the building at least the minimum to meet the building code. Since we don't want a crawlspace under the barn that is even with or below the outside grade so as to collect water, that would mean raising the finish barn floor a minimum of 28" above the highest existing grade (the Southeast corner?). A new perimeter foundation would be installed with footings below the frost line (four feet) and interior pier type footings under posts and girders. The foundation would be concrete but it could be faced with stone or brick, or entirely masonry above the ground for appearance sake. The advantage of this option is that it retains the original timbered floor design.

2. Remove the wood floor structure entirely and replace with a concrete foundation and concrete floor slab. The concrete perimeter walls could extend a few inches up the walls to provide the required separation distance to grade. The finish floor could be concrete, stone, or tile, or a wood floor (using original planks) built on top of the slab. As with option 1, the concrete wall could be faced with stone or brick on the outside (and inside) if desired. The advantage to this option is that it retains the original floor height near grade. It would also permit increasing the clear ceiling height under the loft to 7'-6" to meet the code.
