A Preliminary Report on the  
**Shepherd Barn**

Historic Northampton  
66 Bridge Street, Northampton, MA

May 1, 2020

**Jack A. Sobon: Architect**

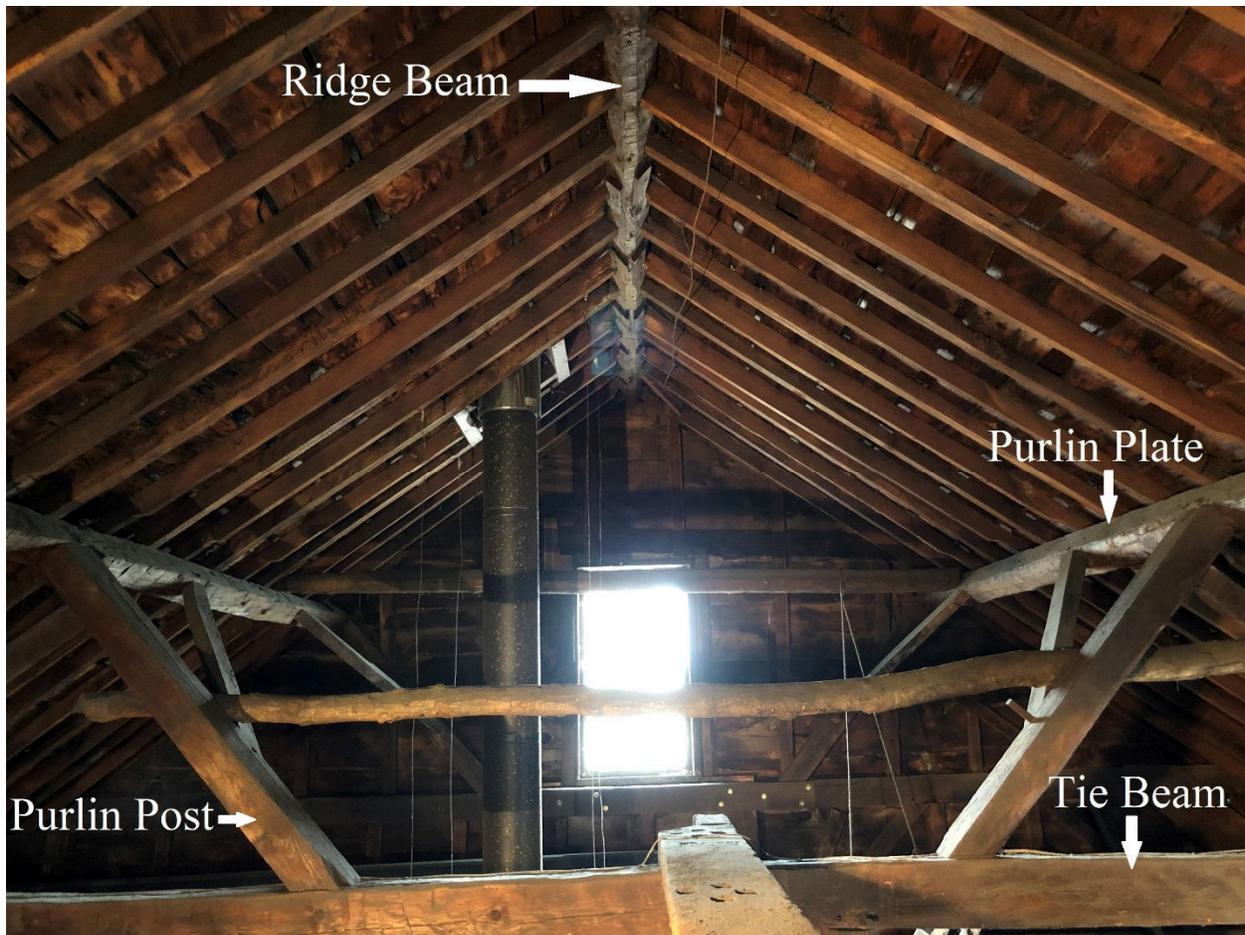
**Fig. 1**

Looking East above the tie beams, one can see the ridge beam at the peak and the purlin plates supporting the rafters at their mid-span. The braces from the inclined purlin posts up to the purlin plate are only in the end bays. The purpose of the poles laid across is unknown at this point.

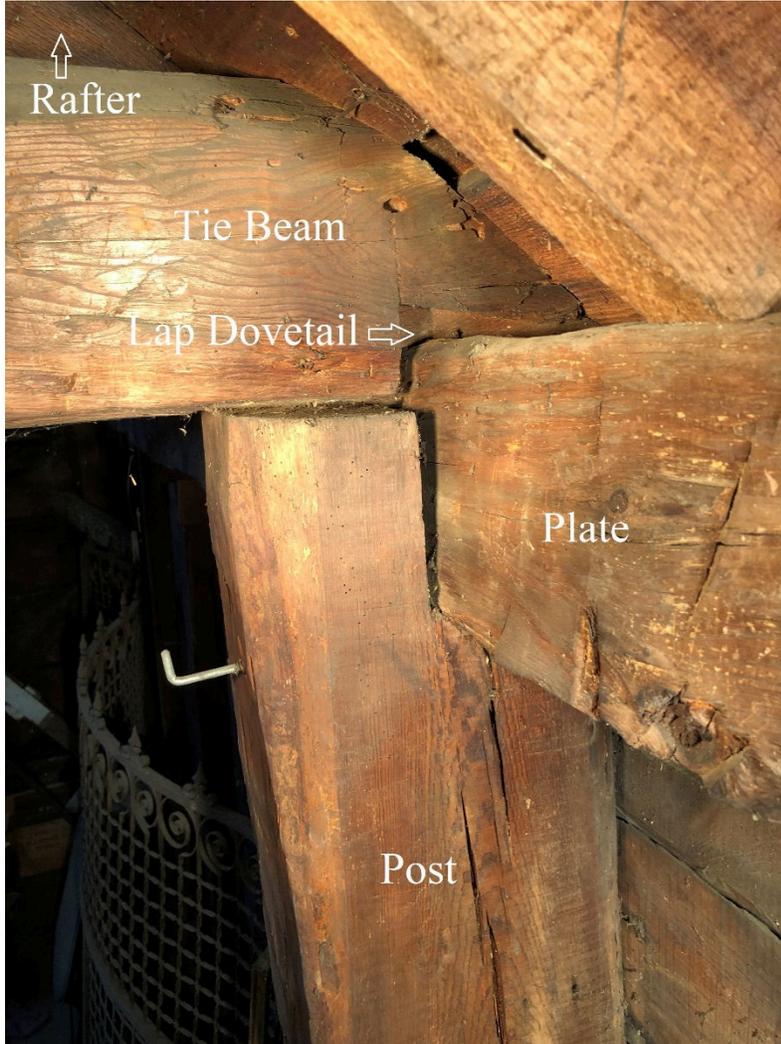
**Fig. 2**

The English tying joint occurs at the top of each wall post (8) and cleverly joins the post-tie beam-plate-rafter. Seasoning and shrinkage have partially revealed the lap half dovetail joint where the bottom two inches of the tie beam laps over the plate. The 8x8 post flares out at its upper end to 10-1/2", providing room for two tenons: one into the plate and a higher one into the tie beam.

While once typical of houses and barns prior to about 1815, English tying joints are rarely seen today. They are usually concealed in house framing and 18<sup>th</sup> century barns are rare in the area. Here are examples that can be seen by the public up close and should be taken advantage of. Perhaps a graphic poster with an exploded view would help point it out to the public.

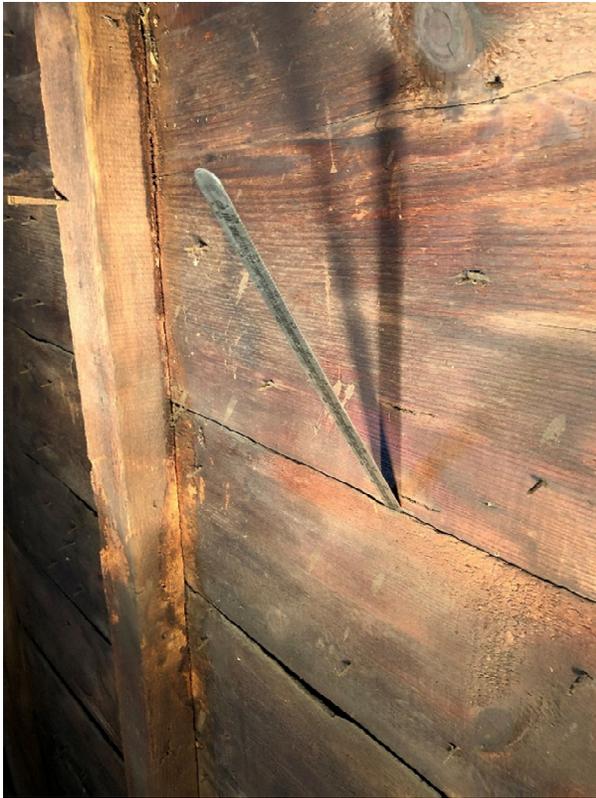
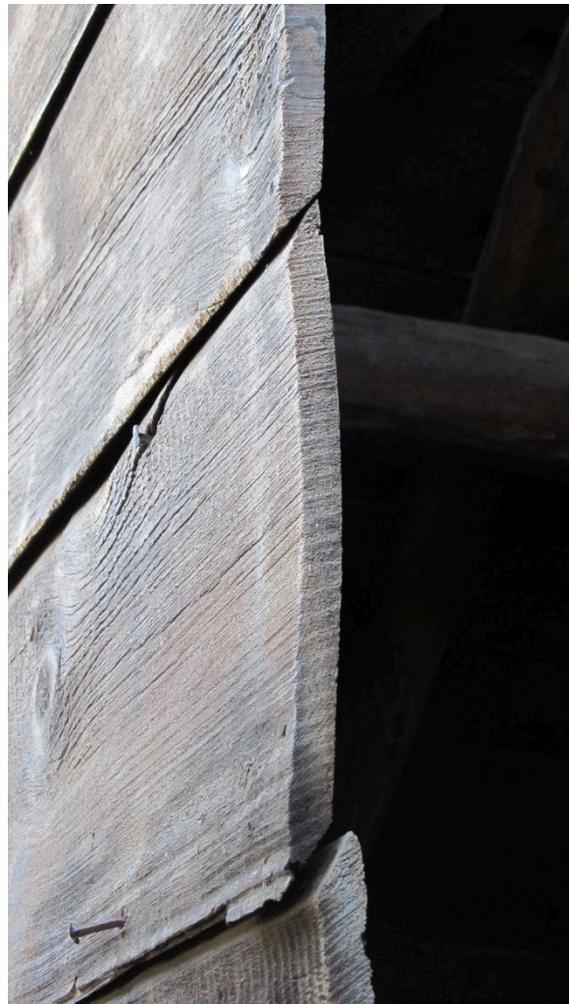
**Fig. 3,4** Bevel Edge Weatherboarding

At left, a steel rule inserted in the siding lap illustrates the bevel angle. At right, similar bevel edged weatherboarding on a 1791 barn in Whately, Massachusetts.

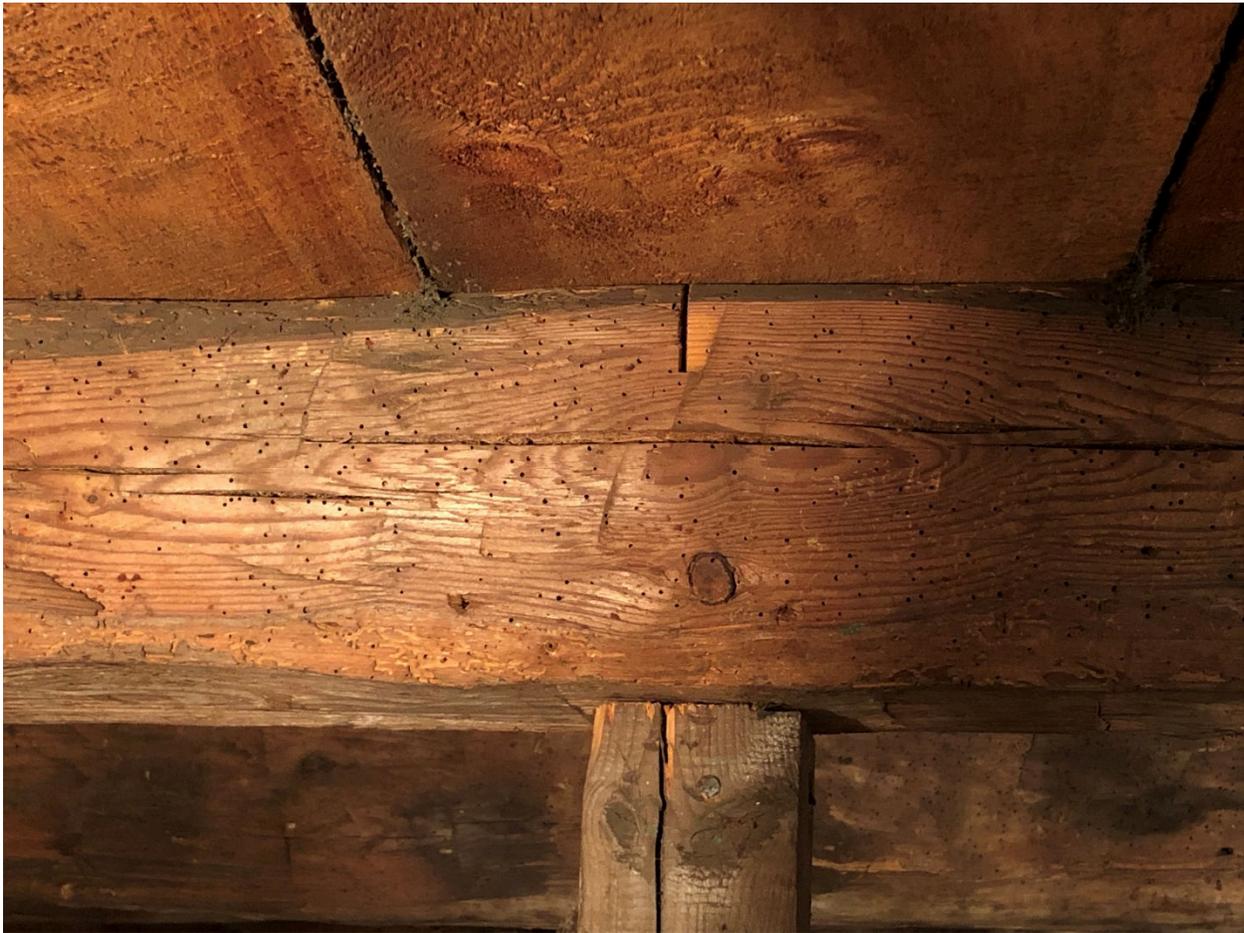
**Fig. 5** Upper Loft Joist Notching

This sixteen-foot long hewn loft joist has been cut on its top edge near mid-span so it could be jacked up, creating a more level floor. The joist is supported with a stud.

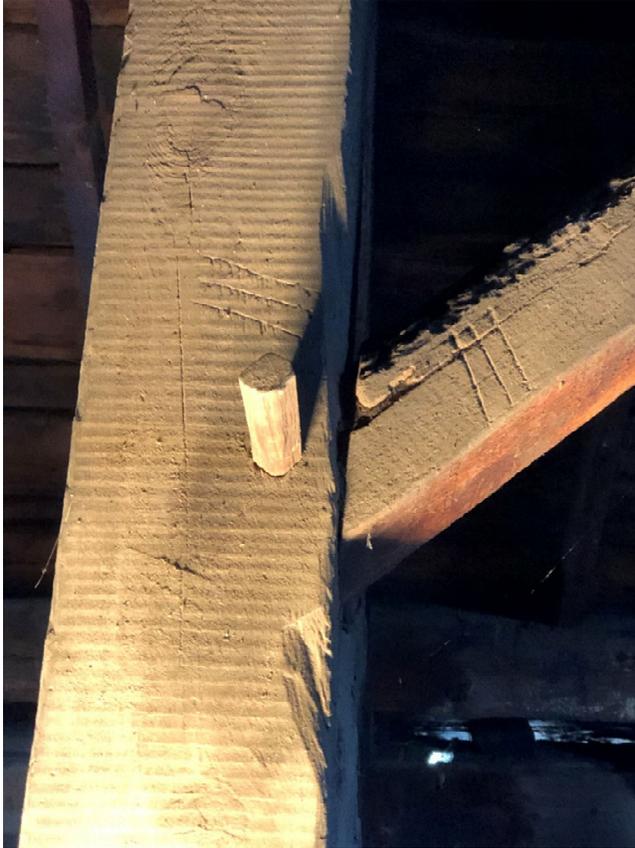
**Fig. 6**

This purlin plate brace and its corresponding purlin post is marked #3 with a race knife. When the purlin plate assembly was set out flat for framing, it was numbered from left to right.

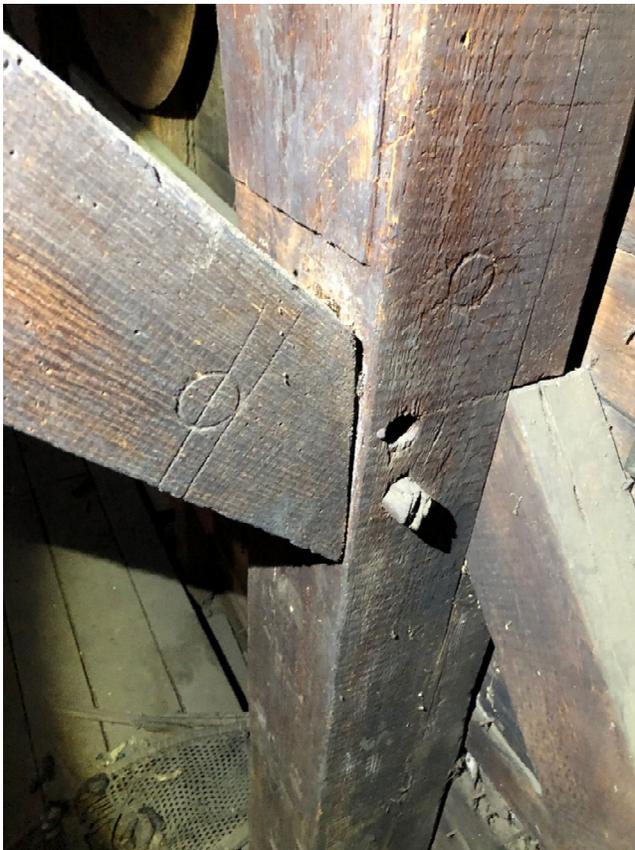
**Fig. 7**

This post to tie beam brace is number 2 but with a circle added using the compass point on the race knife. In this building it appears that the circles were used in cross framing and non-circles in longitudinal framing. Since most of the marks are on faces concealed by sheathing, it is difficult to understand the carpenter's exact system. Interestingly, there is a mistake in the carpentry shown here. The peg hole for the brace was first bored at the wrong end of the mortise. Peg hole diameter is 15/16" to 1"

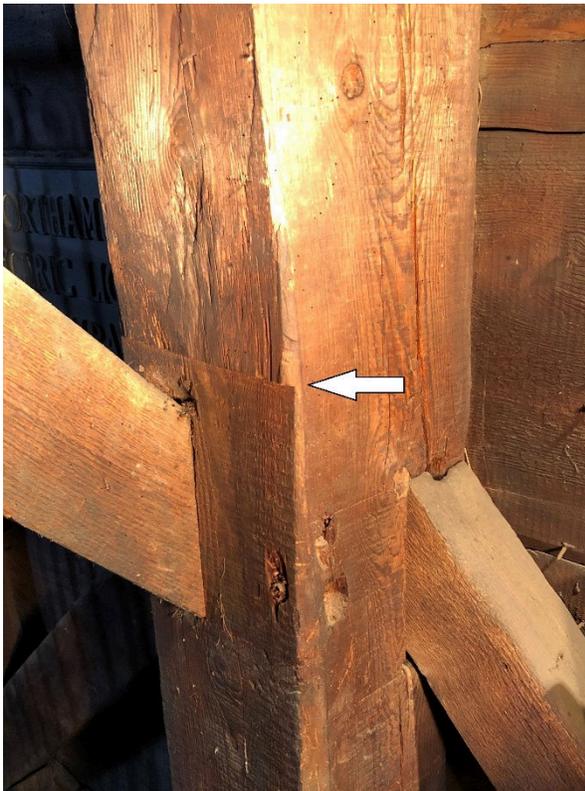
**Fig. 9**

On this post, the sawing stopped just above where the brace would enter. The tapered portion above is hand hewn.

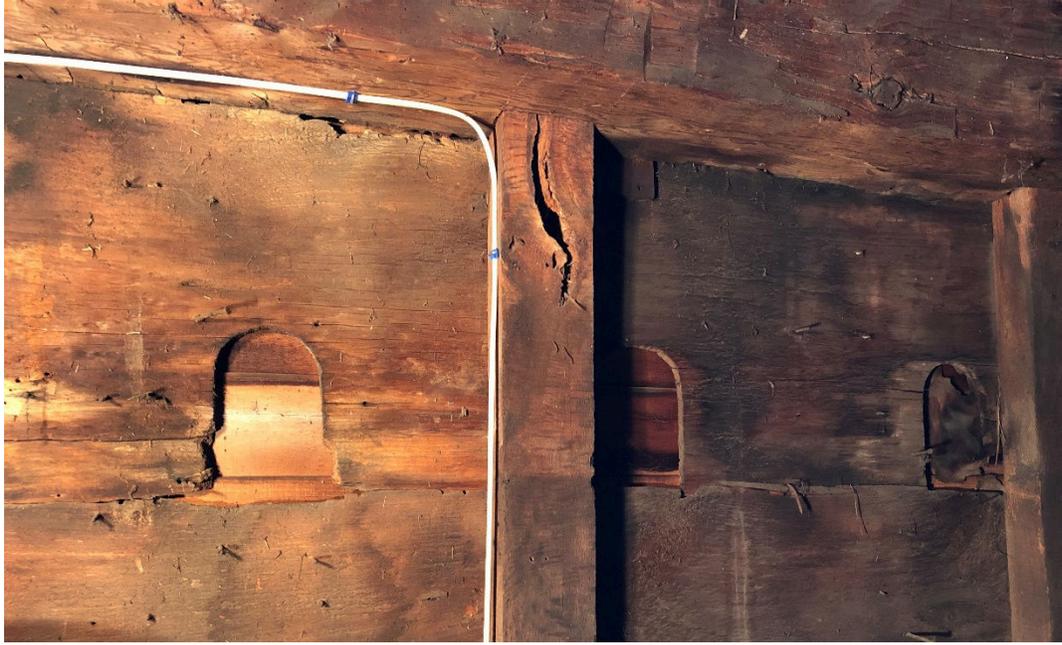
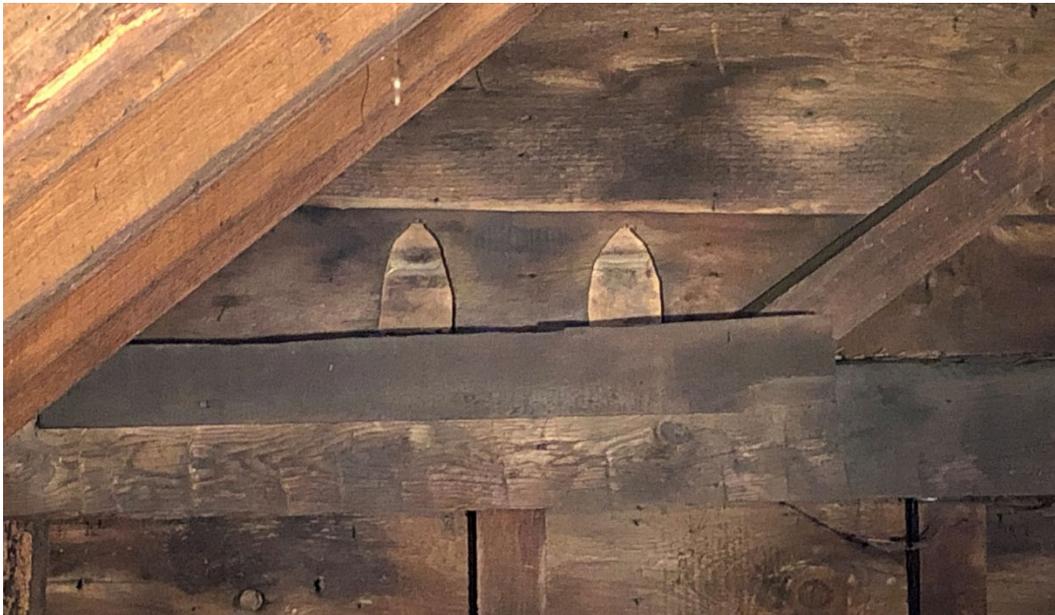
**Fig. 10 & 11**

Dovetail openings in the West gable just below the tie beam (photo above) and those in the East gable just above the tie (below).

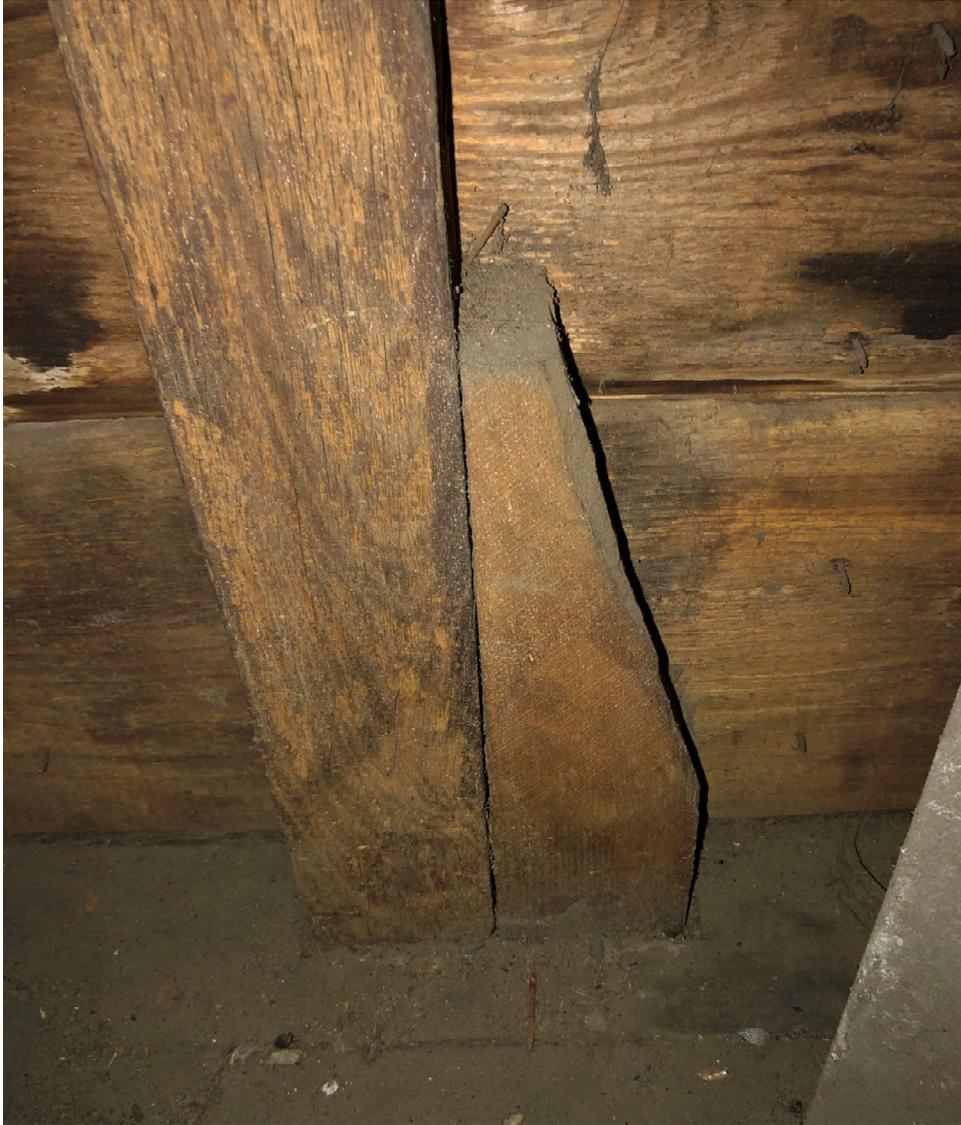
**Fig. 12**

There is also evidence that the structure underwent some restoration work early on, perhaps prior to moving it. Some stud bottoms visible behind the stairs have had their bottoms repaired with a nailed-on section that is probably tenoned in to the sill. This type of repair suggests decayed stud bottom tenons and a replaced sill beam. If the building was to be moved

The replacement piece on the right, which is likely tenoned into the sill, is tapered to permit nailing into the existing stud.

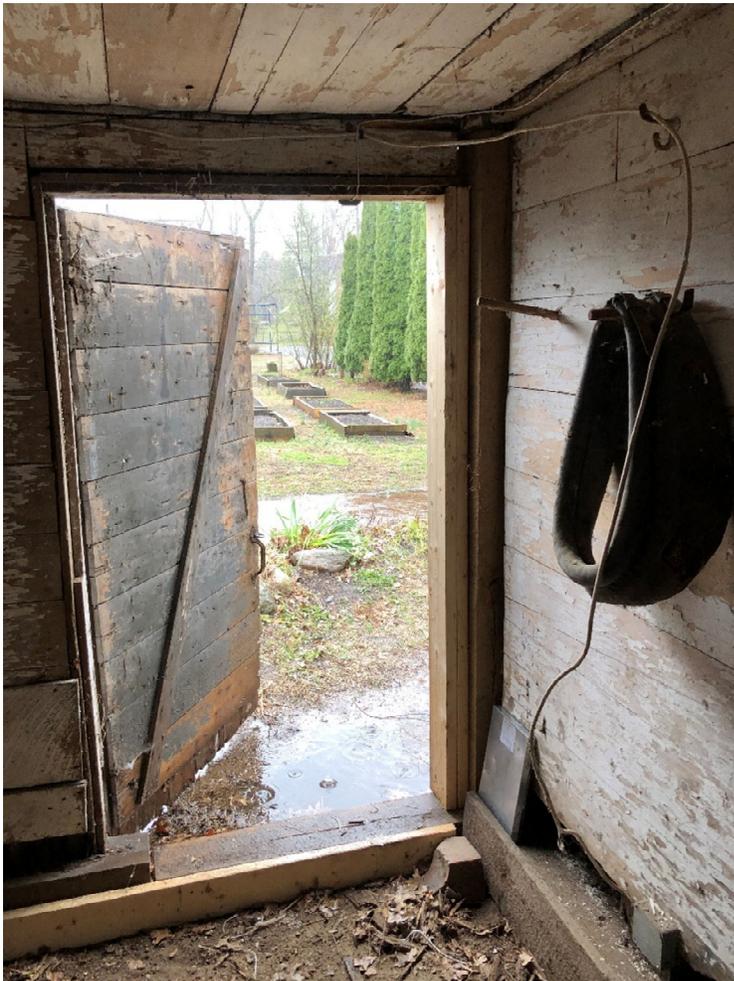
**Fig. 13**

For safety of the occupants in any future use, the flooring should be lifted up and this area examined. When originally constructed, the building's sill beams would have sat on a stone foundation wall along its perimeter and under interior posts, the sills would have borne on stone piers. Over the building's lifetime, these stones have sunken into the earth and the exterior ground has also risen so now the building appears to sit right on the ground. Wood, even preservative treated wood, does not last when on the ground.

Southwest corner horse stall doorway illustrates the at-grade condition of the barn. Note that much of this framing has already been replaced and some of it recently.

For permanence, wood needs to be elevated above the ground. Per the building code, untreated wood sills must be a minimum of 8" above grade, floor joists must be 18" above earth, and floor timbers 12" above earth. Preservative treated members can be used, but their life expectancy is only 20 or 30 years longer than untreated if exposed to ground and dampness. That is too short a time frame for such an important component to last before replacing. Thus, there are two basic options for this barn:

1. Repair or replace the floor structure as necessary, elevate the building at least the minimum to meet the building code. Since we don't want a crawlspace under the barn that is even with or below the outside grade so as to collect water, that would mean raising the finish barn floor a minimum of 28" above the highest existing grade (the Southeast corner?). A new perimeter foundation would be installed with footings below the frost line (four feet) and interior pier type footings under posts and girders. The foundation would be concrete but it could be faced with stone or brick, or entirely masonry above the ground for appearance sake. The advantage of this option is that it retains the original timbered floor design.

2. Remove the wood floor structure entirely and replace with a concrete foundation and concrete floor slab. The concrete perimeter walls could extend a few inches up the walls to provide the required separation distance to grade. The finish floor could be concrete, stone, or tile, or a wood floor (using original planks) built on top of the slab. As with option 1, the concrete wall could be faced with stone or brick on the outside (and inside) if desired. The advantage to this option is that it retains the original floor height near grade. It would also permit increasing the clear ceiling height under the loft to 7' - 6" to meet the code.
