HISTORIC NORTHAMPTON

Application for Community Preservation Committee Funding, September 9, 2015 *Structural Repairs and Environmental Control*

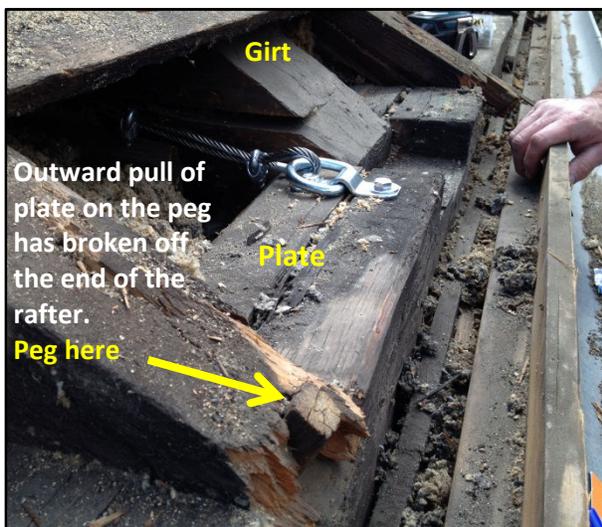
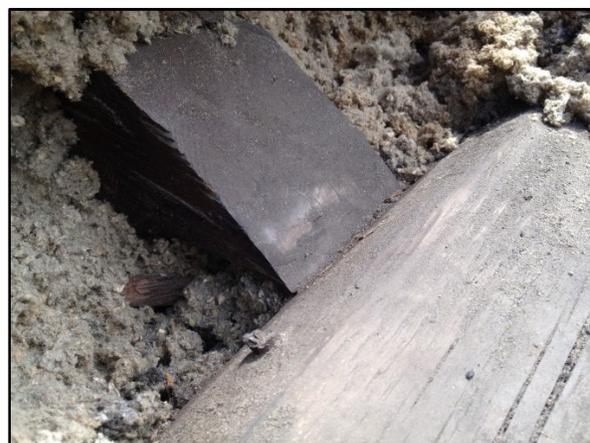
Case in point: When Kris Thomson uncovered the rear plate at Parsons House in the course of CPA-funded work this summer, he found that the pegs pinning the rafters to the rear plate had completely ripped the bottoms of the rafters out. The rear plate, for those of you who aren't timber framers, is the beam at the top of the back wall where it connects to the roof. Kris also discovered that the girts that tie the front and back of the house together had slipped four inches out of position and that some of the ceiling joists were being held up only by lath and plaster. The extent of the displacement startled everybody and we were all glad this work had not been delayed. Another year or two and the situation would have been quite dangerous and far more costly to repair.

Above: View of attic joist (darker) slipped entirely off the rear plate (lighter) that it should be sitting on.

Left: View of rear plate (now cabled to stable beams in main house) showing how movement of plate has caused (1) the peg to rip through the rafter (foreground), and (2) the girt to slip out of its slot in the plate (upper right, near hand).

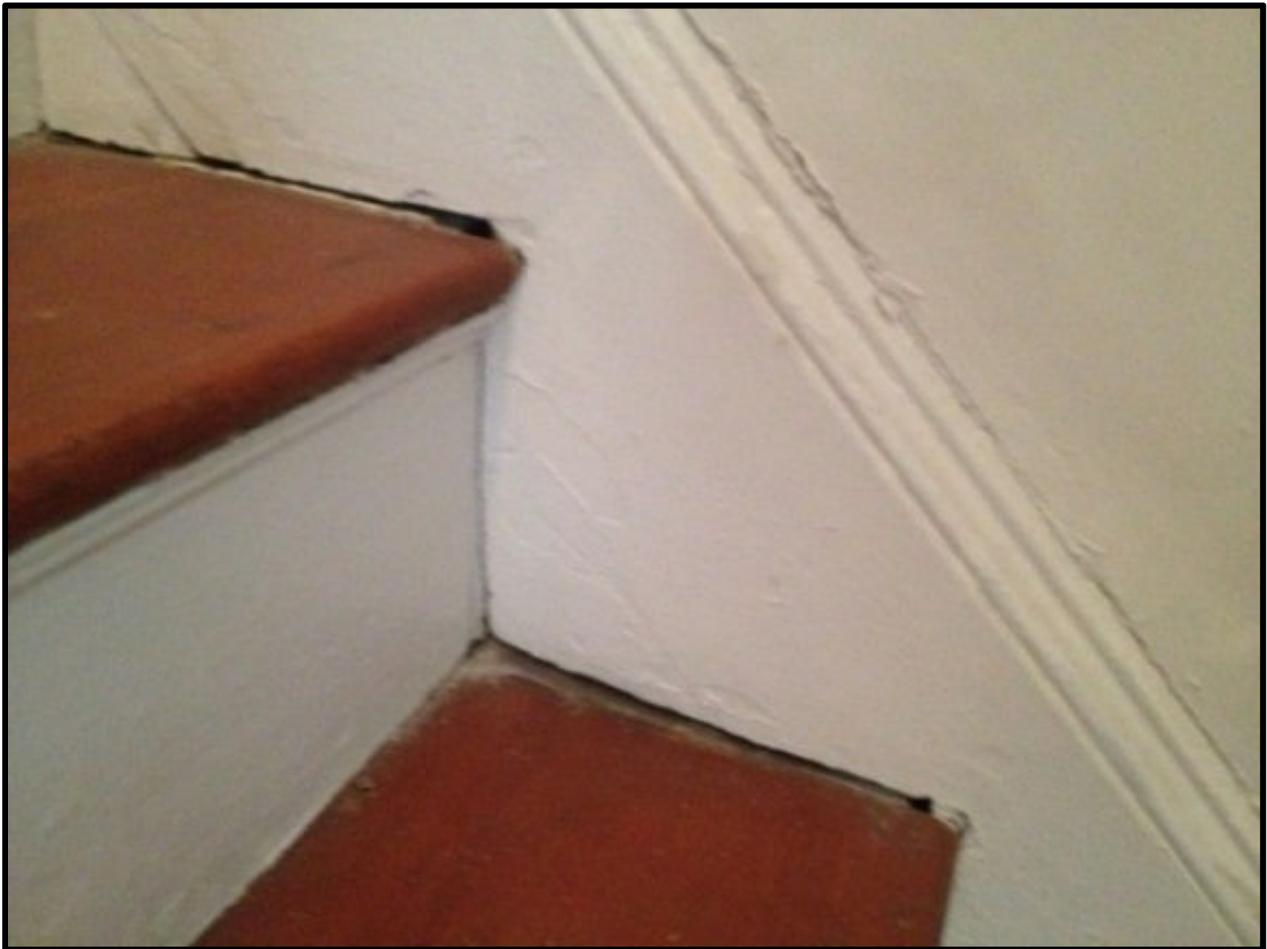
Like Shepherd House, which was stabilized using the 2014 CPC grant, Damon House is a four-over-four-room center hall house with two chimneys, one serving the rooms on the west side, the other serving the rooms on the east. Like Shepherd, it is sagging in the middle between the chimneys. In Shepherd, the cause was clear: water had rotted the bases of the support posts in the basement and they had fallen over. In Damon, the cause can't be photographed because the basement ceiling and posts were covered over about 1980, but the effects upstairs are even more pronounced. On the west side, there are dramatic stress cracks in the first-floor wall plaster between the chimney and the central hall, while on the east side, the floor has dropped 1.5 inches below the bottom of the walls.

Above: the center hall front stairs in Damon House, showing a crack opening up between the treads and the stair skirt as the stair itself sinks.

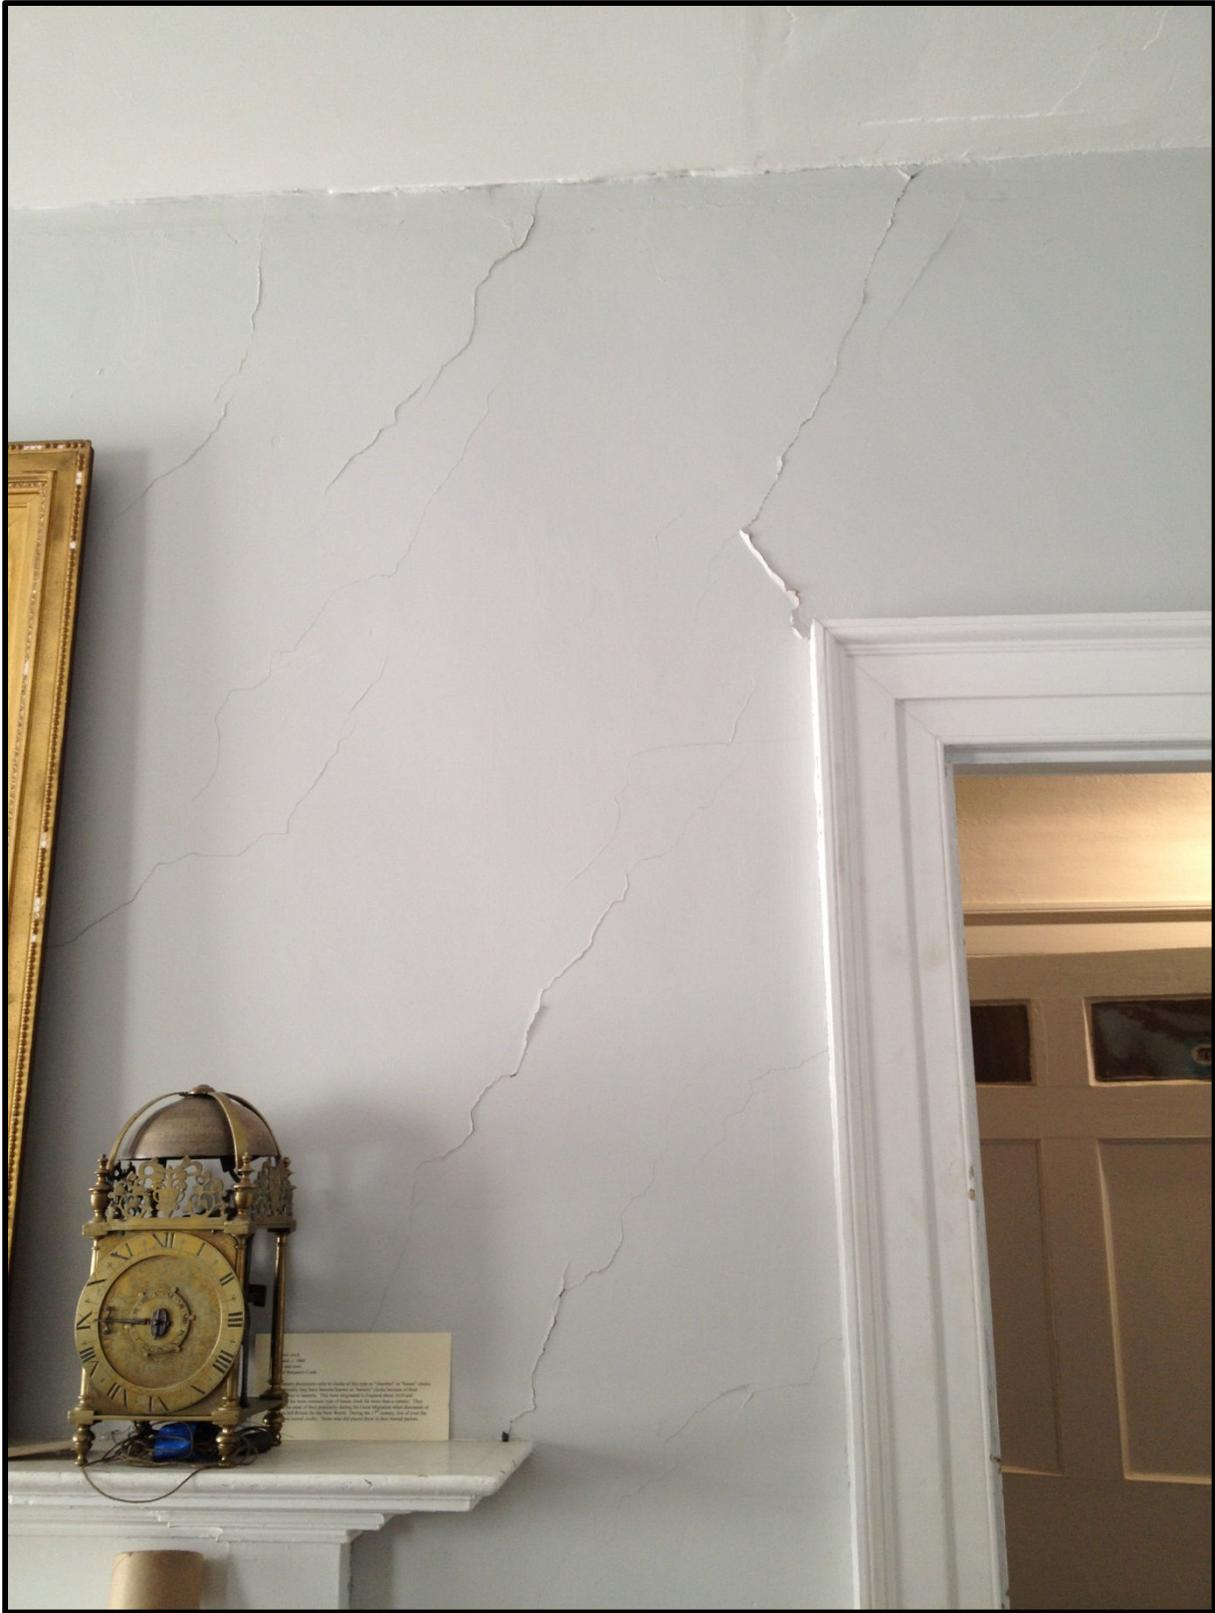
Above: Damon West Parlor showing stress cracks over fireplace as center (to right) sinks.

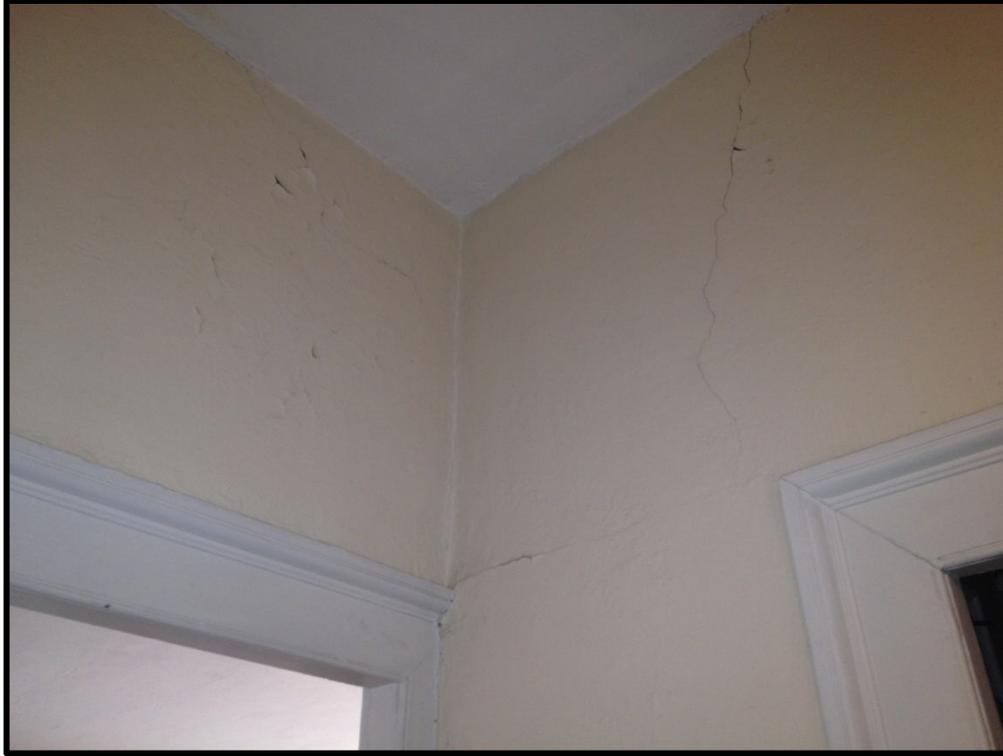
Above: East Parlor, less dramatic cracks where interior wall meets exterior wall (R).

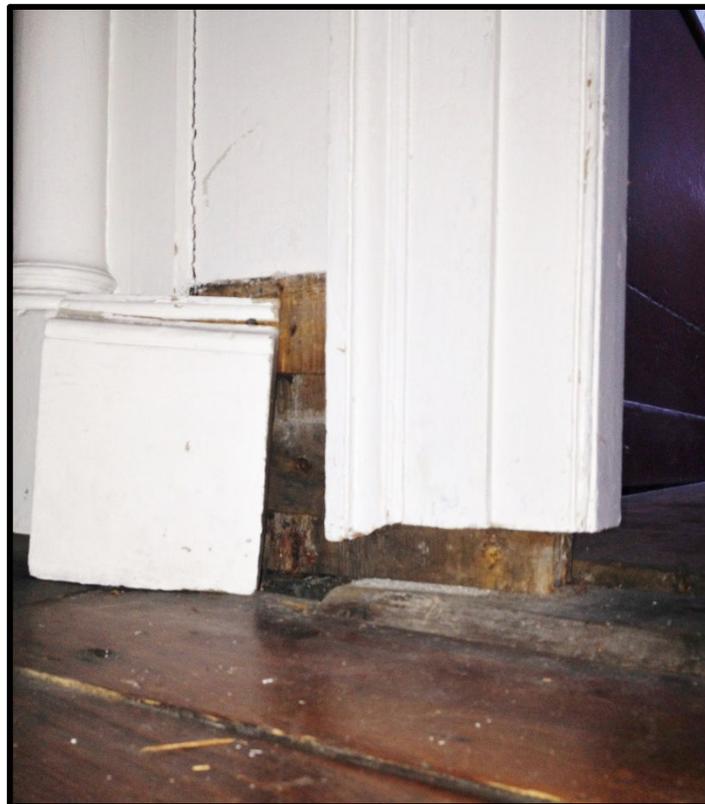
Below: East Parlor, floor is sinking and separating from trim between fireplace and door.

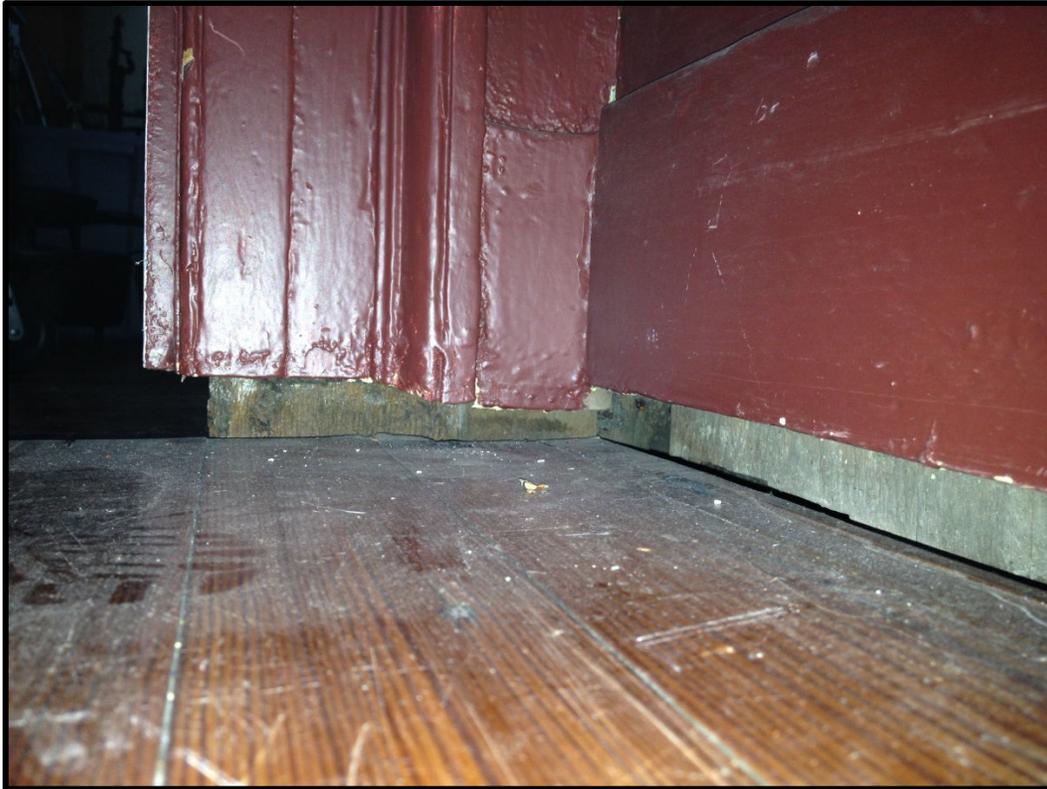
Above: Research room directly behind East Parlor, showing drop in floor from other side.

The plan for fixing this is similar to what we did in Shepherd House. First we will remove part of the basement ceiling to confirm the nature of the problem. Most likely we will add a series of posts to support the beams under the walls of the center hall and under the interior partition that divides the front rooms from the back. This requires taking down and then replacing sections of the basement ceiling, which was installed in about 1980 to keep the area cleaner for collection storage. Below we show pictures of what Damon basement looks like now.

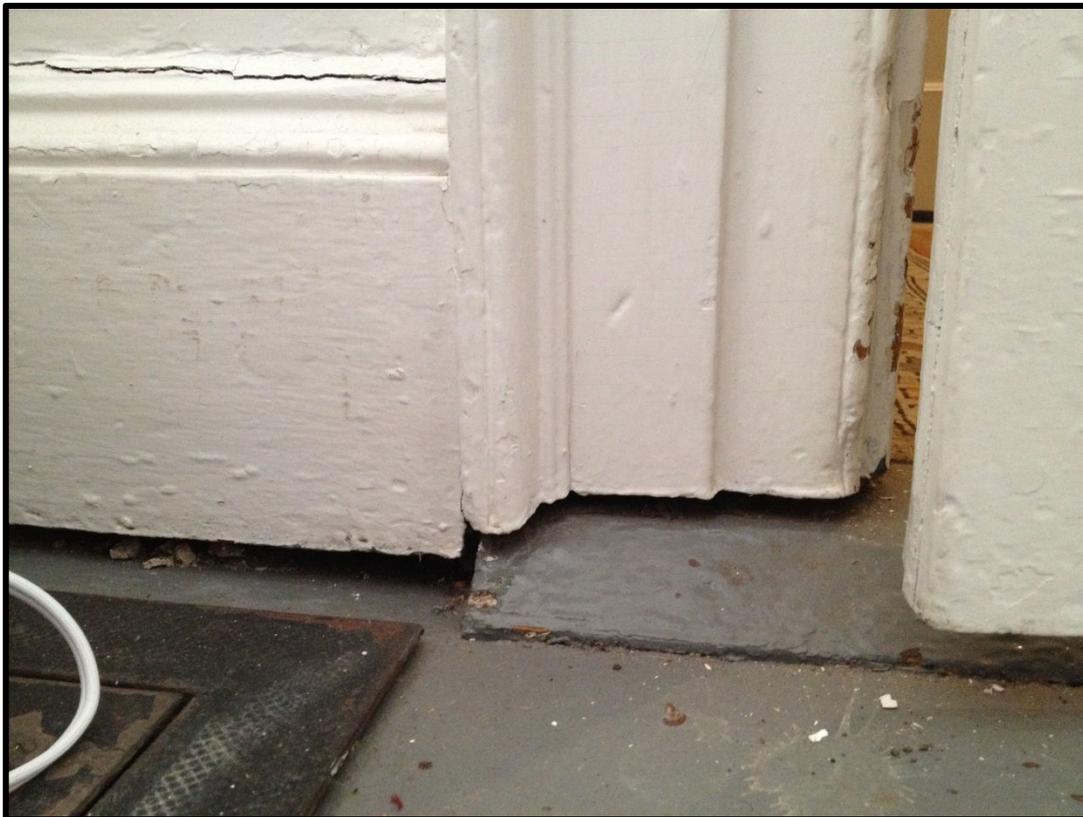
Below: separation of floor and wall in West Parlor to right of fireplace.

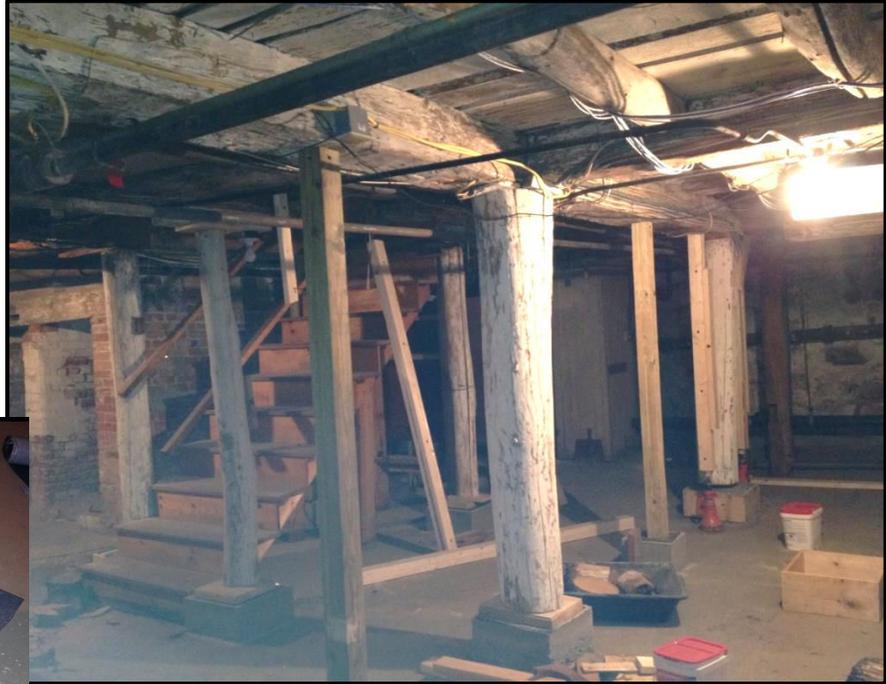
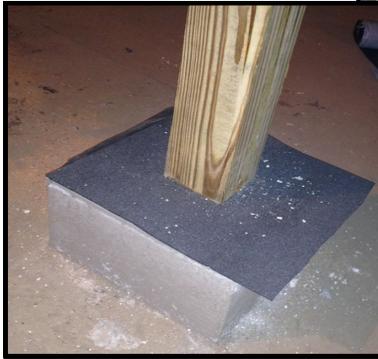
Below: Here is what the posts look like in Shepherd House (which is now asbestos, fiberglass, and mold-free, not to mention mud-free and dry for the first time in living memory). The original posts are upside-down tree trunks. The modern ones on either side provide additional support for the center-hall bearing beam.

Left: The black layer prevents dampness from migrating from the concrete up into the post.

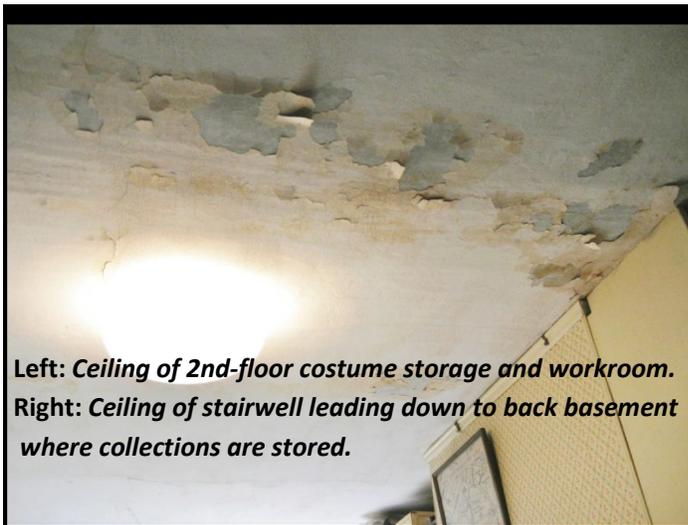
Our roofer, Jim Flannery, warned us some time ago that we would need to replace the Damon House roof soon. This hardly came as a surprise. We had been experiencing leaks for several years in the typical problem areas where the planes of the roof come together, but we had only been able to replace two or three small sections. The most cursory inspection shows stained and sagging ceilings in several rooms.

Left: Ceiling of 2nd-floor costume storage and workroom.
Right: Ceiling of stairwell leading down to back basement where collections are stored.

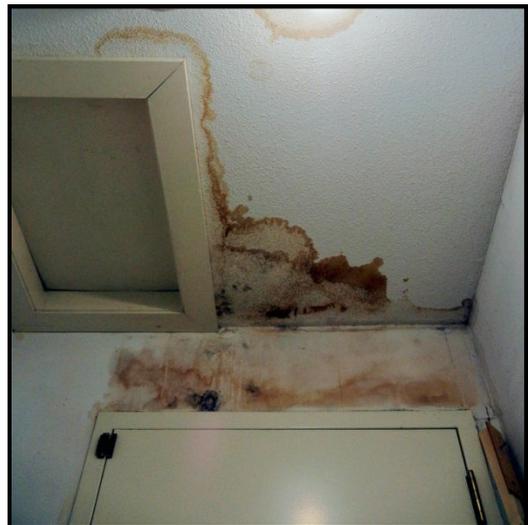
Right: Ceiling over the quilts in the flat textile storage room.

The estimate for the roof includes replacing the entire roof except for those areas recently done (see detail in attached estimate). The price is higher than one might expect because the balustrade around the edge of the roof needs to be removed and then replaced. All the posts in the balustrade have to be flashed.

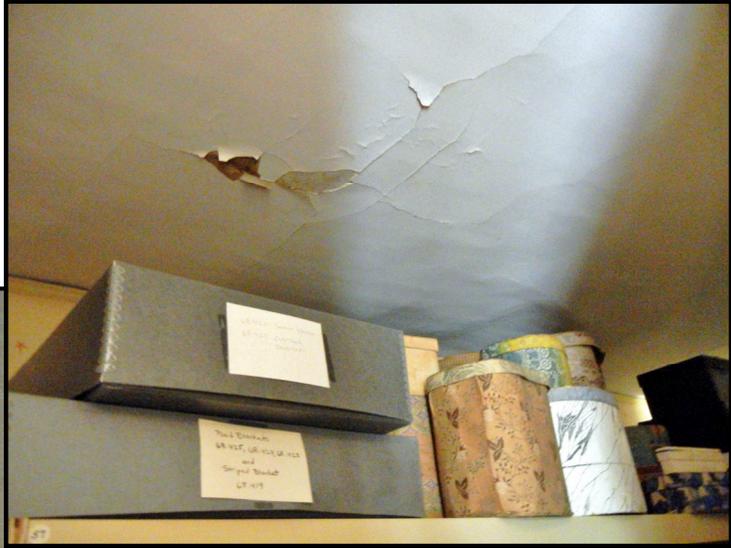
Below: Ceiling of research room over doorway to Marie's office.

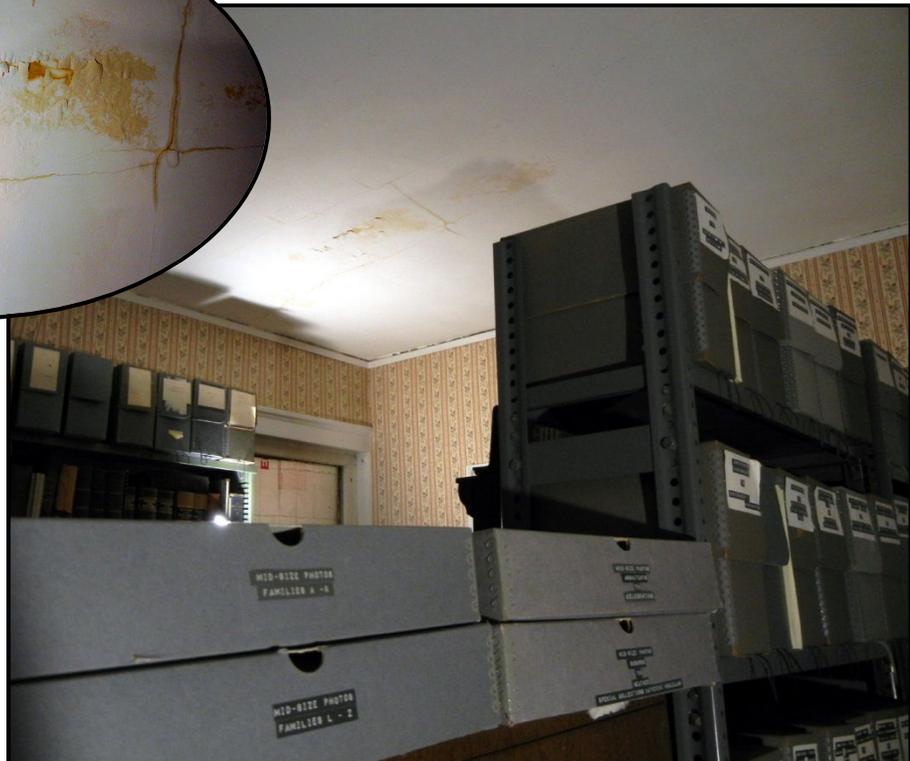
Below: Photo and ephemera storage room with close-up of damage.

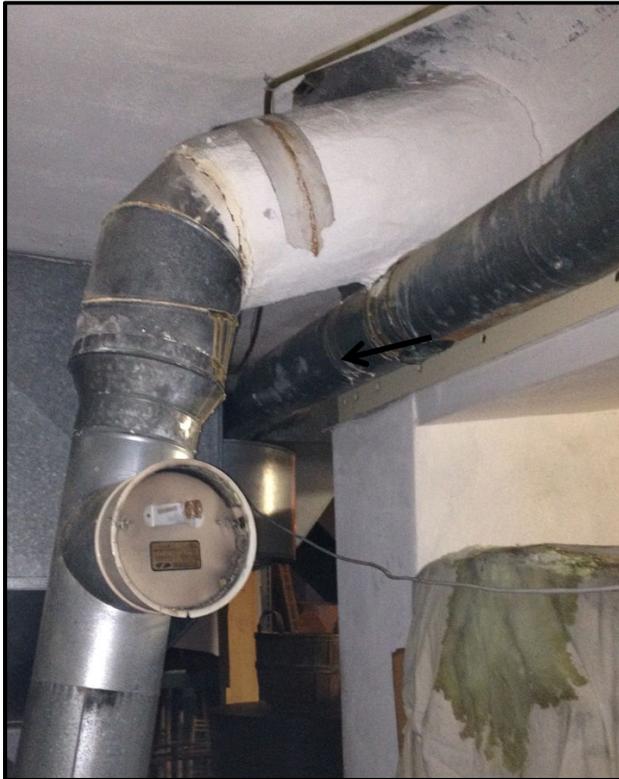
Above: Water leaked from chimney through asbestos casing around furnace pipe. Drip left a green deposit on dust cover over collections

Last fall, when we discovered yet more leaks, in this case damaging asbestos in the basement, we had new copper flashing put around the chimneys (and yes, the asbestos was also fixed).

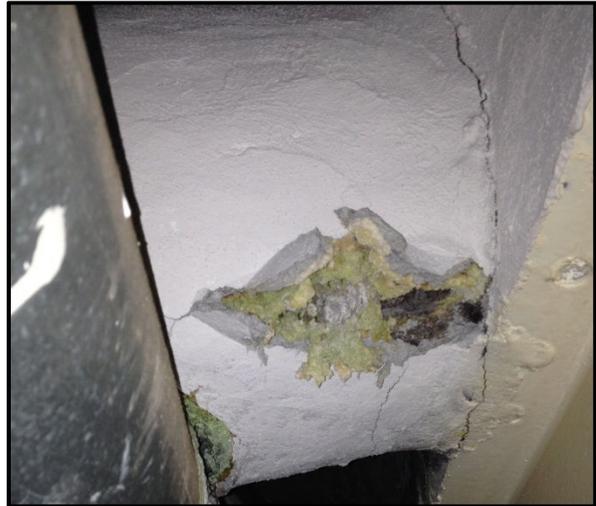
Above: Leak through the asbestos (hidden by pipe at left)

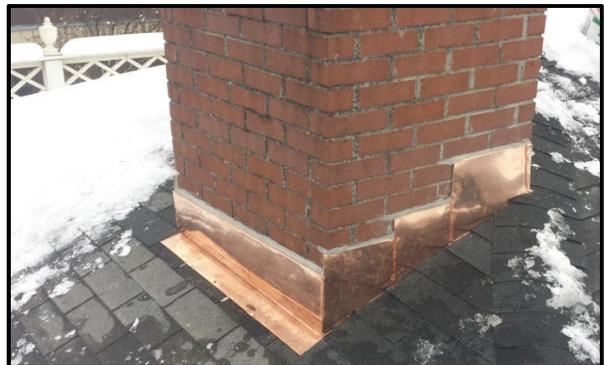
Gorgeous new flashing!

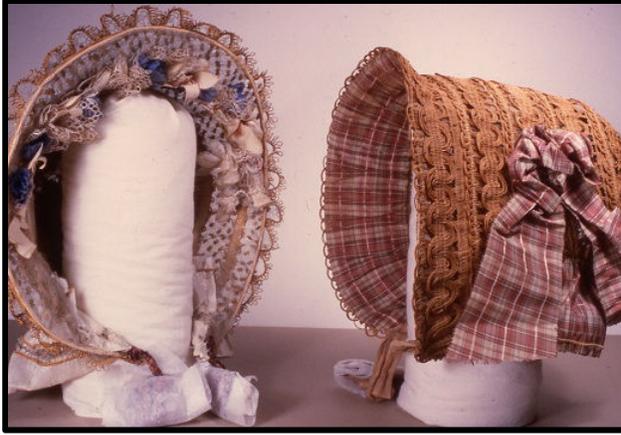
Then this summer when we went up to clean one of the costume storage rooms, we found a leak on the shelves holding our world-class collection of mid-19th-century bonnets.¹ They are rare and irreplaceable and conservation is beyond our means. We have draped the storage shelves in plastic, but we now believe the roof to be an urgent issue.

Above, close-ups of bonnets stored near the leak.

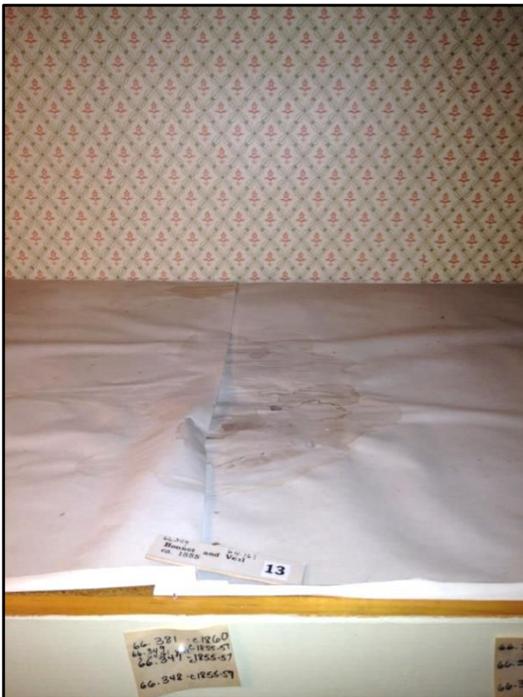
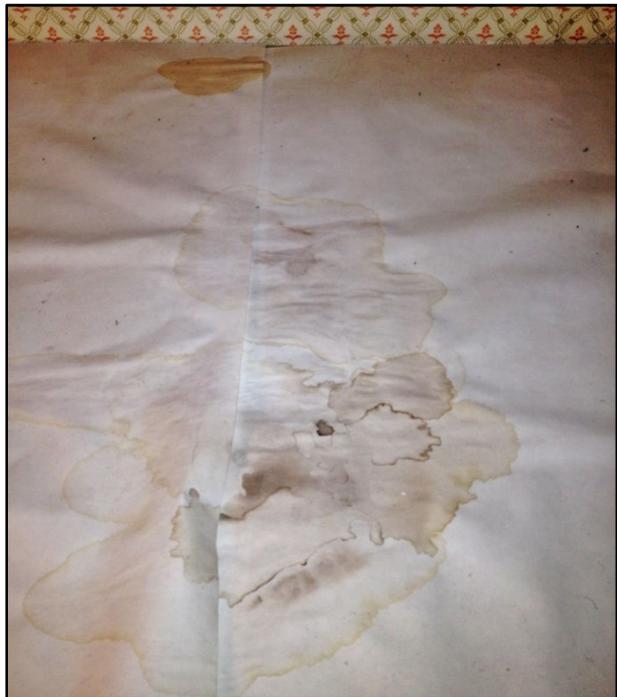
Below, two views of the upper shelf showing evidence of water dripping onto the bonnets from the ceiling.

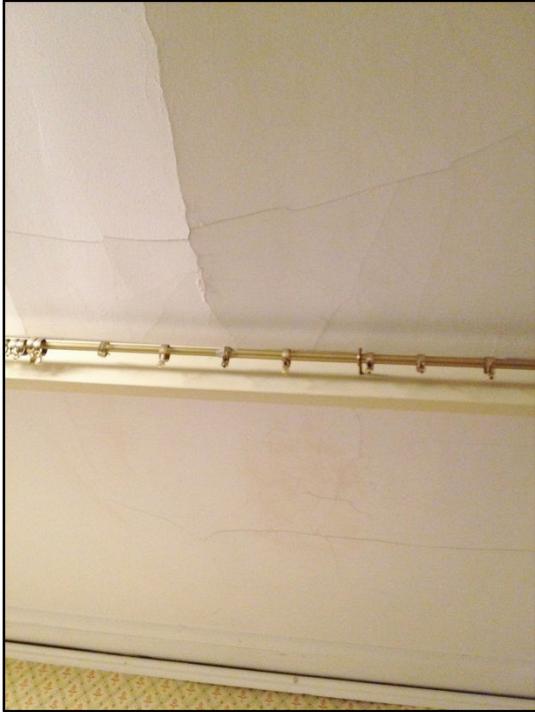
Left: looking up at leak-damaged ceiling crossed by a strip of wood supporting the brass rod for hanging the curtain in front of the storage shelves. Shows plaster beginning to drop. The rod fixture is probably what kept the ceiling from falling. **Below right,** volunteers making a plastic roof over the bonnet storage shelves.

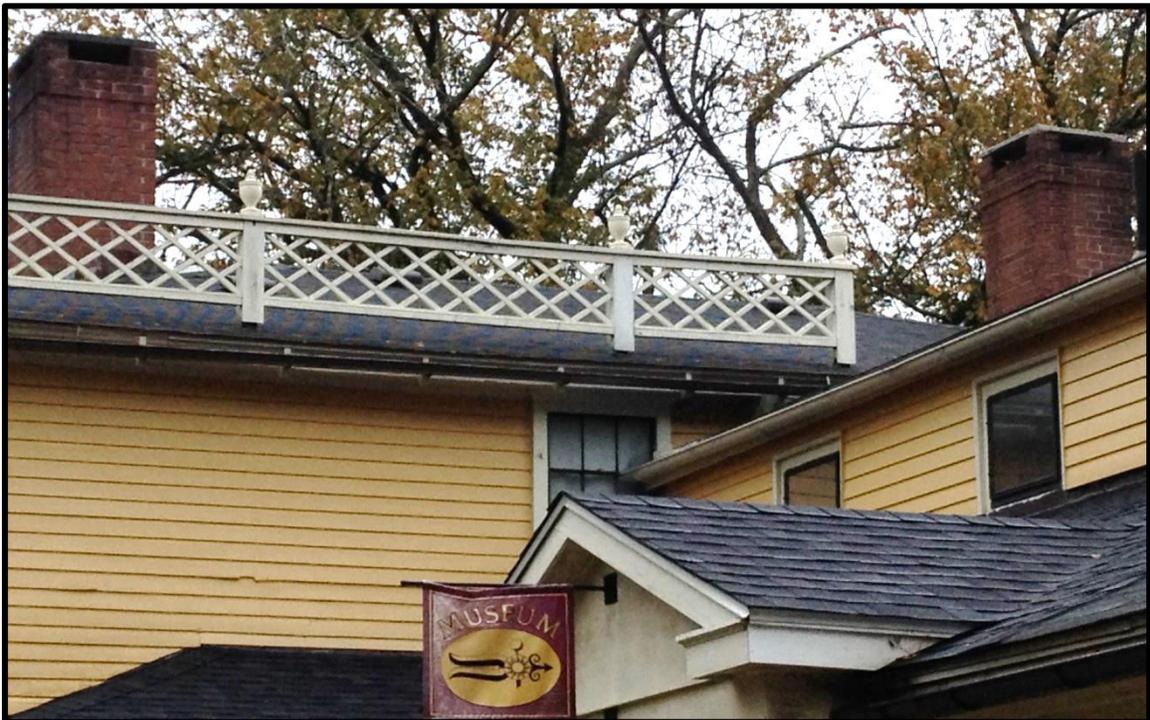
Below: View of Damon showing various roofs. The darker one in the middle is the section more recently done.

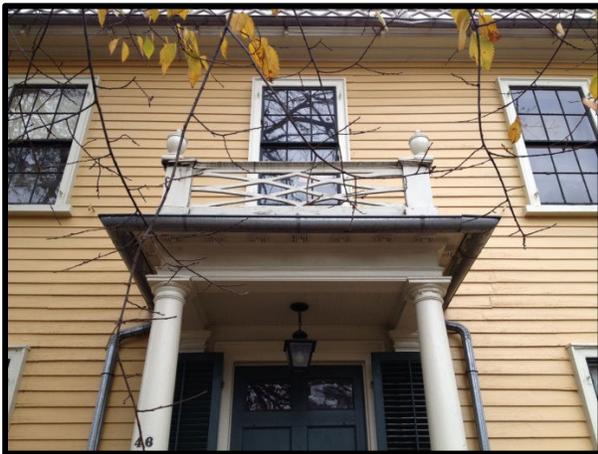
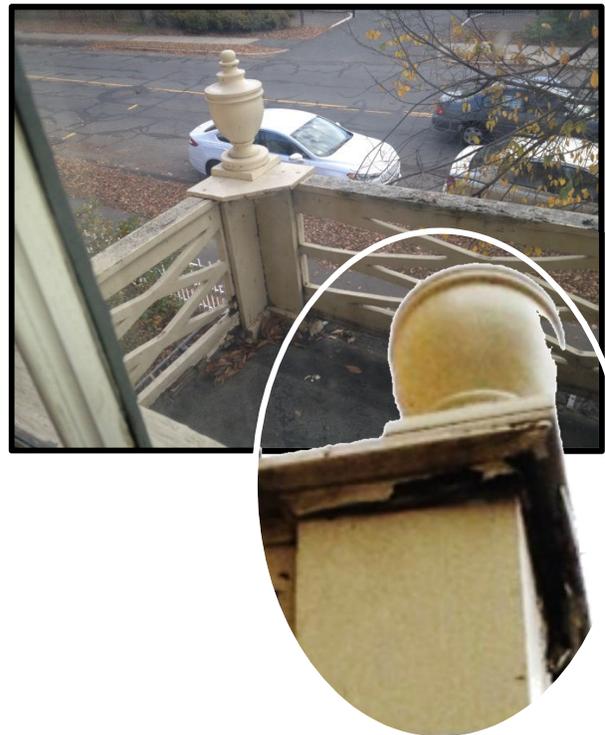
Replacing the roof includes replacing the small porch roof over the front door. To do that, we need to remove the balustrade, so that makes this a good time to repair it. At least part of this structure is a modern plywood replacement. We would like to restore this properly with rounded top pieces that will shed water rather than rotting like the current ones. The Historical Commission has already approved this work.

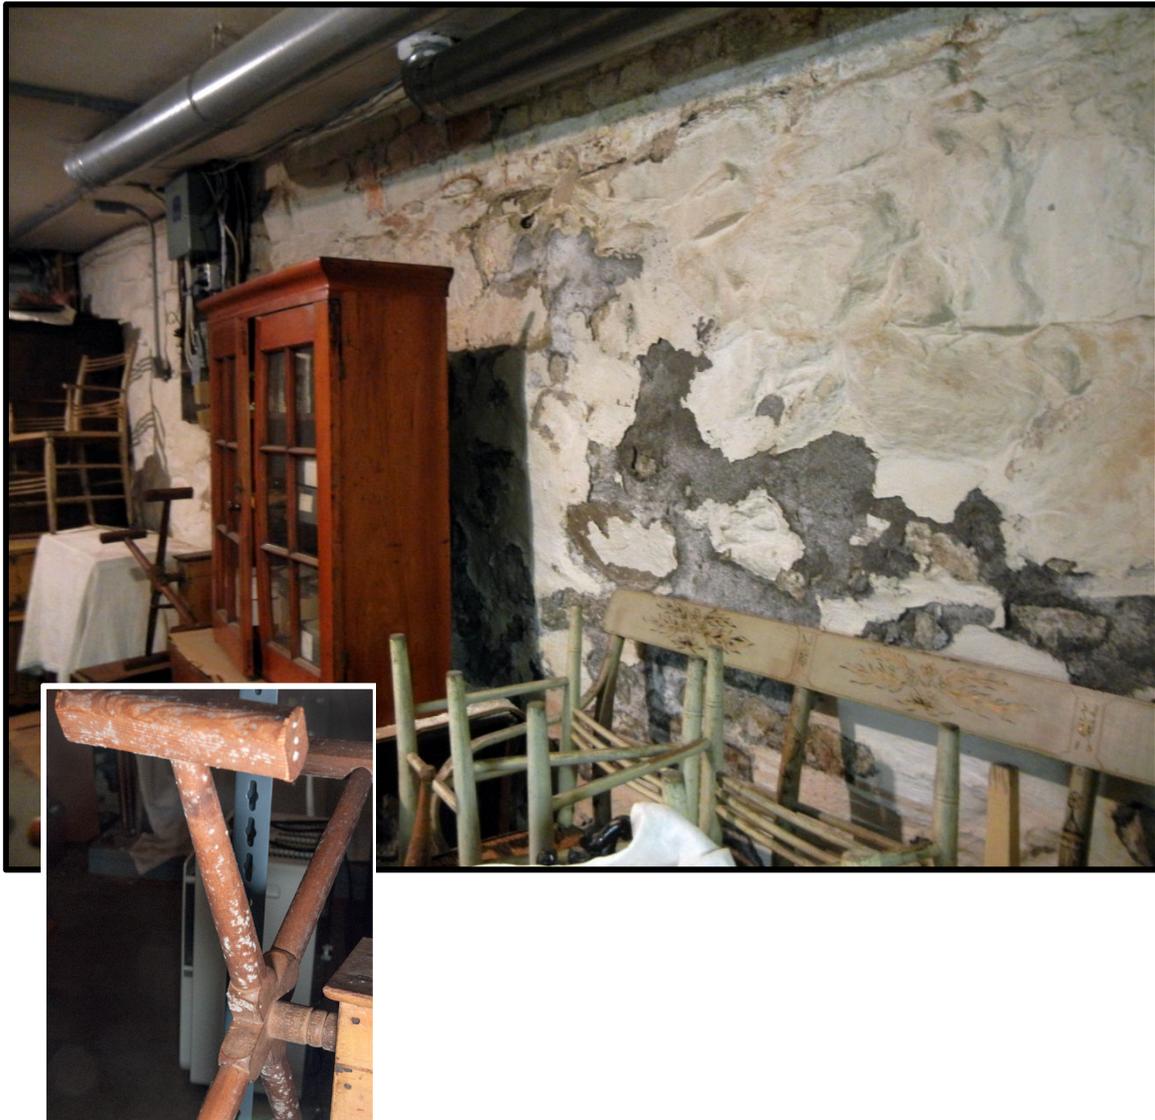
In about 1980, the fieldstone basement foundation walls were given a waterproof coating that looks like white paint. This worked well enough where the grading and guttering were correct. But because water from the front step flows down along the outside of the front basement wall and then seeps between the stones, that section of wall is always damp, and the dampness causes spalling (the breaking off of bits of stone, mortar and wall coating). Now, with the 1980 coating broken down, the walls are dropping dust and dirt and the dampness has caused mold to grow on the collections.

Once the doorstep, gutters and bulkhead are taken care of, the preferred way to waterproof the interior is to line the foundation with closed-cell spray-foam insulation, as shown in the internet photo below. This creates a very effective vapor barrier which is then covered with wallboard.

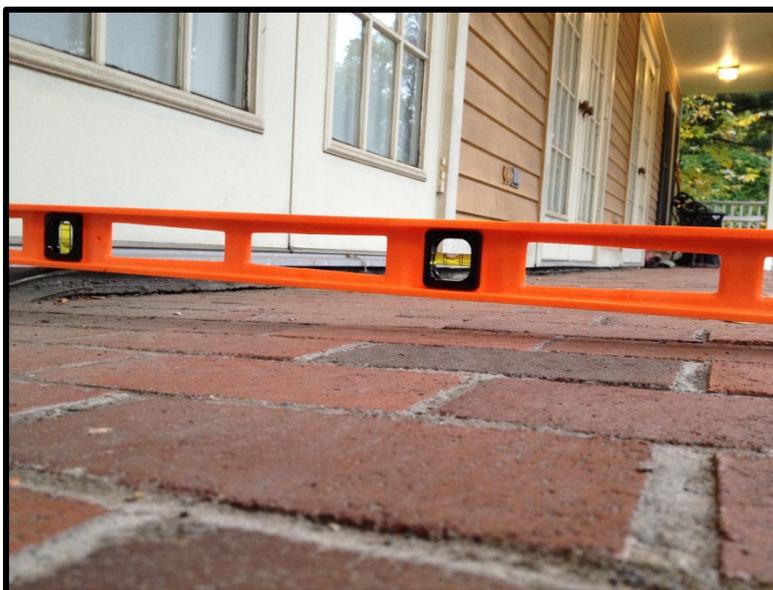
Just as the front step is letting water flow into the front basement, the brick floor of the veranda is allowing water to flow into the back basement. Over time, the sand underneath it has settled and the entire walkway now tilts toward the building.

This picture had to be brightened to show the rain. Note the darkened low spot on the brick under the window where the water is collecting at the foundation.

It is not enough to even out the sand underneath the walk and re-lay the bricks because the same syndrome is likely to happen again. Instead, the mason plans to remove the existing walkway, dig down along the edge of the foundation, and create a series of masonry supports that tie into the existing block foundation and stick out just below the walkway. Then the sand will indeed be brought up to level, but the concrete pad on top of it will have its edge resting on the new supports and will thus be supported by the basement wall and footings, so that even if the sand settles, the concrete pad shouldn't go with it. This plan may need to be adjusted depending on what we find when we remove the brick.

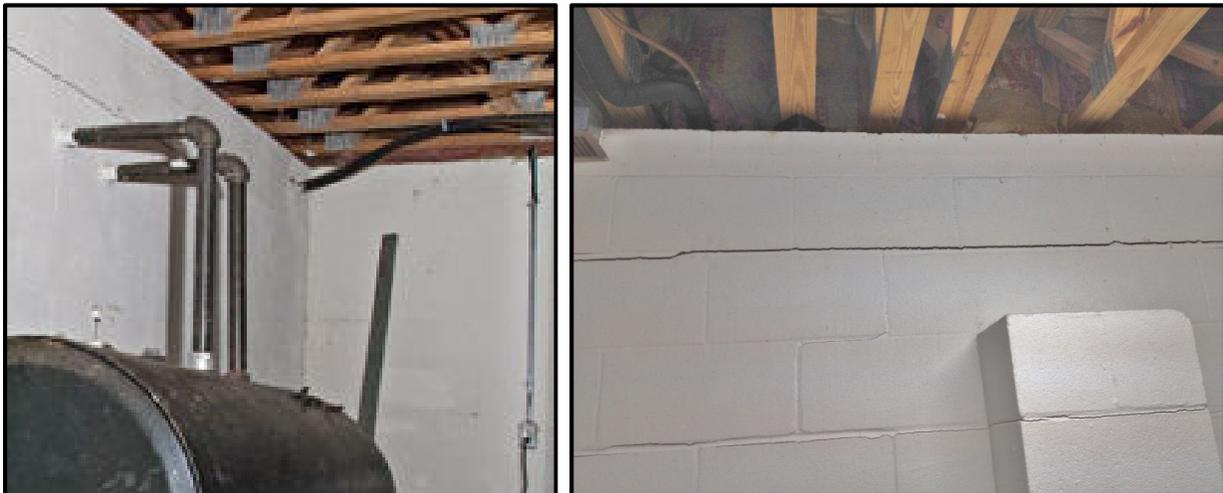
The seepage is not the only problem. Apparently the pressure of the tilting walkway pushing against the east foundation is causing problems in the foundation on the *other* side of the building. The floor in the Damon Education Wing has to span a very large open area and it is supported by a system of interlocking wooden trusses strong and stiff enough to move as a unit. The truss system is attached to the top of the masonry walls on both sides. The tilting brick walkway (which, being mortared together, also moves as a unit) is pushing against the eastern edge of this truss system. Under that pressure, the truss system has pushed the upper courses of the west foundation wall out of alignment. The lower part of the west basement wall is perfectly straight and plumb, but the top bends outward toward the Talbot's parking lot. The mason and general contractor believe that the way to fix this is to fix the walk, to stop the pressure of the walk against the floor/sill and that then the west wall can be patched and will be OK. In the pictures below you get a glimpse of the floor trusses and the long crack that has opened on the west wall a short way below them.

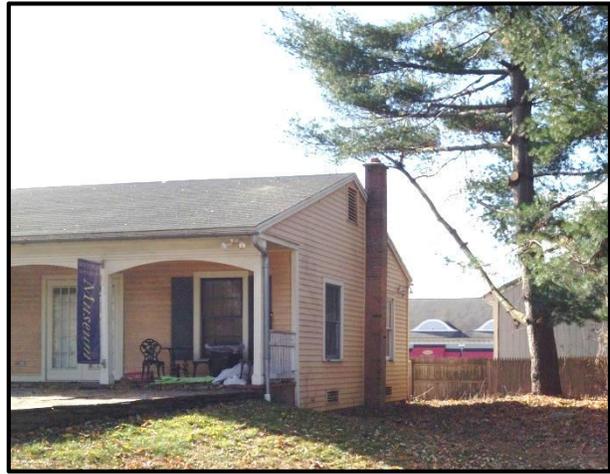
Right: Windows in question are on each side of the chimney.
Below Right: Damage requires replacement or removal

The last item on the Damon House list is to close up two windows at the back end of the 1985 Damon Education Wing. This will require approval by the Historical Commission. These windows have been blocked on the inside for about fifteen years because the interior space is used as a gallery. The interior covers limit the arrangement of the room and create yet one more obstacle to using our spaces. On the exterior the windows are badly damaged because for a long time trees and bushes were allowed to grow up thickly next to the building. The original materials were of very poor quality (pieced lengths of trim). Removing them and closing up the openings is cheaper than replacing them. These windows are non-functional and rarely noticed. A third window in the same gallery is also blocked on the interior, but it faces the veranda and is part of the rhythm of the public façade. That will not be changed.

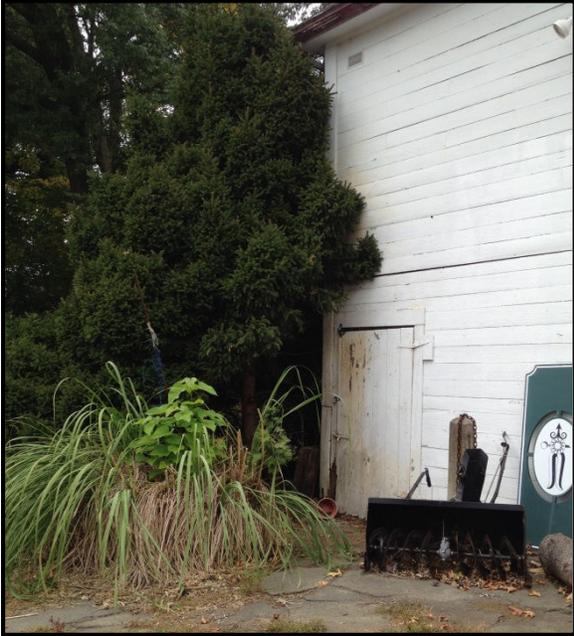
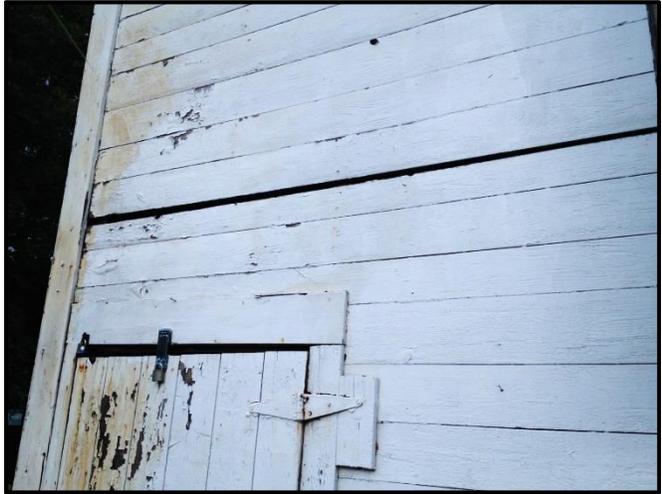
- A “bush” planted at the corner that grew into a vampire
- Gutters that rusted into holes
- Broken roof slates that were not replaced
- Brush and leaves piled up against walls of the building

Above: Southwest corner of barn in the vampire embrace of a badly-placed "bush." Entire corner post must now be replaced.

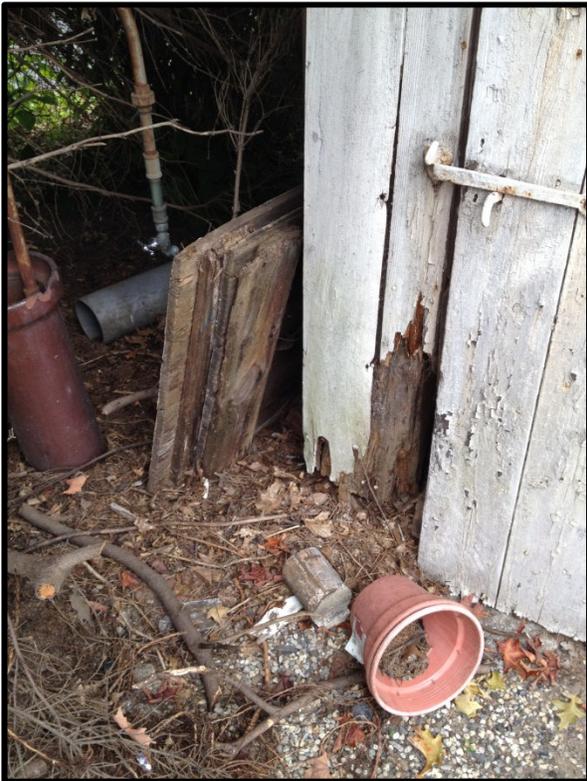
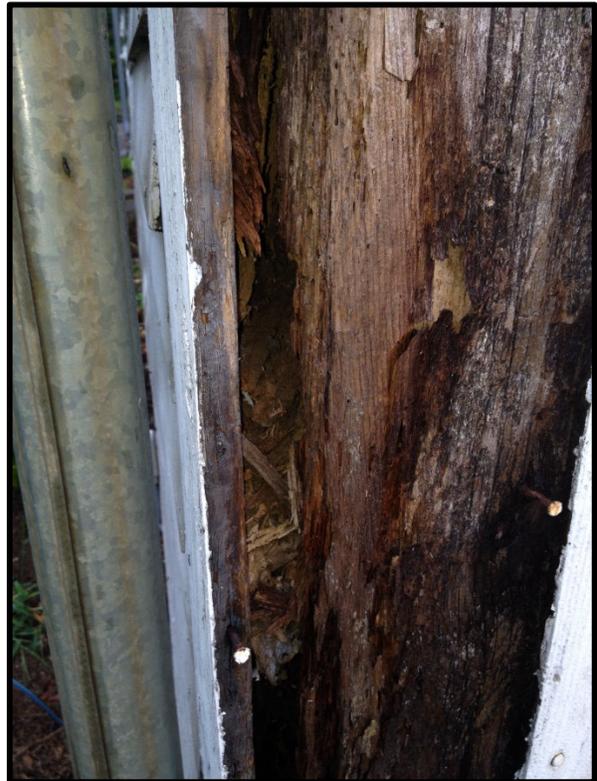
Below left and right: The corner post shaded by the tree is completely rotten.

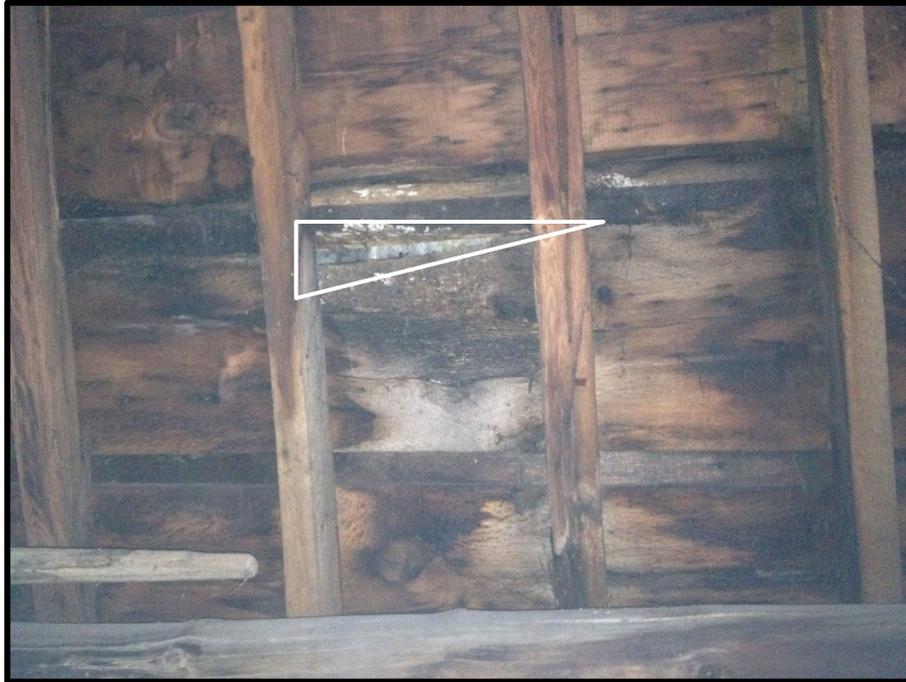
Water dripping through the roof where slates were not repaired has caused major damage to the rear plate, the front plate and three posts, and has worn a hole completely through the second floor, illustrated below.

Above: A missing roof slate let water pour through a gap in the sheathing onto the floor below . . .
Below: . . . creating a hole in the floor the same shape as the hole in the roof
