HISTORIC NORTHAMPTON

Application for Community Preservation Committee Funding, September 9, 2015 *Structural Repairs and Environmental Control*

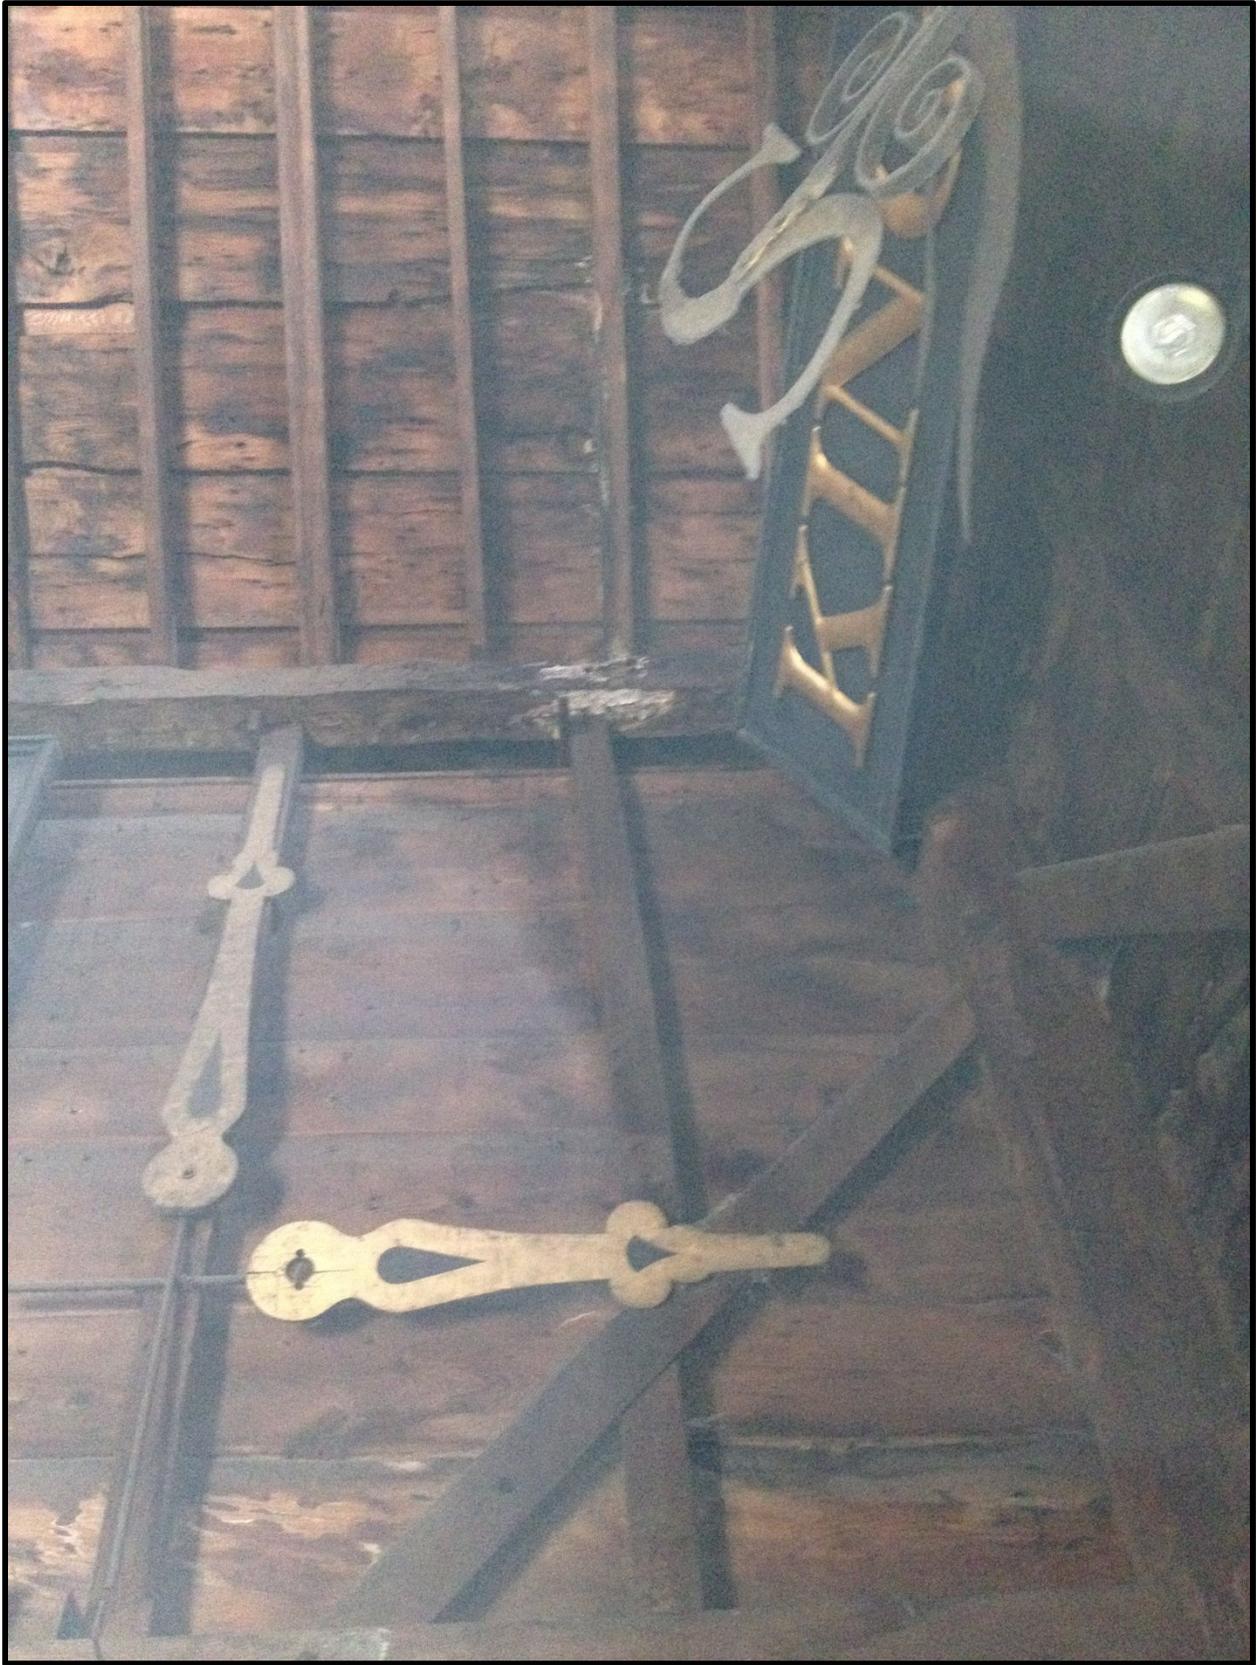
Looking up at the northeast corner where there was a major leak in the roof. See close-up next page.

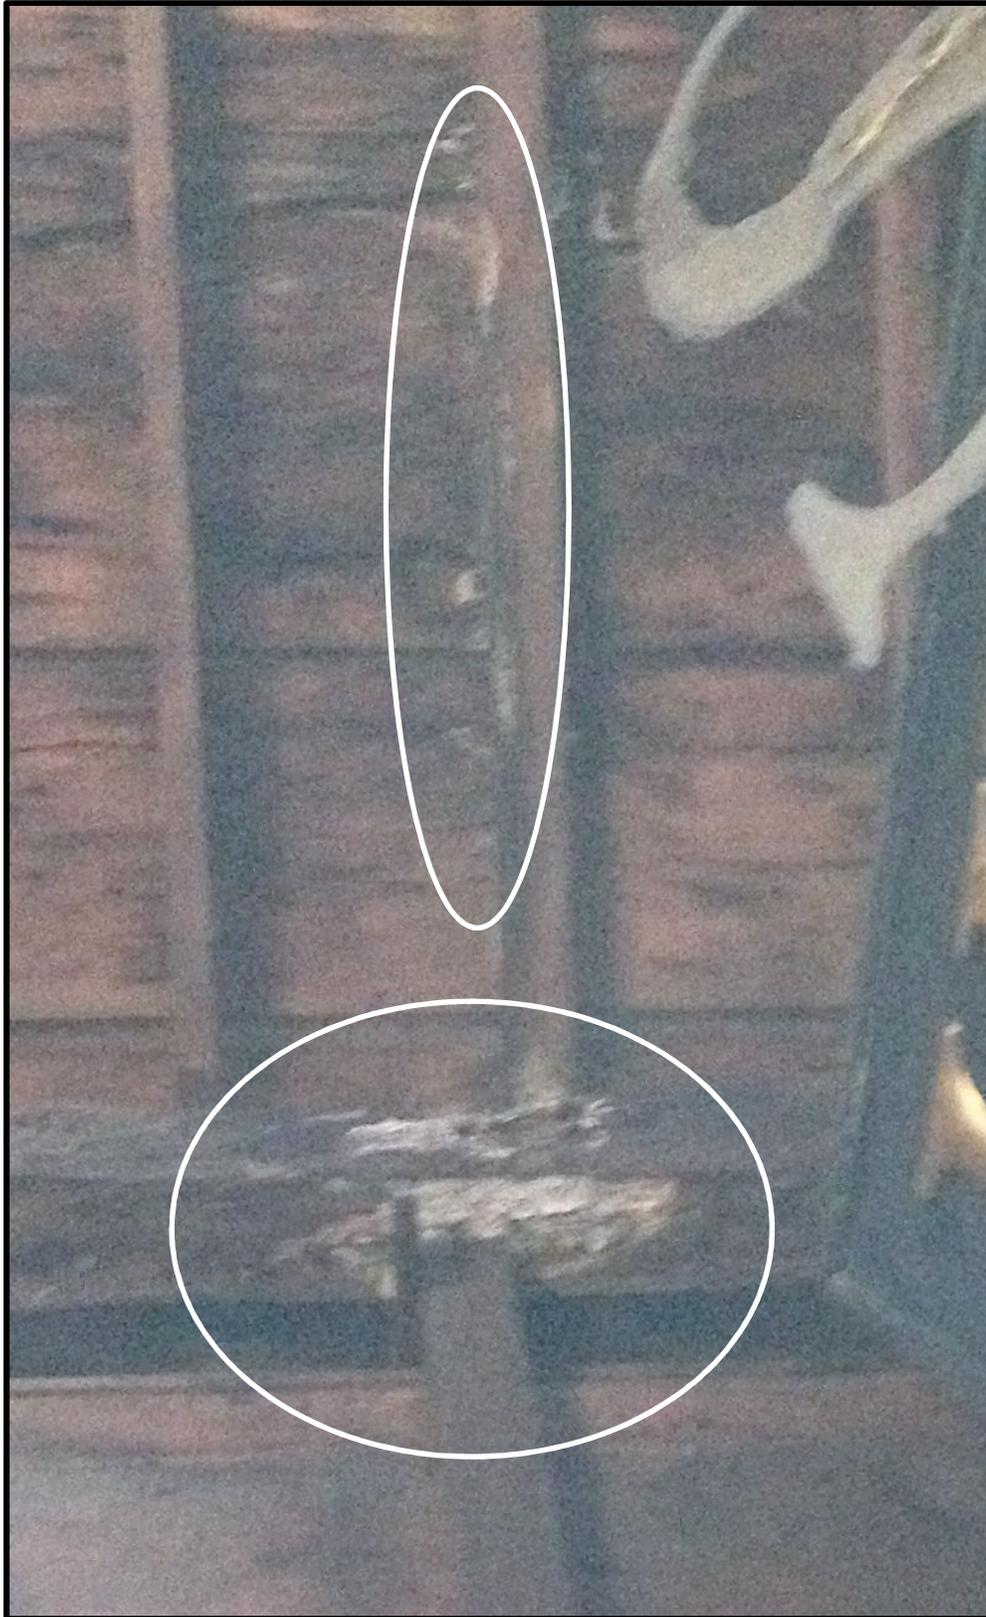
Close-up of the east end of the rear plate, which supports the roof, showing heavy mold damage.

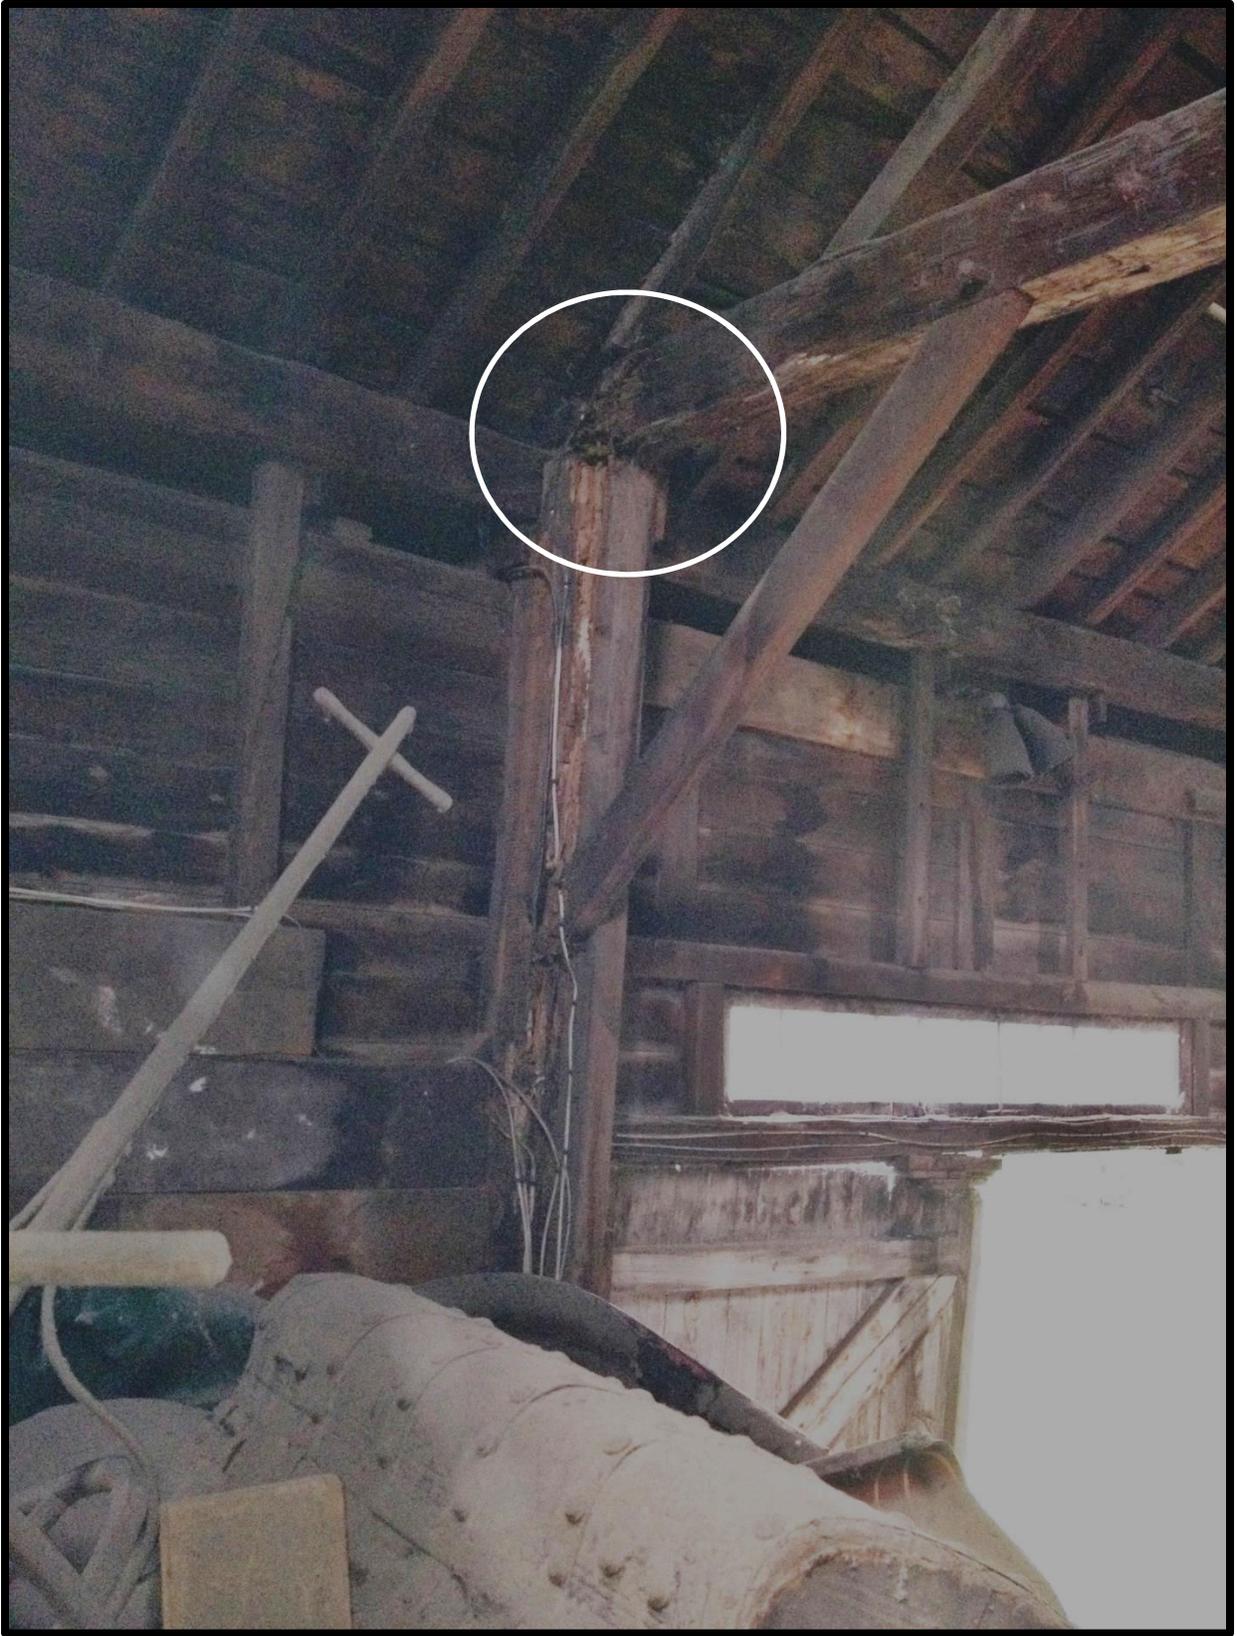
Above: Area is too dark and distant to photograph well, but the circled juncture of post and beam appears to be reduced to splinters.

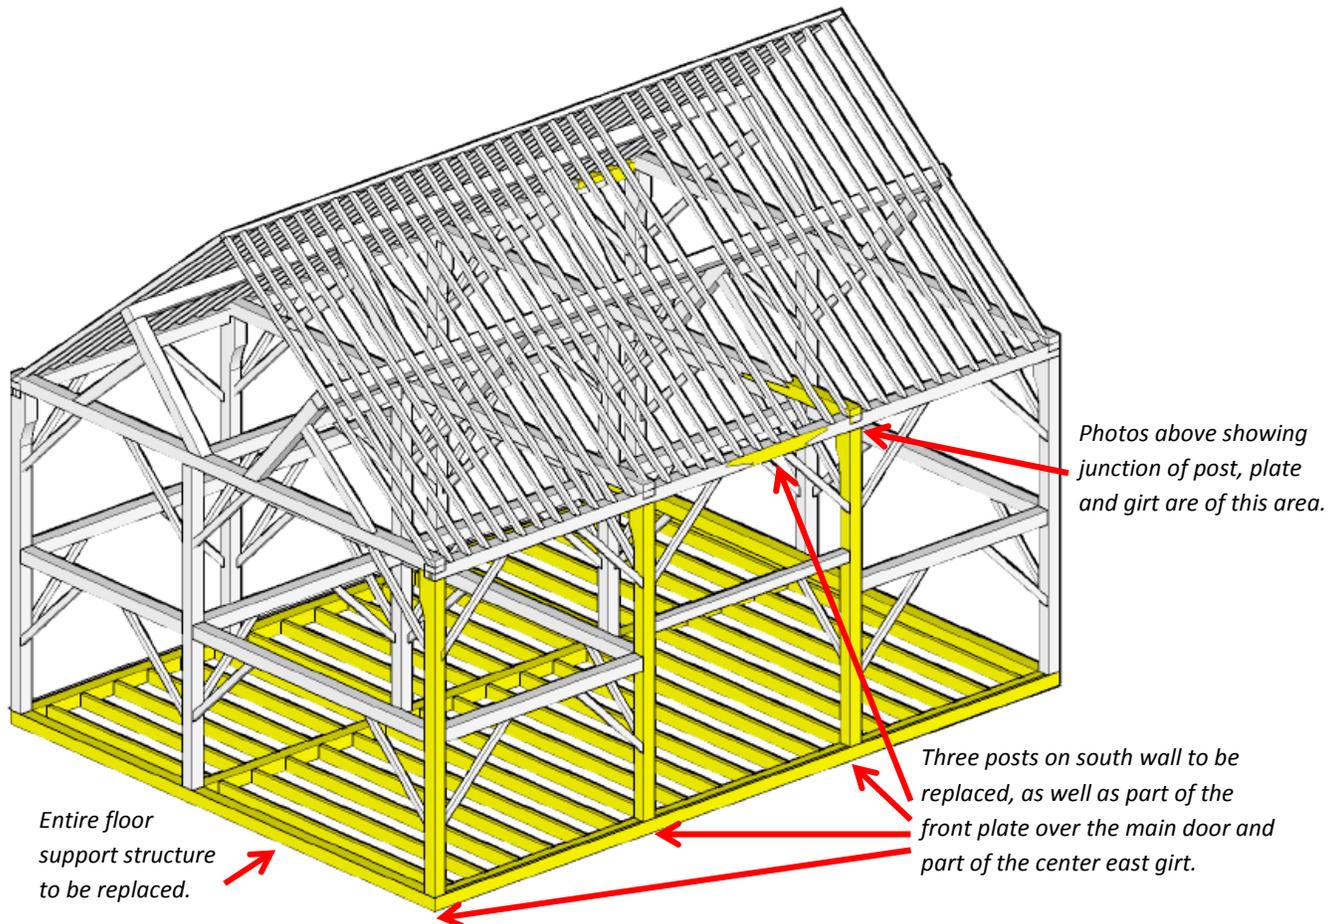
Kris Thomson, general contractor for the 2014 CPC work, and Alicia Spence, the internationally-known timber framer who worked on Parsons House, have investigated the Shepherd Barn as much as is possible in current conditions, and are proposing to replace all the framing elements that appear in yellow in the diagram below:

- All sills
- All floor joists
- Three full posts on the south (front) wall
- Replace sections of the front and rear plate
- Replace section of east central girt

- Work one row of posts at a time
- Pick up posts (replacing if needed), add footings, replace sills, bring posts back down
- Install concrete footings for posts with layer of ice-and-water seal on top to prevent dampness from migrating into the posts
- At end, wait to install sill at gable-end by driveway until after excavation phase

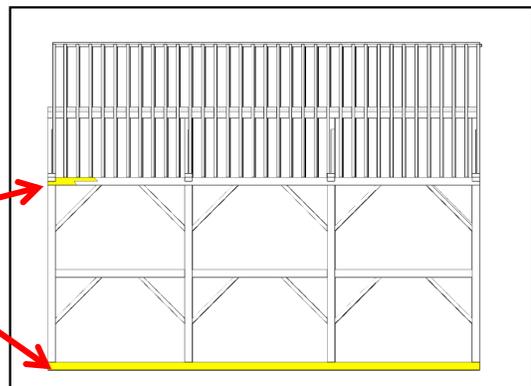
Diagram at right shows north (back) elevation with replacement of sill and section of the rear plate.

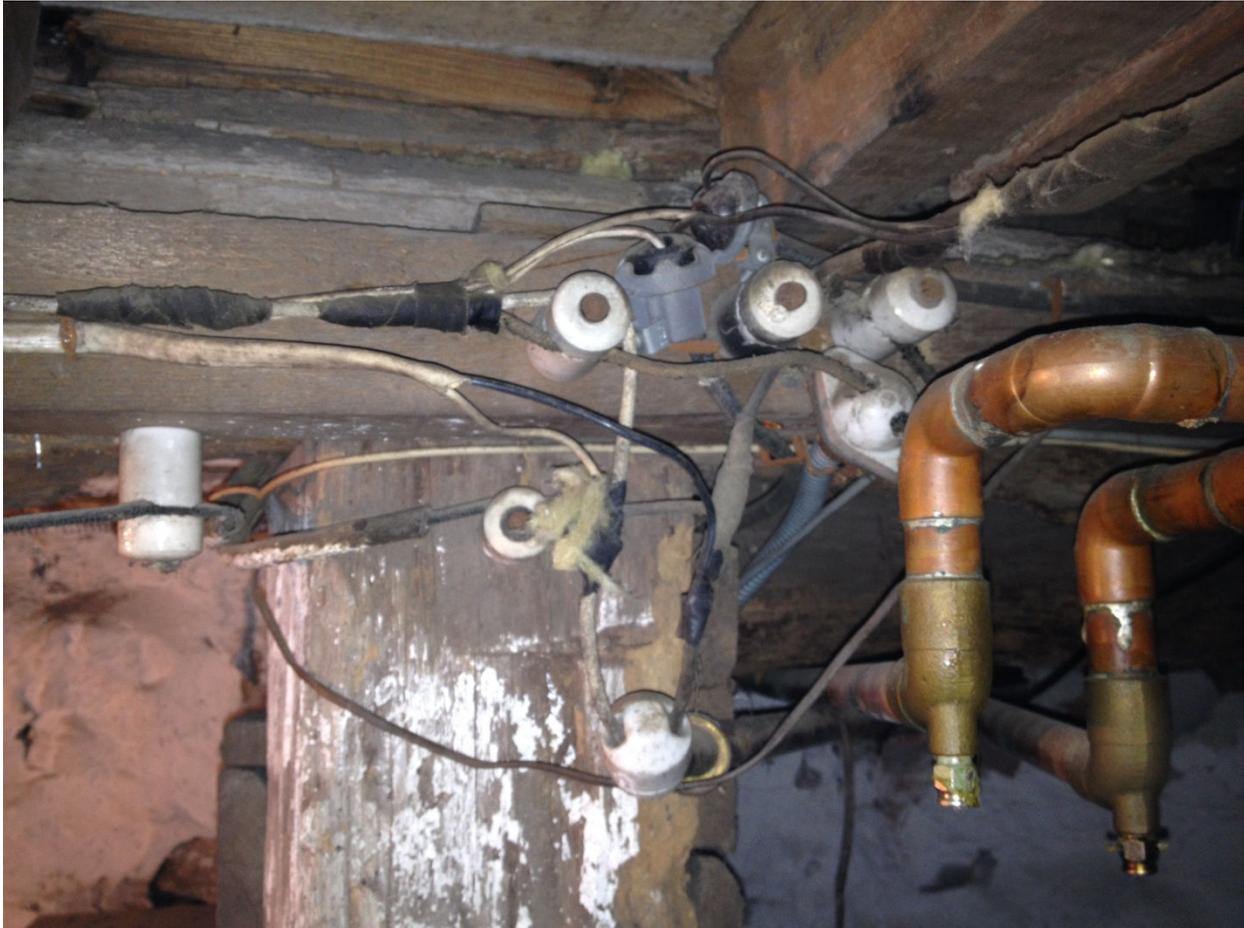
Parsons House was probably first wired after Anna Catharine Bliss moved here in 1910 with a minimal number of ungrounded two-prong outlets served by knob and tube wiring. Over the years, some sections were upgraded, especially near the west ell, which was used as an office in the 1970s. Over the years, as people required more electrical equipment, wiring was added and extended, resulting in arrangements like this:

As soon as our contractor Kris Thomson saw this, he brought in an electrician and an inspector to review the entire house and he reports that it is critical to replace the wiring in Parsons House.

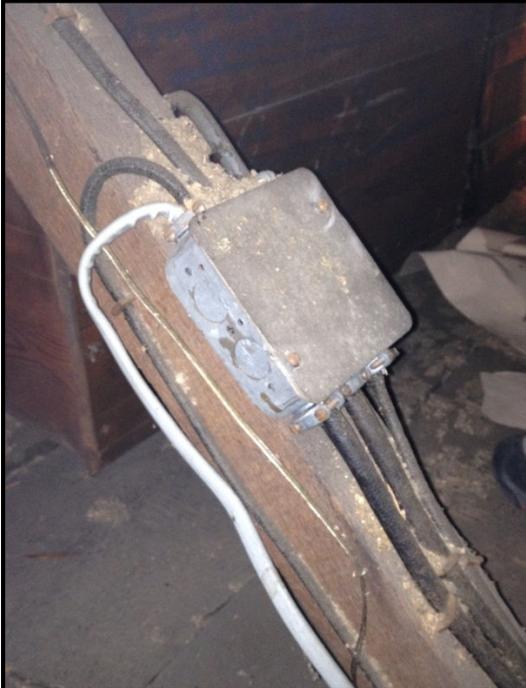
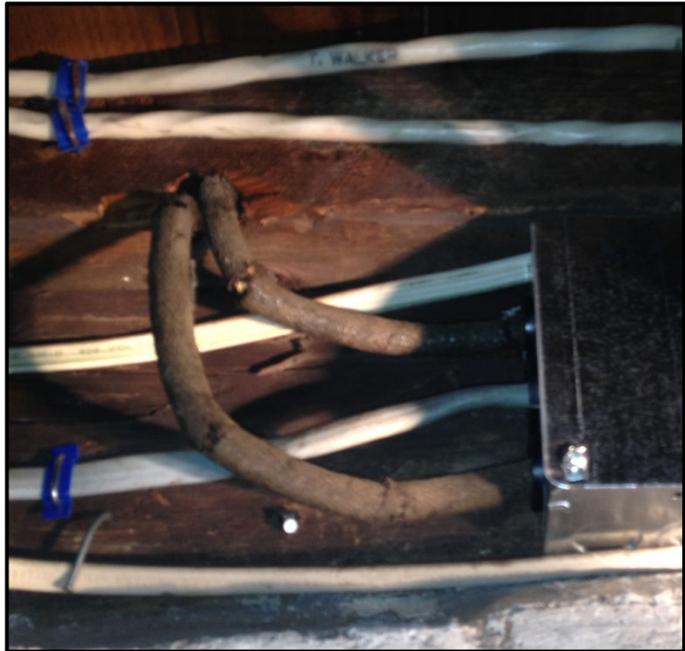
One of the **most common problems** with this kind of wiring is its insulation, which is made of rubber instead of plastic. Over time, the rubber degrades, exposing bare wires to air and moisture, in turn increasing the chance of a short or a fire.

We definitely have overloads and damaged insulation:

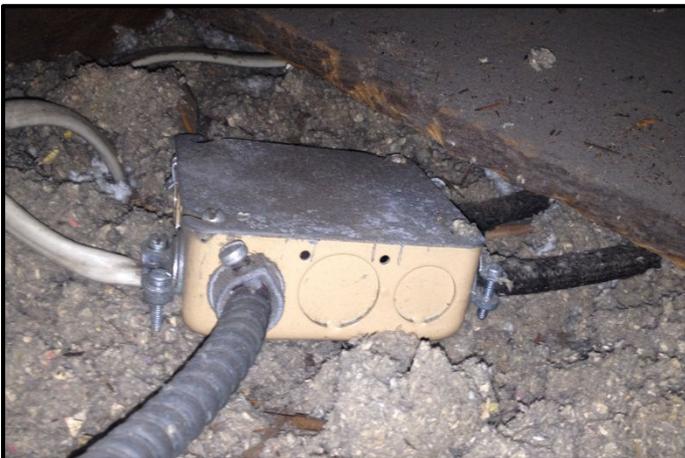
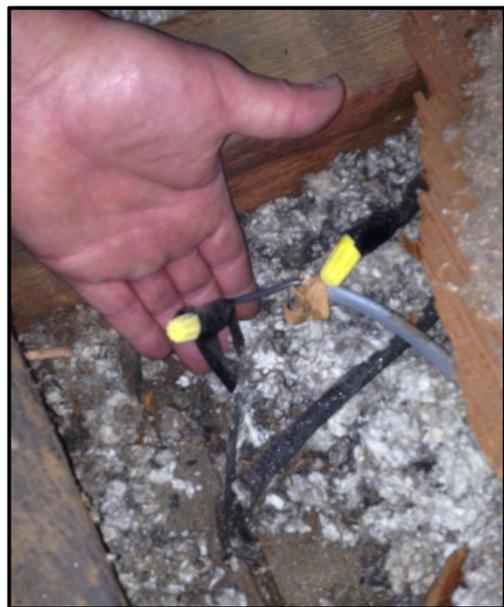
The [2008 National Electric Code](#) addressed some issues with knob and tube wiring, most notably its high heat dissipation that poses a fire hazard when combined with fiberglass insulation. As a result, the NEC now requires that knob and tube wiring not be in "hollow spaces of walls, ceilings and attics where such spaces are insulated by loose, rolled or foamed-in-place insulating material that envelops the conductors."

When Kris and his experts dug around in the attic, they found these junctions embedded in the insulation. The one at right is particularly bad because the joins aren't even in a box.

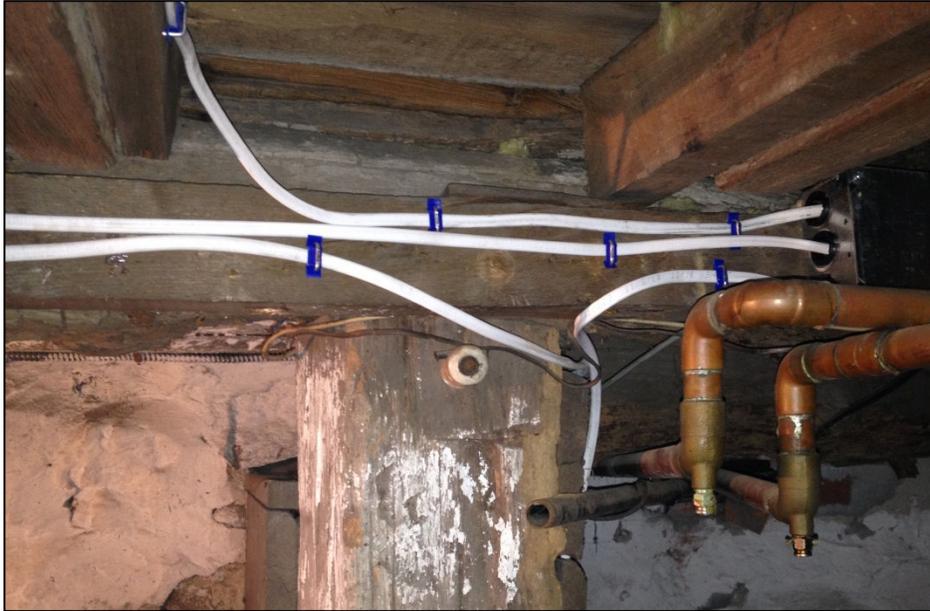
As a first step, we have already replaced all the knob and tube wiring that could be accessed from the basement. That horrifying spider web of decaying insulation and electrical tape now looks like this:

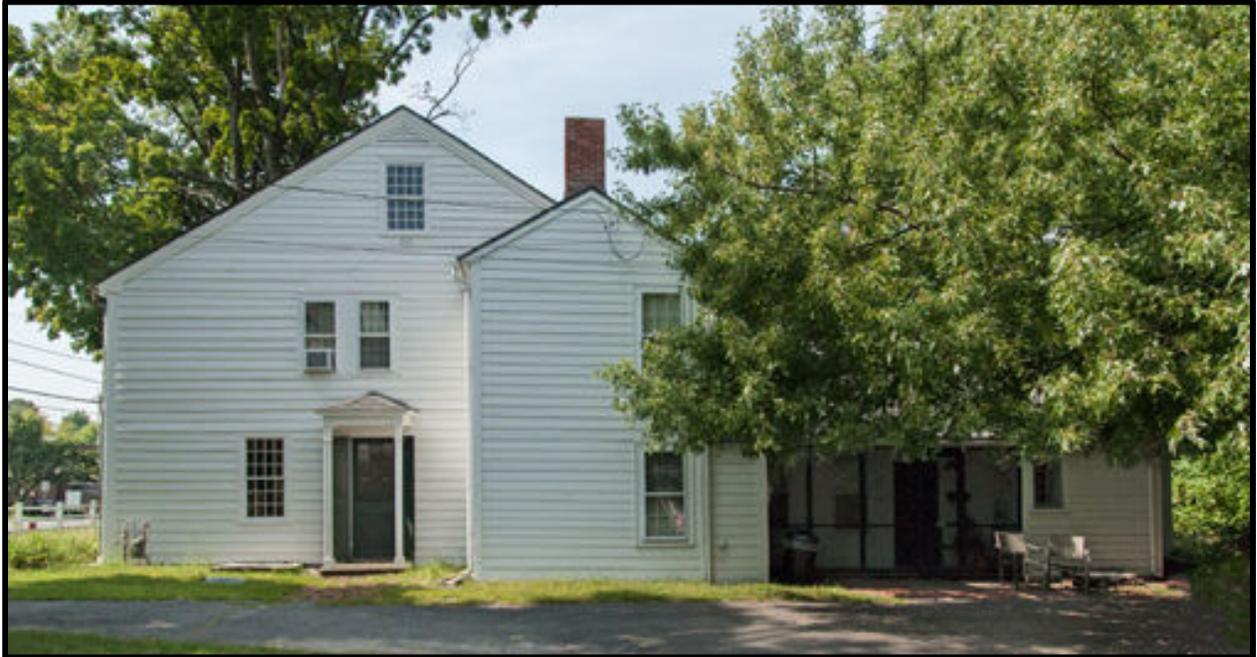
The entire east side of Parsons House, shown below, is supported by a full foundation with a basement. The main house and east ell (jutting out toward the camera) are supported by the 1981 basement. The one-story north ell (whose roof is obscured by the tree) is supported by an old brick basement. As you can see, the sills of the entire house appear to be at ground level.

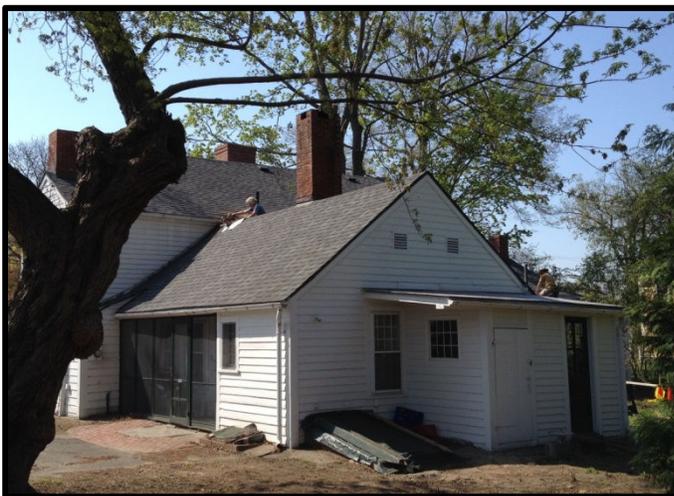
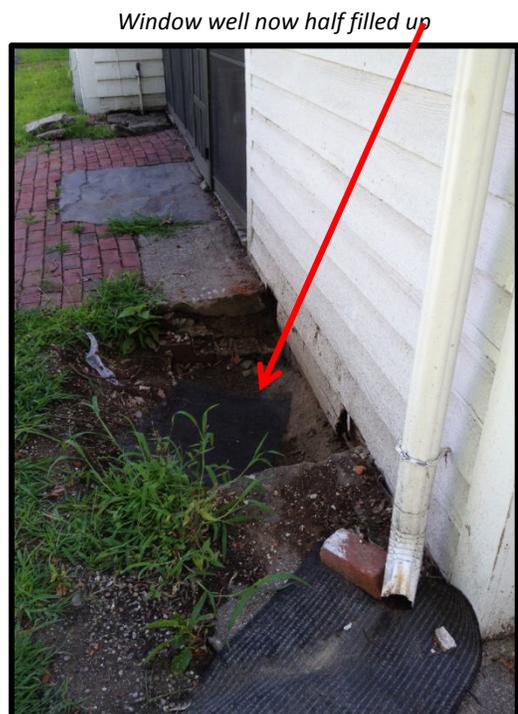
The porch side of the north ell has suffered water damage going back decades. Concrete slabs and metal liners were installed around the sills in an attempt to prevent water getting in, but these only made it harder for the sills to dry out. Add to this a poorly maintained window well and the result was inevitable.

The pictures below show the ground line along the porch of the north ell. The sill that supports the north ell runs directly under the outer edge of the porch, right under the screens. In other words, the sills are below ground level and there is a basement under the porch floor. Any water not diverted from the edge of the porch will saturate the sill and eventually run into the basement (see picture next page). The outdoor faucet at left only adds to the problem.

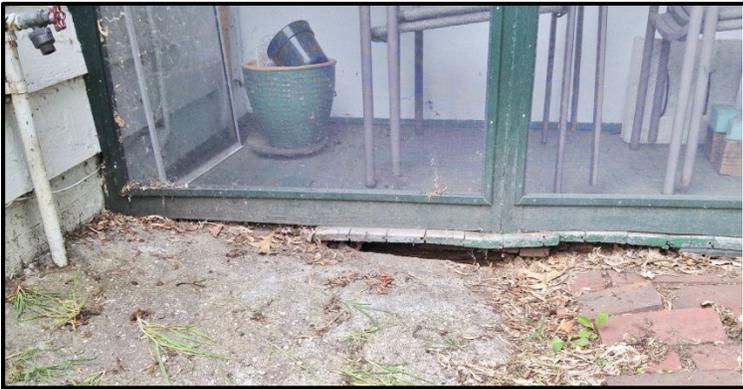
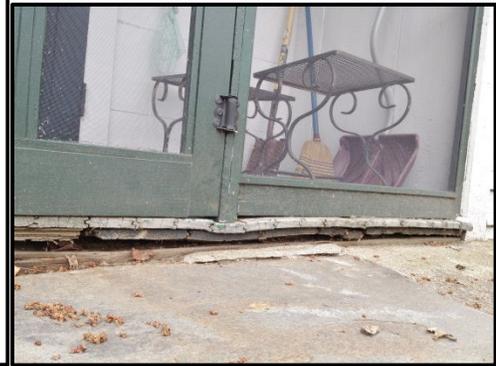
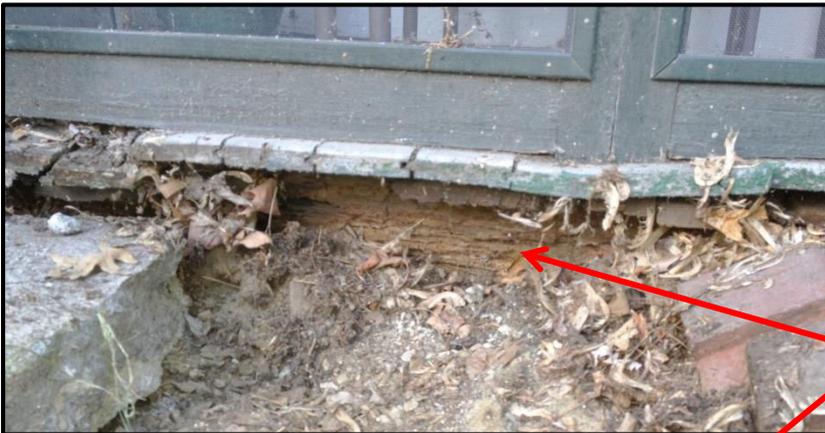
Rotten below-grade sills exposed

Left: This is a close-up of the sill under the left end of the porch, after we broke away half of the concrete splash slab under the outdoor faucet. The sill is clearly rotten and probably has termites.

However we will be grading around the house this fall when the basement excavation is ready to be filled in. When the perimeter is properly sloped, it will be covered with ice-and-water shield and a layer of stones. This technique has worked extremely well in solving the similar problem in the Shepherd basement.

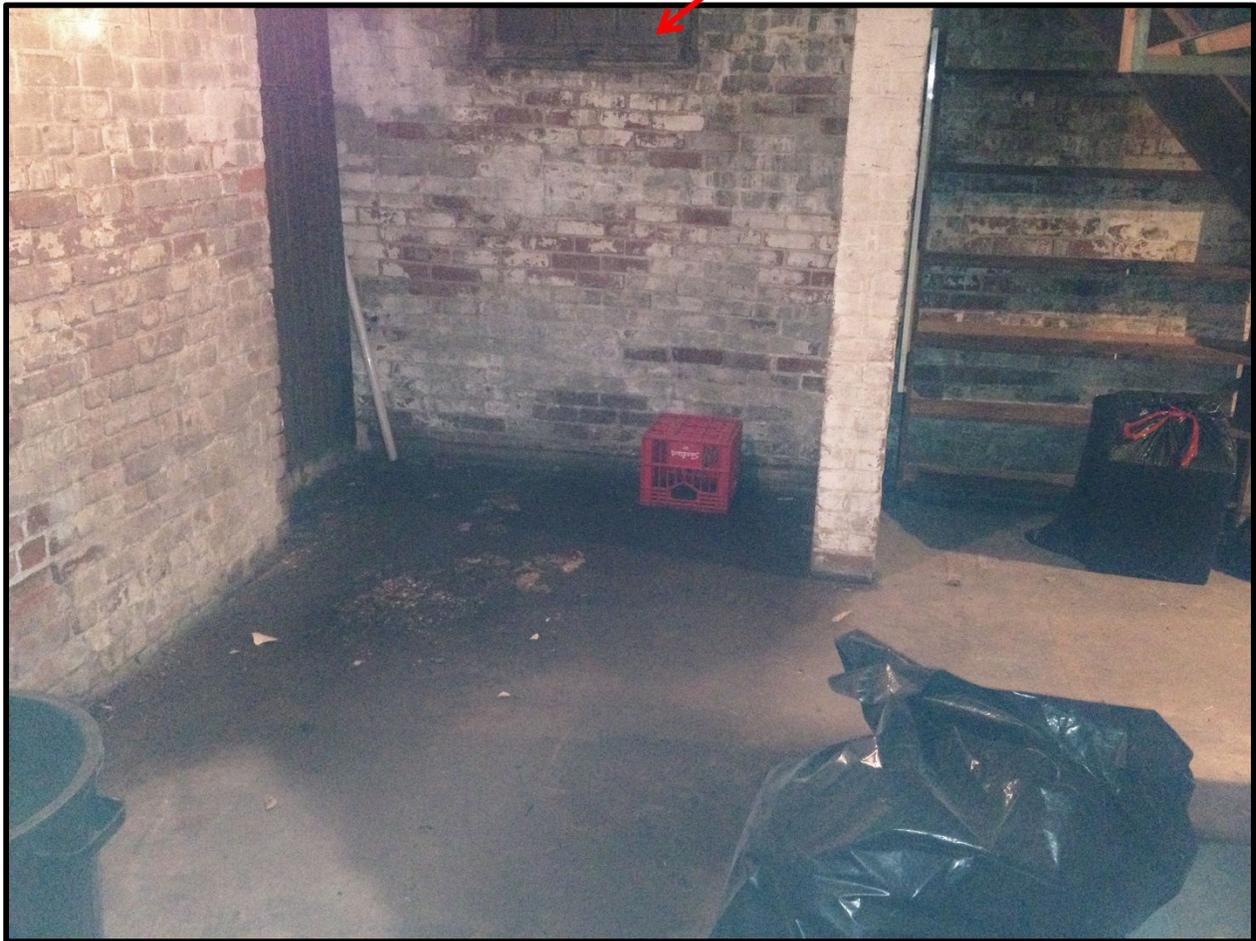
Water in the north ell basement after an ordinary rain.

This is the problematic window, now blocked.

We expect that these steps will go a long way toward keeping water out of the basement in the future, and the new dehumidifier purchased with grant funds from the Beveridge Family Foundation will gradually dry out the residual dampness in the walls. Therefore we can look forward to having usable basements and a healthier house before long.

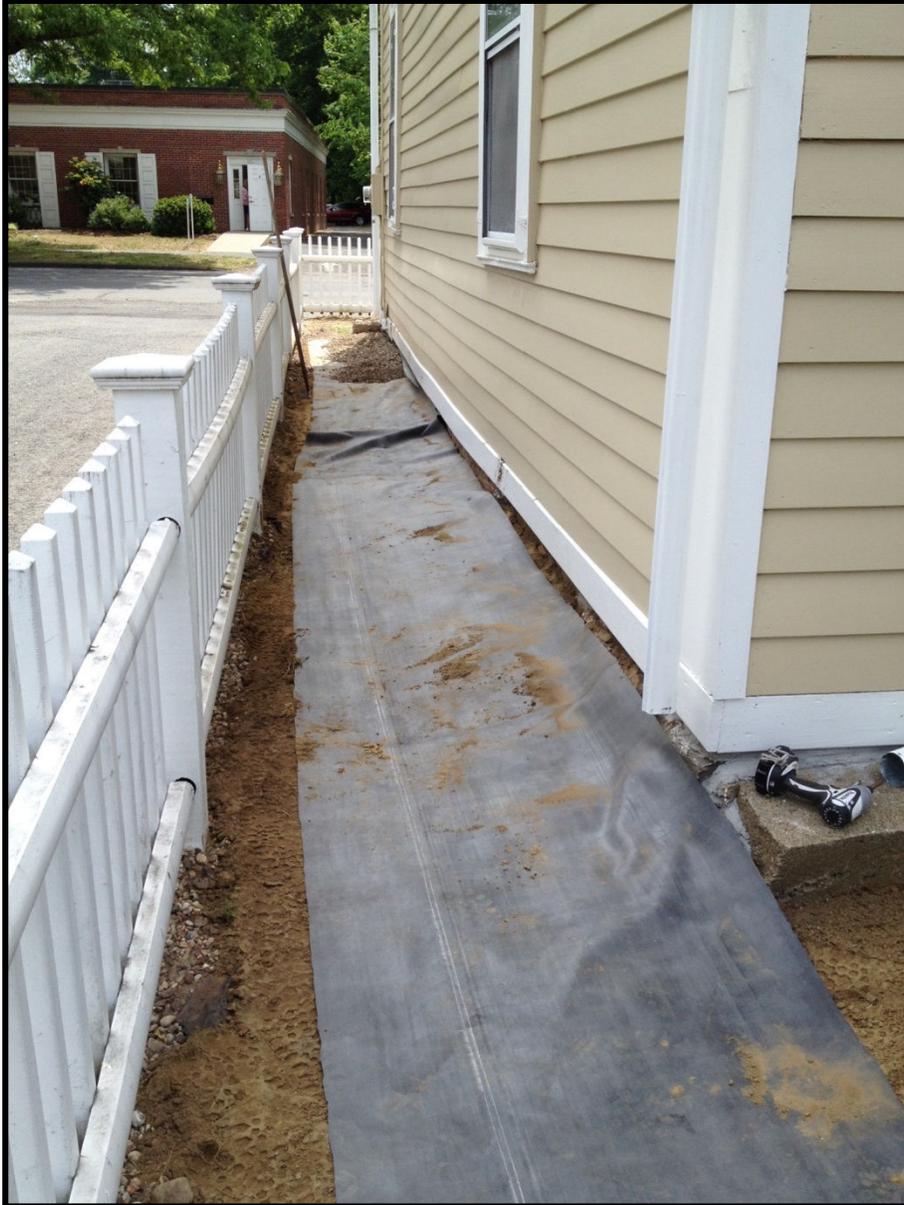
This technique has resulted in a dry basement in Shepherd House.

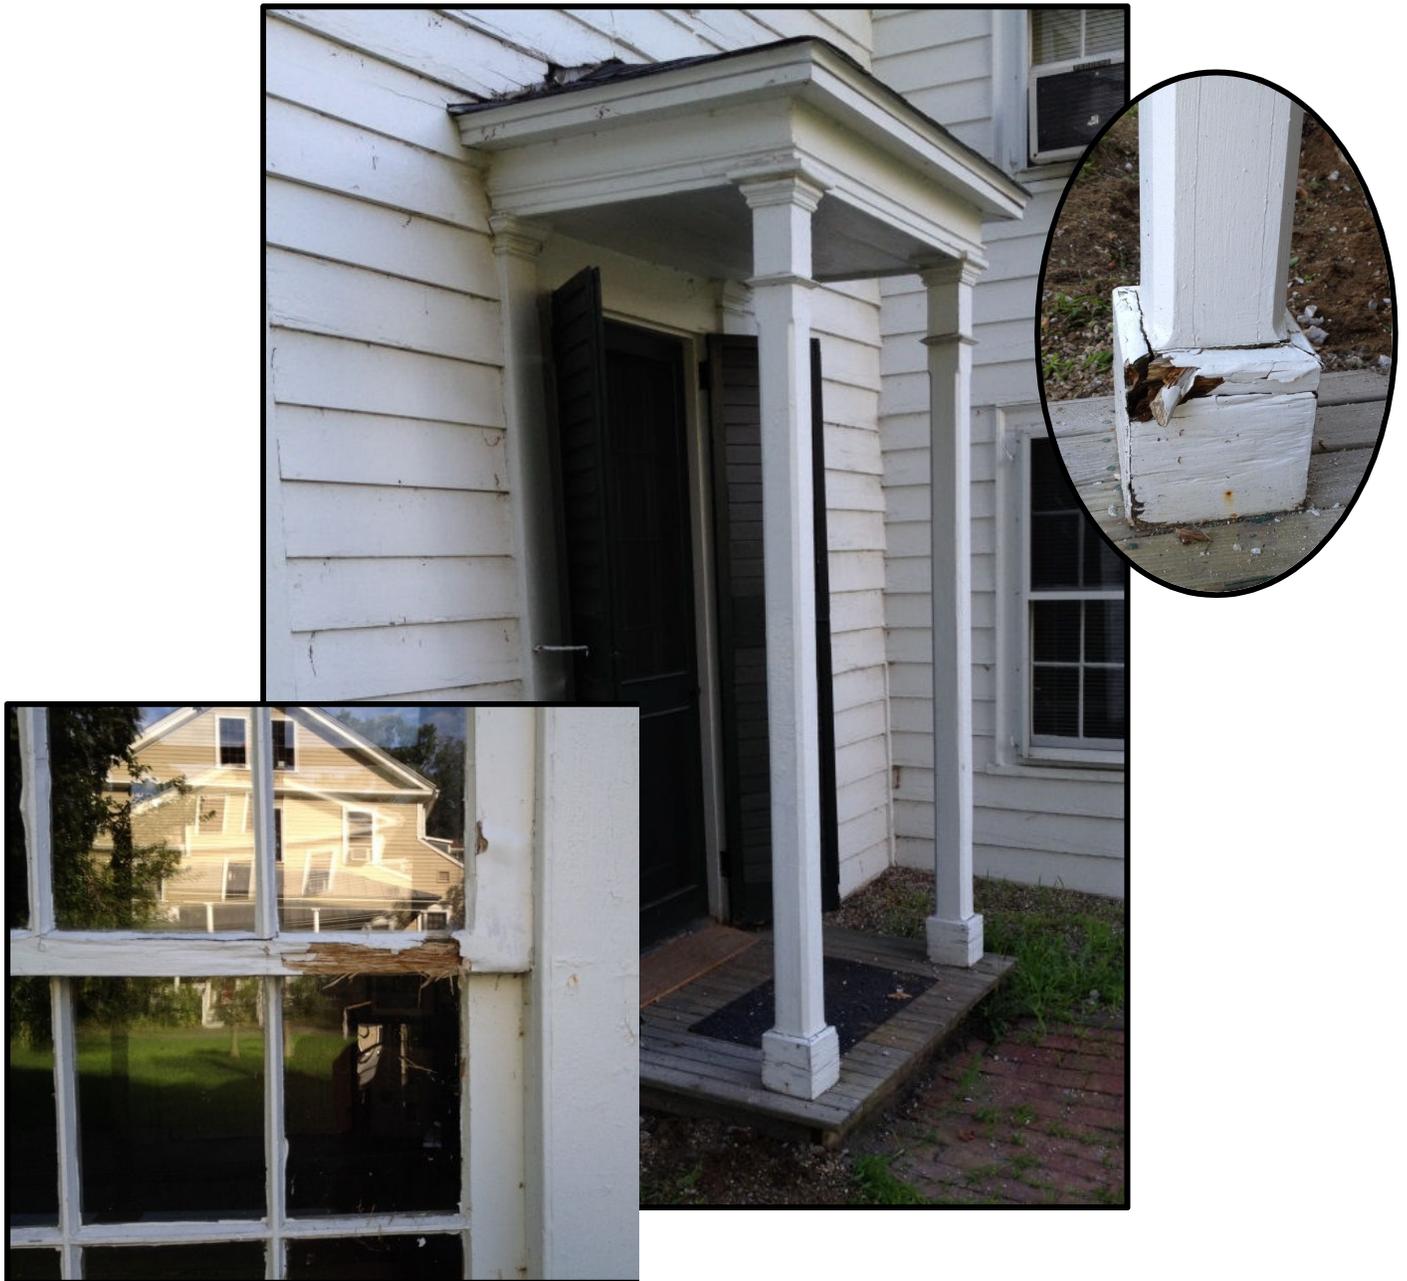
In addition to these structural repairs, we add some smaller ones that should not be allowed to get worse. These include replacing three windows and fixing the bases of the columns on the little porch over the east parlor side door. The bottoms of the porch posts have already been replaced, but the modern lumber used in the repair has not held up very well. The window sashes are also modern, installed about 1980. Like the posts, the lumber they are made of has not held up to exposure to the weather. At some time in the 1990s, the decision was made to remove the storm windows and use interior storms. This looked pretty, but interior storms promote mold growth on the inside of the window sashes and offer zero protection from the weather on the outside. The 2014 CPC grant is paying for storm windows for all the buildings, so this kind of deterioration will not continue.
