REPORT ON BUILDING ARCHEOLOGY
AT THE

ISAAC DAMON HOUSE

NORTHAMPTON, MASSACHUSETTS

GREGORY CLANCEY
ARCHITECTURAL CONSERVATOR
SOCIETY FOR THE PRESERVATION OF NEW ENGLAND ANTIQUITIES

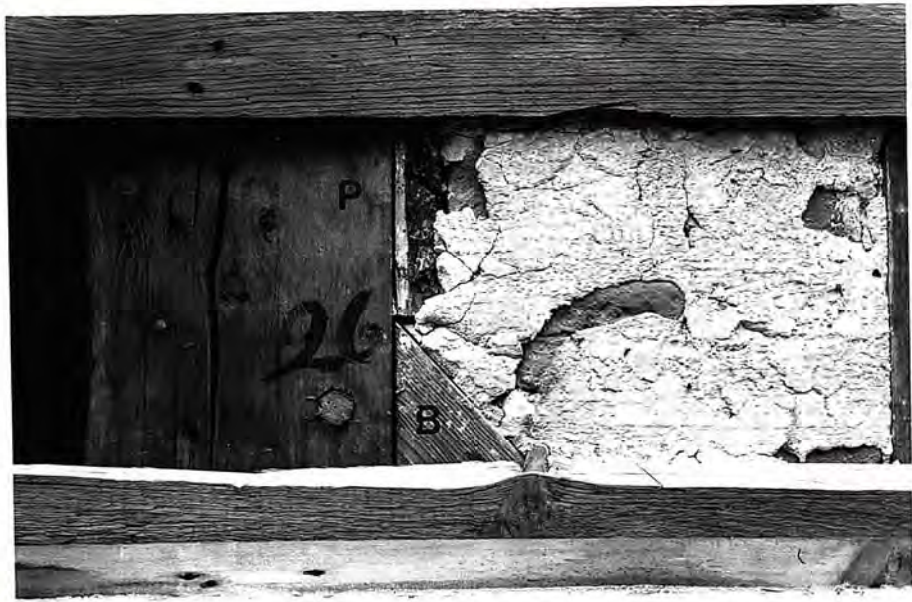
EXT - 2

The wall to the north of the post is filled with a nogging of under-burned bricks in a lime stucco. We are unsure how far the nogging extends, but this view suggests that it may only cover the outer walls of the kitchen. This would conform to a practice in many (though not all) 18th century houses of only nogging the walls of the kitchen and those other spaces where food was stored, perhaps as a rodent-proofing method.

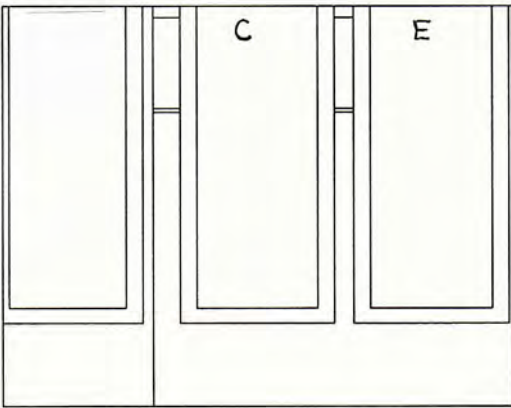
RML 104

The door to room 112 (A) was originally fitted with a Norfolk latch, now visible only as paint lines. This door was also re-hung on new hinges in the late 19th/early 20th centuries.

There was once a door at the base of the staircase to the second floor (B), although it is difficult to date from its hinge marks.

Doors also stood in the openings to the hall (C) and room 113 (D). The door to the cellar (E) still retains one half of its original Norfolk latch; the other half is still in the house and should be re-attached to the door.

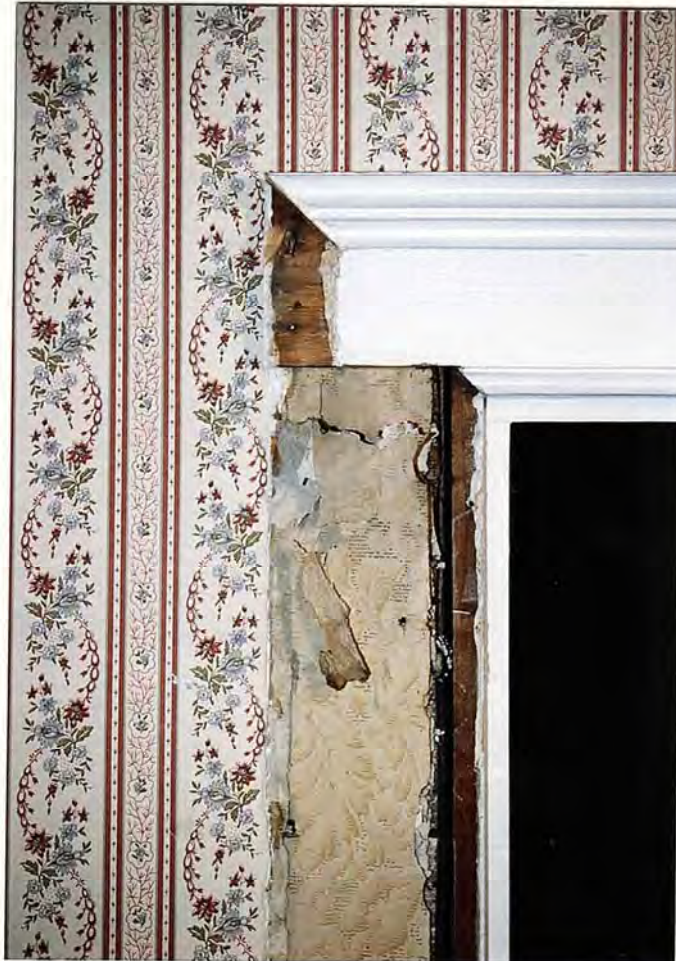
113 - A

We removed the casing of the door to room 112, added in the early 20th century, and discovered a number of wallpaper fragments. The top paper is a roller-printed Roccoco design typical of the period 1900-20 (R. Nylander). The sample seems badly faded. Beneath this were two other papers so closely bound to the top fragment that we did not separate them. These fragments might still be separable by a wallpaper conservator. More samples will likely be found under the other two pieces of casing.

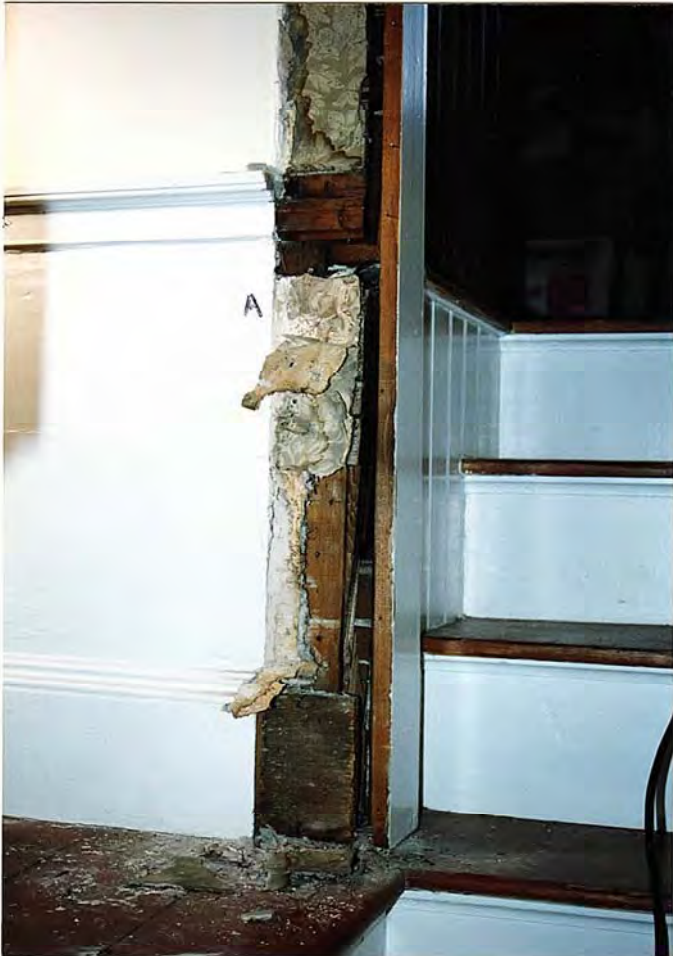
201 - 2

The paper directly under the casing (**photos 4 and 6**) is a pale green roller-printed design probably dating to the 1870s/80s (R. Nylander). This paper was still hanging when the door was cut through. It was applied to the plaster dado as well as the wall (**photo 2**).

The third paper is a very powdery and deteriorated fragment (**A in photos 2 and 3**) attached only to the dado plaster. This likely dates to the 1850s/60s (R. Nylander).

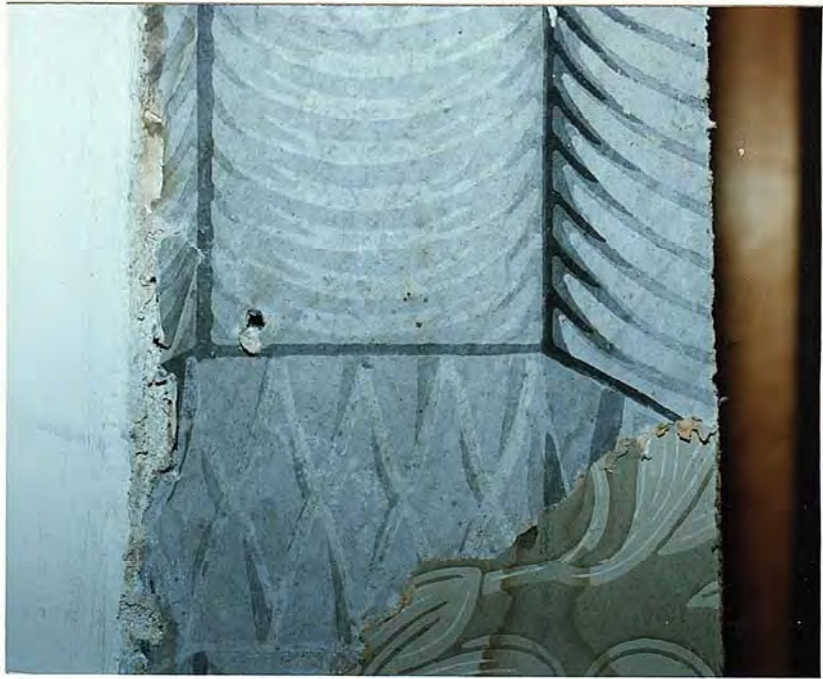
201 - 5

Directly under this sample, but only above the chair rail, is an elaborate Federal-period paper printed in multiple shades of grey (**photos 4 and 5**). This is applied directly over the plaster, and could well be the original hall paper of c. 1813 (R. Nylander)

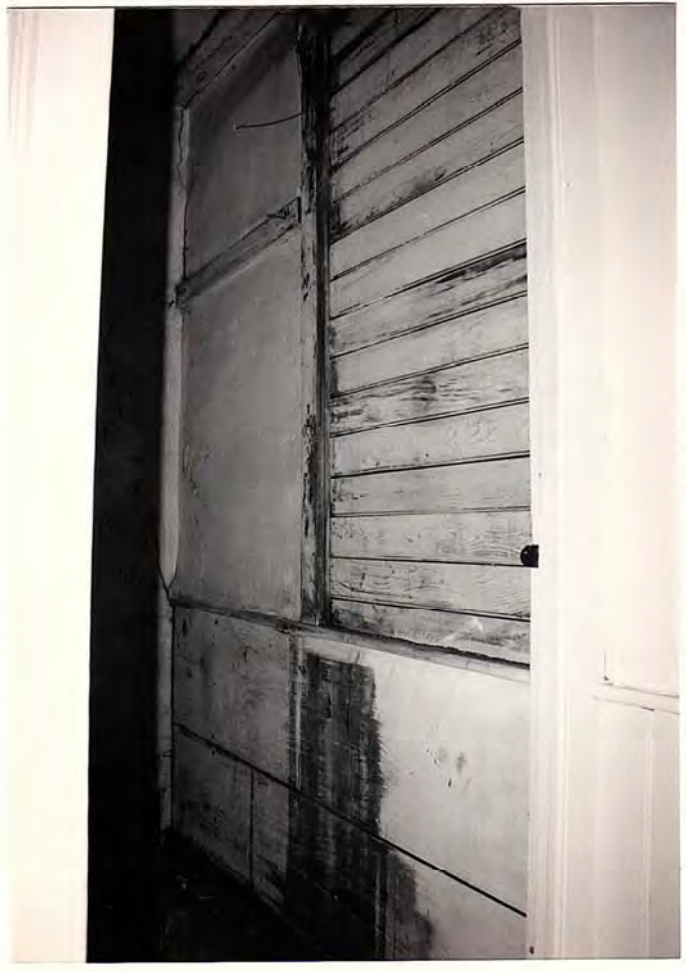
112 - 1

The wall in the stairwell (photo 1) is sheathed with simple wainscoting, below an unmolded window surround. This ancillary space appears to have been unpainted originally; the paint now covering sections of the woodwork looks to have been daubed on after the corner became a stair hall. There was also no coating on the plaster. An early cellar window sash also survives in this enclosure.

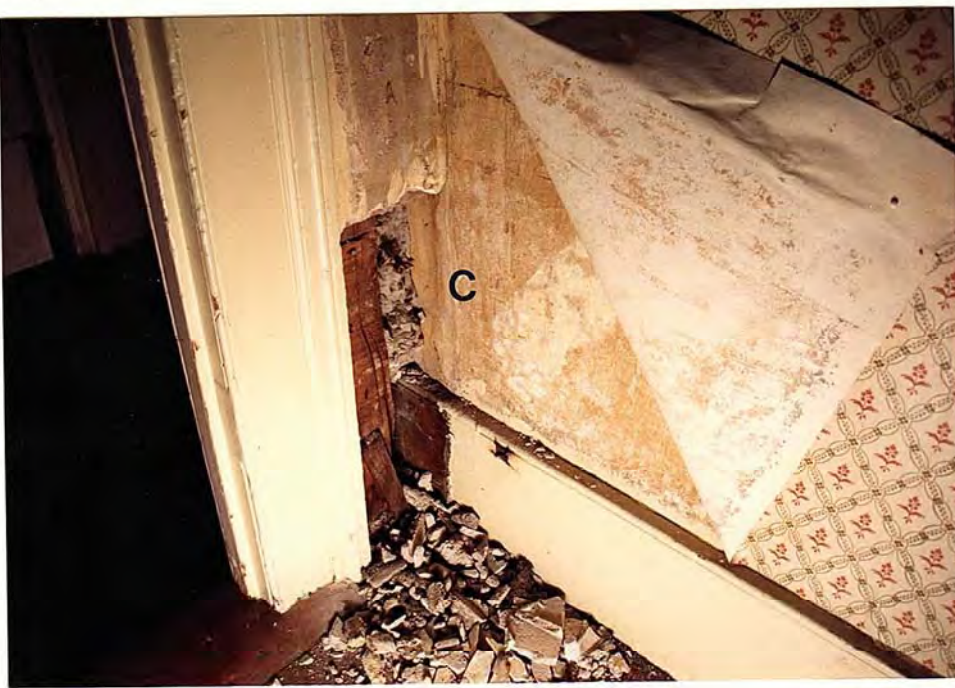
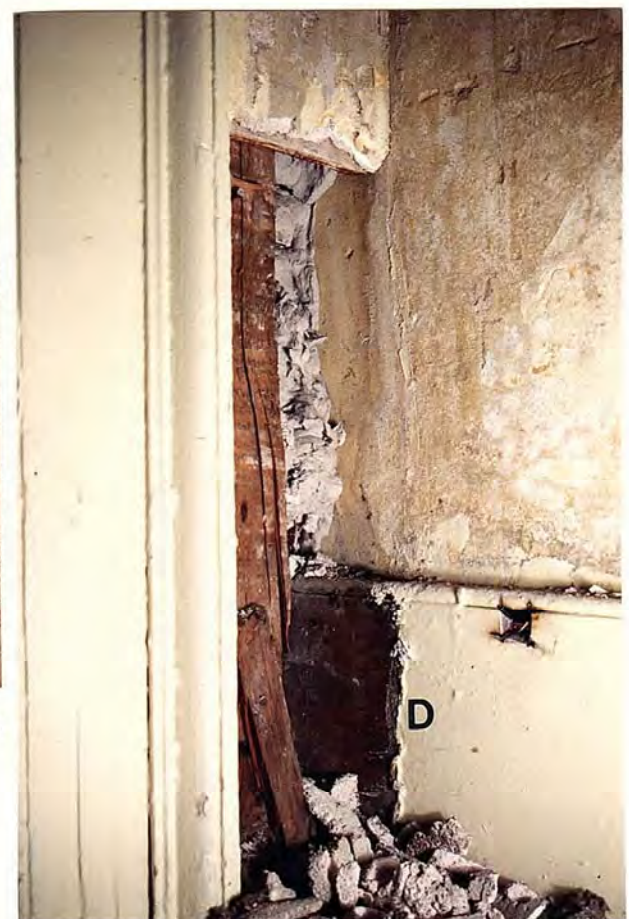
204 - 4

An excavation made into the room side of this partition uncovered an area of early, perhaps original hall wall paint (**C** in photos 4 and 5). Solubility tests indicated that the paint is a distemper, a standard 19th century wall coating. Residue of the same wall paint is also under the modern wallpaper to the right of the partition. Interestingly, the baseboard in the same cavity (**D**) is unpainted.

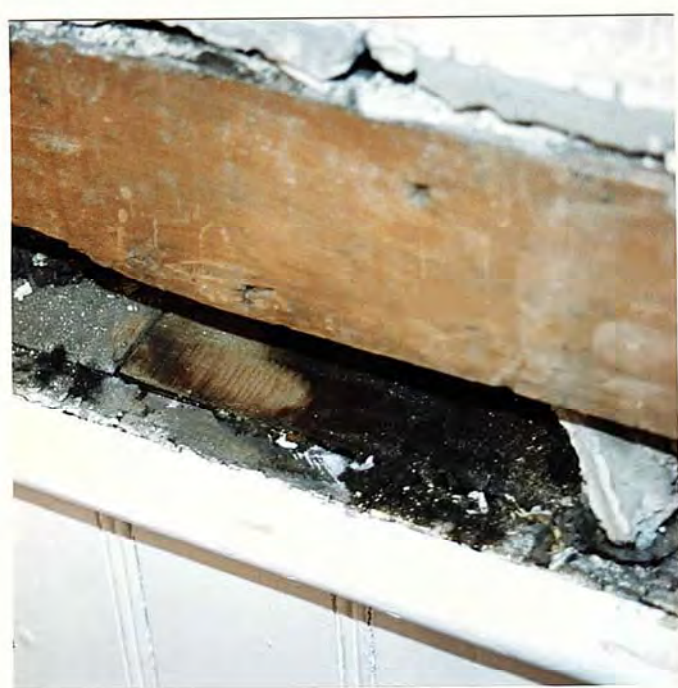
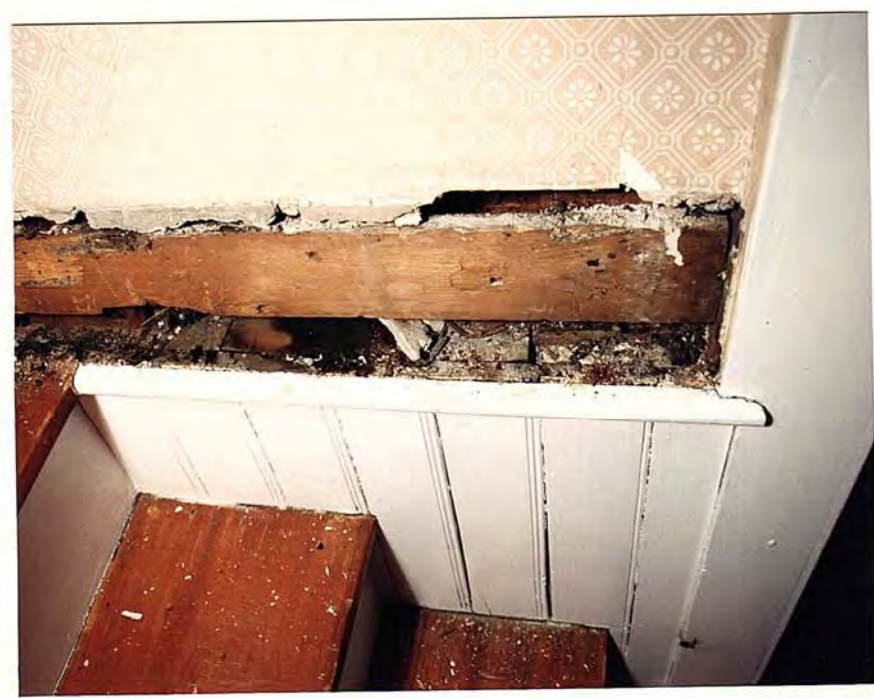
204 - 6

We also removed the baseboard on the hall side of the partition to examine the floorboards (photos 6 and 7). These were unpainted at the time the partition was moved, likely indicating that the hall was carpeted from an early date.
