HISTORICAL CHRONOLOGY

The purpose of this report is to review the existing conditions of several significant structures within the Bridge Street Cemetery in the City of Northampton, Massachusetts.

Existing Conditions of Structures

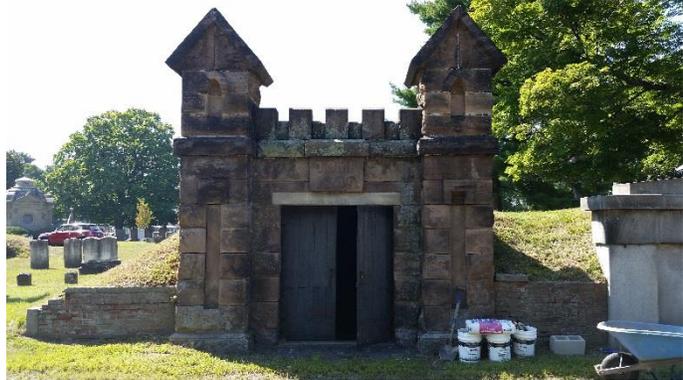
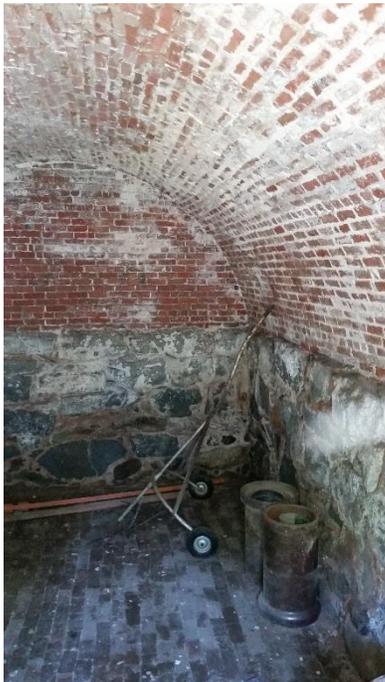
The receiving tomb is dated 1849. Its design and detailing are somewhat unique when compared to tombs of this era. The majority of the stonework is brownstone, with the exception of the door lintel, which is granite. The use of brownstone and the decorative towers and the crenellated parapet are unusual for a receiving tomb. The tomb was opened for inspection. The interior of the tomb measures 12' wide by 20' deep and 11' tall (at the apex of the brick barrel arch roof). The tomb is fairly large for a receiving tomb of this era; however its size is commensurate with the overall size of the cemetery.

The tomb has two short brick masonry wingwalls that may not be original to the tomb. They may have been added to help retain soil. The wingwalls are small earth retaining wall structures. The interior walls are constructed with mortared granite. The roof is a half-round barrel arch made with brick, which is in very good condition. The stonework has been repointed several times. The brick mortar appears to be mostly original. The floor of the tomb is approximately 2 feet below the entrance threshold and is constructed with brick pavers. It appears that the stonework and the brick may have been whitewashed at one time. There is minor efflorescence (white staining), which is a sign of water infiltration.

The receiving tomb is in need of re-pointing. The overall integrity of the front facade is good, however the mortar joints are in poor condition. This is not a structural problem, but it is an aesthetic one. The repointing process would not result in a significant change to the appearance of the facade. The joints could be cleaned and properly re-pointed with a quality mortar. It is important to not use cement based mortars, which are much stiffer than the older historic mortars. The use of cement based mortar can lead to cracking and spalling as the modern mortars will produce stress concentrations in the stones. The US Department of the Interior's "*Preservation Brief for Repointing Mortar Joints in Historic Masonry Buildings*" should be followed. This document generally recommends the use of a mortar that contains 1 part cement to 1 part lime combined with 5-6 parts sand. The color of the sand may be important if some of the older mortar is to remain. Sand color can affect the color of the final mortar. If all joints are to be repointed (which is most likely the case in the receiving tomb, the color may not be as critical.

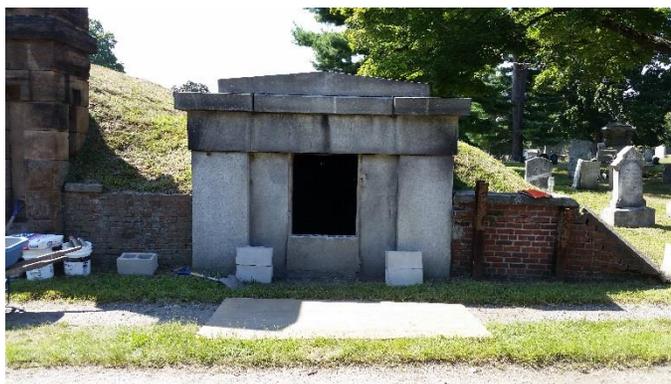
is quite full of human remains (more than 10). None was disturbed during the inspection. The tomb has two short brick masonry wingwalls that may not be original to the tomb. They may have been added to help retain soil. The right wall has completely failed. The steel posts were added to help support the wall; however these are also failing.

The failed brick wingwall on the Ansel Wright tomb should be dis-assembled and re-constructed. Additional mass will be required in order to improve the structural integrity of the wall. This can be done with stone masonry behind the facing brick. The design of the new wall should be undertaken by a structural engineer. The addition of minor drainage behind the walls is recommended in order to relieve the water pressures that can build up. The use of free draining backfill materials is also recommended.

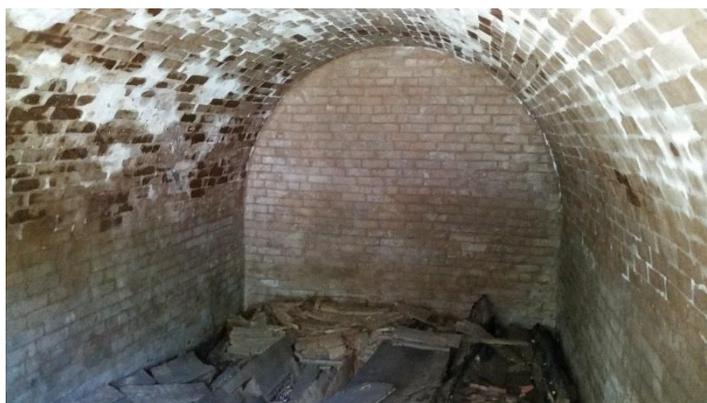
The interior walls and roof are constructed with mortared brick, which are in very good condition. The brick mortar appears to be mostly original. The floor of the tomb is approximately 2 feet below the entrance threshold. The amount of debris in the tomb made inspection of the floor impossible. The floor may be dirt or brick. There is efflorescence (white staining), which is a sign of minor water infiltration.

The interior brickwork is in good condition and not visible to the public. Based on this, we do not recommend restoration of the bricks at this time. The minor cracks in the brickwork can be pointed with mortar.

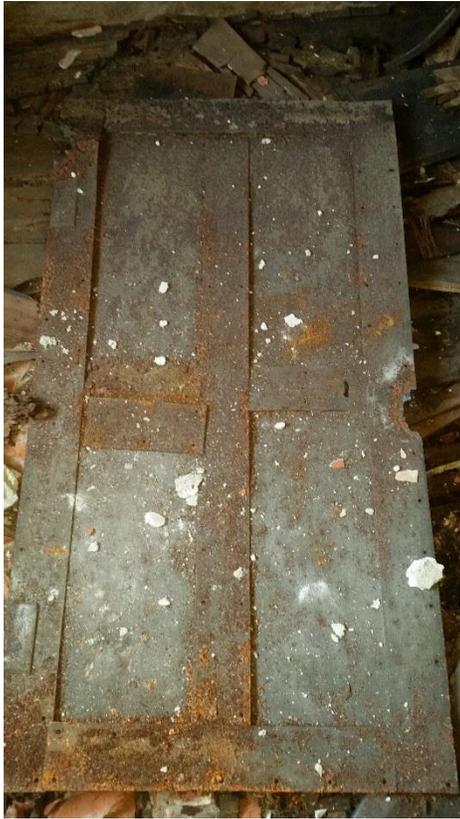
Prior to the inspection, a review of the front façade indicated that there was most likely a past door denoted by a recessed door jamb, broken hinges, and a broken striker plate in the granite door jambs. Upon opening the tomb, a significant discovery was made. A steel door was found inside the tomb laying on top of some of the remains. It is a raised panel style door that is consistent with receiving tombs of this era. The door is in poor condition with severe corrosion and delamination (most likely beyond repair). The door was measured and documented. Based on the measurements of the door and the door jamb, it is apparent that the door is the original door to the tomb. The width of the door exactly matches the door jamb. The height of the door is slightly taller than the current opening, which indicates that the sill may have been raised at some time in the past.

There are signs of a previous interior wood door which would have opened inward. There are hinges on both sides of the door opening and a small portion of one of the wood doors remains.

The door on the Ansel Wright Tomb can be replaced, using the original door that is in the tomb as a guide. The door would be similar to the doors on the receiving tomb. The repairs would include the construction of new hinges and a strike plate, as the originals are lost.

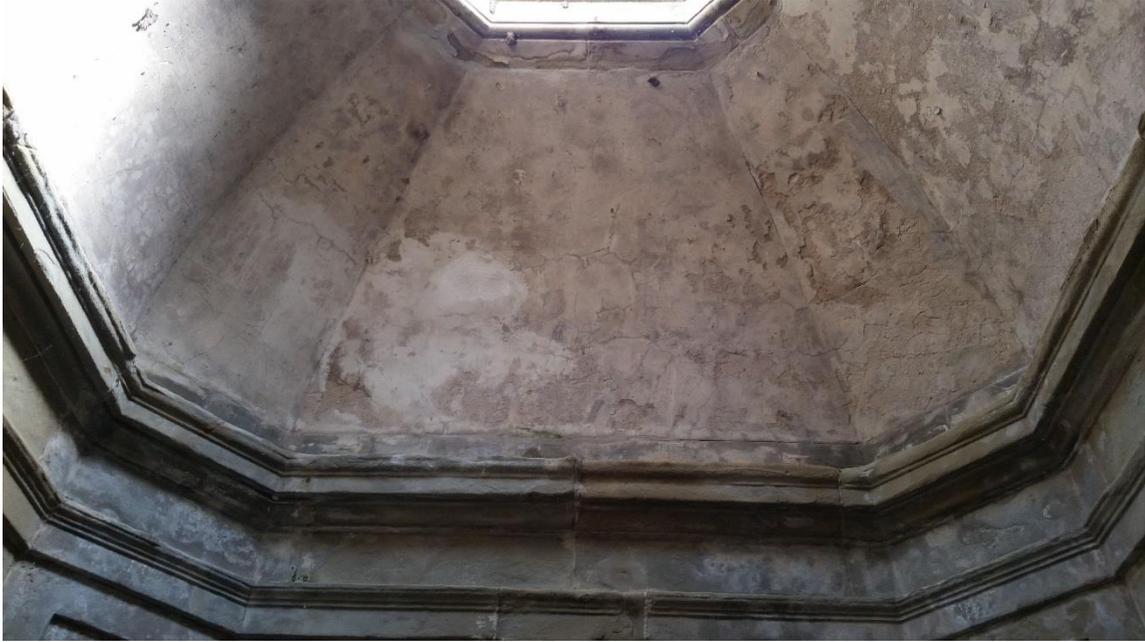
Condition of Ceiling and Crown Molding

There are signs of water infiltration in the structure. The ceiling and interior stones are stained and deteriorated. The deterioration is a combination of erosion, scaling and delaminations. This has led to a loss of portions of the original architectural detail, especially on the crown molding at the top of the walls. There are noticeable open joints in the roof tiles, which is a likely cause of the water penetration. The moisture penetrates the joints in the masonry leading to staining and delamination of the cement parging on the ceiling (see below). The condition of the interior stonework can be classified as fair to poor.

1. Preservation of existing conditions: This would be an effort to simply stop the current decay and preserve the structure as is. No significant replacement or repairs to the damaged stonework would be done. The sealing of the roof structure is paramount to any preservation project. It is likely that the roof stones would need to be removed, the underlying masonry repaired and sealed, and the roof stone reset properly with quality joints.

2. Complete Restoration: This would involve the work described above combined with major repairs to damaged stones. Simple spalled areas can be patched with color-matching mortars. Some of the stonework will inevitably need to be replaced entirely. New carved stones can be made to match the original design and reset one at a time. Color matching of the stone as well as quality carving techniques are critical to the success of this process. This type of work is very expensive and probably not justified unless the mausoleum is to be used on a regular basis.

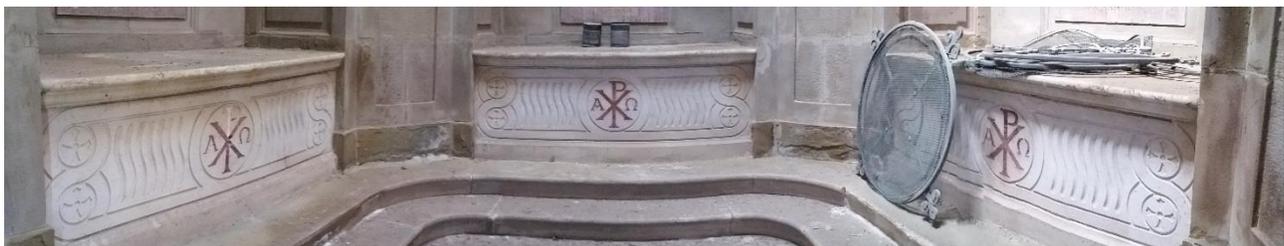
Panoramic Photo of Sarcophagi

The sarcophagi are made with carved white marble. The marble is inlaid with a soft sandstone or red marble. In general, the sarcophagi are in good condition. The inlay materials on one of the sarcophagi has fallen away.

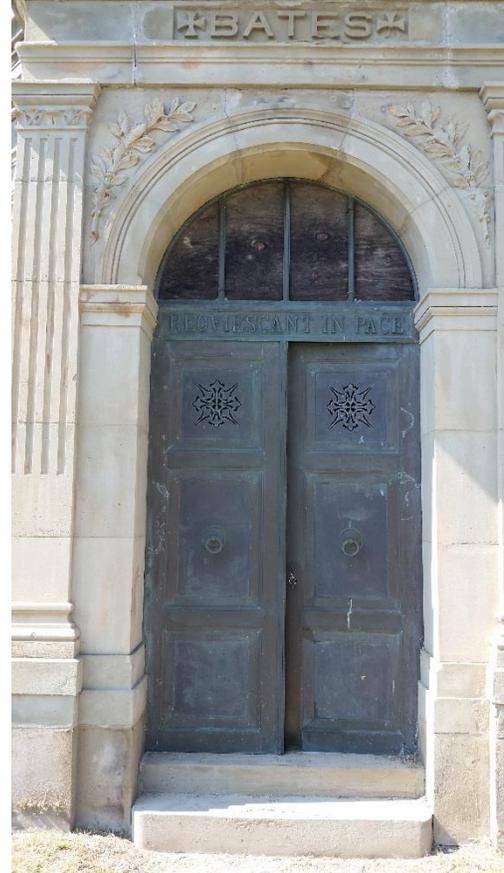
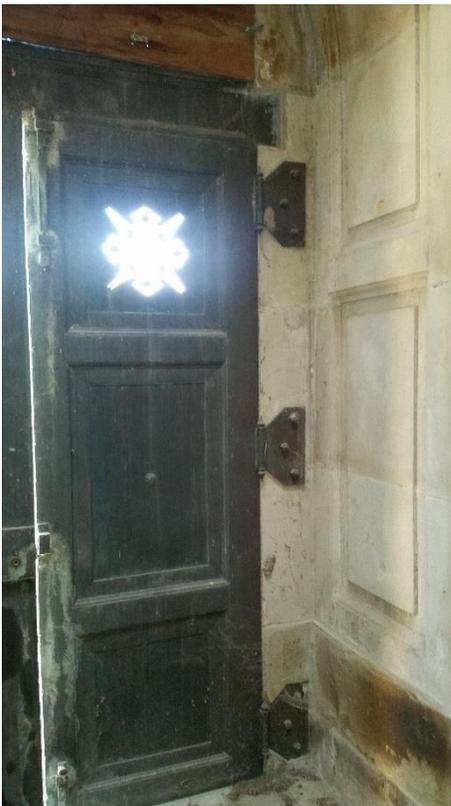
The door to the mausoleum is a finely detailed double bronze door with an arched transom window. The windows over the doorway are broken have been removed and replaced with plywood. The door is a raised panel design with bronze knockers and ornate cutouts for light penetration. A fairly uniform patina has formed on the exterior of the door. The interior is more stained due to the water infiltration. The hinges are quite massive and are anchored into the stonework.

The doors appear to be original to the tomb. The lockset and hinges are functional, however the door does catch on the floor when partially open. The condition of the door is very good.

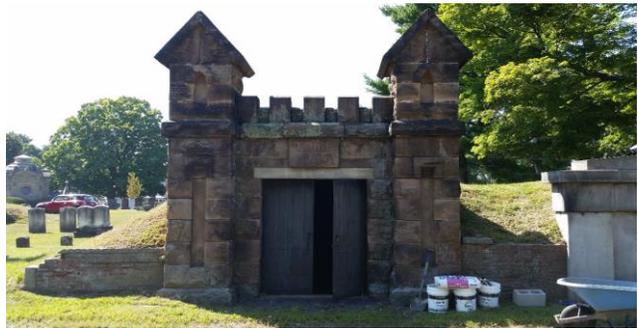
Front Elevation

Inspection Items	Comments
Movement	Nothing significant Minor cracking on interior brick indicating minor movement of front façade
Joints	Most joints are fair Some has been repointed before Some joints are open
Staining	Considerable stains due to weathering Efflorescence on interior
Plant Growth	Heavy lichen in areas
Doors	Paint is failing, Hinges are fair condition, Original doors were bifold (welded together now).
Wingwalls	Right wingwall is missing cap stones Minor shifting of both wingwalls Signs of previous interior wood doors (hinges)
Notes	<ol style="list-style-type: none"> 1. Brownstone facade with mortar 2. Granite lintel over door 3. Brick mortar arch roof (VG condition). 4. Stone masonry base walls (repointed and white washed). (VG condition) 5. Brick and stone interior steps (good condition). 6. Brick Floor (good condition) 7. No signs of significant movement. 6. Doors appear to be salvageable.

Short Term Repairs	None
Long Term Repairs	Clean and Repoint Exterior Stonework Rehabilitate doors Repair cracked interior bricks (mortar)

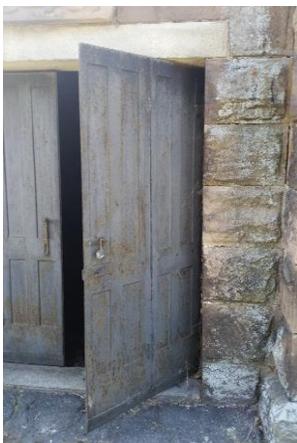
Steel Doors

The entry doors appear to be original. The raised panel style is consistent with receiving tombs of this era. Each side door was most likely a bi-fold door in the original construction. This was inferred following an inspection of the rear face of the doors. There is a well-defined joint between the sections of the doors. At some point, they were converted to single action doors. The adjacent doors were welded together and backing plates were added. A small steel plate appears to have been added at the base of the doors, probably due to a modification of the threshold at one time. The steel is in fair to good condition; however the paint system is currently failing.

The steel work can then be repaired and a quality modern paint system applied. The doors could then be re-set. The hinges may need to be repaired and re-installed.

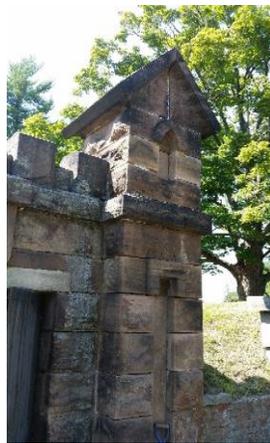
Typical Exterior Stone Conditions

The grout joints in the front façade appear to have been re-pointed at least one time. Many joints are missing mortar as well. We managed to inspect several open joints and found several different types of mortar. The deepest mortar appears to be a lime based mix, which is most likely the original mortar. This would have been typical of what would be used in the mid-1800's. The new pointing is a gray cement based mortar that is used throughout the structure. The missing mortar has not affected the structural integrity of the façade. There is staining and lichen on many parts of the stonework. Overall, the stonework is in very good condition. The brick wingwalls are showing signs of minor movement (tilting). The cause of this movement will be discussed in further detail in a subsequent section of this report. Several granite cap stones on the right wingwall are missing.

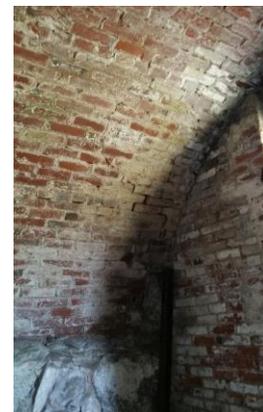
Minor Cracking near front façade

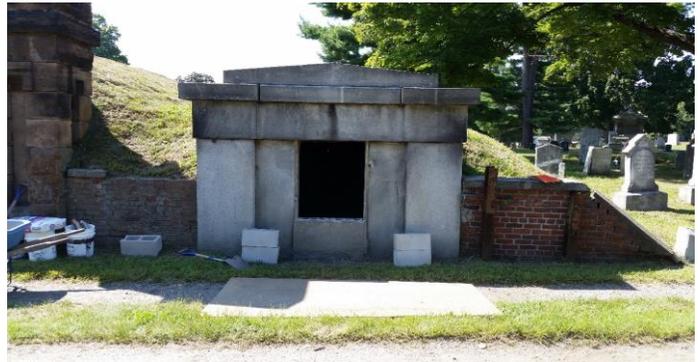
Front Elevation

Inspection Items	Comments
Movement	No significant movement noted. Front façade has not moved. Top left stone has shifted slightly
Joints	Façade joints are dry laid (unmortared)
Staining	Moderate staining on exterior Efflorescence on interior
Plant Growth	Minor plant growth in joints
Door	Original steel door is in the tomb Signs of previous interior wood doors (hinges and remnants of the doors).
Wingwalls	Right wingwall has failed Left wingwall is reported in other tomb report
Notes	<ol style="list-style-type: none"> 1. Granite façade with dry joints 2. No signs of significant movement 3. Brick mortar arch structure(VG condition). 4. Minor cracking of brick at door jambs. 5. Door was measured and will fit in the door opening. The doors, hinges and striker plate are damaged beyond repair.
Short Term Repairs	None
Long Term Repairs	Reset shifted stones Replace original door with new door (same) Repair cracked interior bricks (mortar) Clean exterior stone surfaces

There are no significant repairs required for the Ansel Wright Tomb façade. The displaced stone on the top left corner can be easily reset. No repointing is necessary, since the original construction was not mortared.

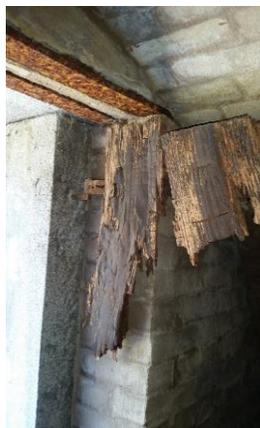
Original Door In Tomb

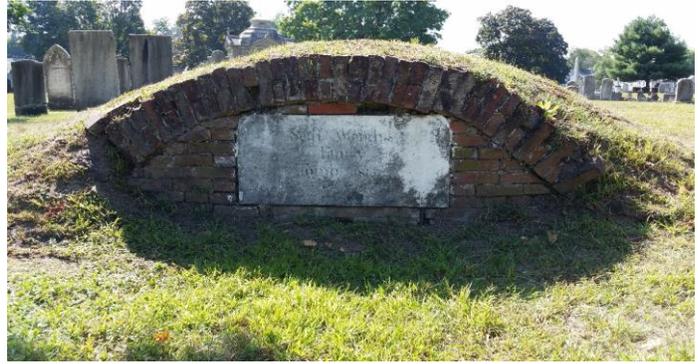
Front Elevation

Inspection Items	Comments
Movement	Front façade is failing in a few areas. Several bricks have fallen away.
Joints	Brick façade with mortar joints (fair to poor condition)
Staining	Significant staining
Plant Growth	Lichen growth
Door	No door. Stone access door is in fair condition
Notes	<ol style="list-style-type: none"> 1. This tomb was not opened for inspection. There signs that it is also a brick arch structure. There is no sign of settlement, therefore the structure is most likely intact. 2. Brick mortar arch structure. 3. Front facade is failing.
Short Term Repairs	None
Long Term Repairs	Remove and reset façade brickwork and stone door.

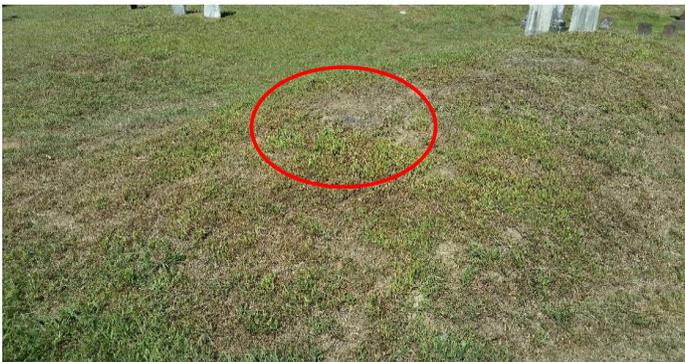
Portion of brick arch exposed

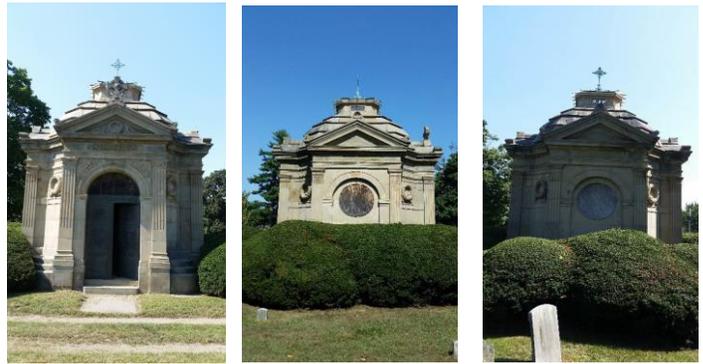
Elevations (3 shown, 4th similar)

Inspection Items	Comments
Movement	No signs of movement. No cracks.
Joints	Many joints are open allowing water to infiltrate.
Staining	Moderate staining
Plant Growth	Shrubs are growing into the stonework and partially blocking the ventilation grates
Door	The door is in very good condition.
Windows	4 Windows are missing Window over door is broken 3 side windows are missing, but the frames are in the tomb (one severely damaged)
Skylight and Vent.	Skylight is damaged (broken glass) Natural ventilation system (functional)
Notes	<ol style="list-style-type: none"> 1. There is spalling and scaling of the limestone facade and interior in many areas. 2. The doors are in very good condition. 3. The roof is leaking, causing damage to interior surfaces. 4. The natural ventilation system is functional.
Short Term Repairs	Repair leaking roof to stabilize interior. Replace the broken and damaged windows and skylight.

Long Term Repairs	Rehabilitate all stonework inside and outside. Clean stone surfaces.

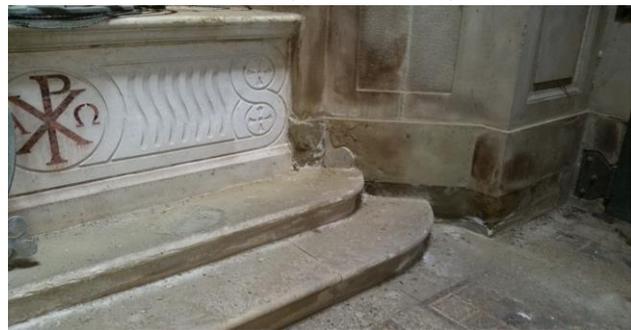
Typical Interior conditions

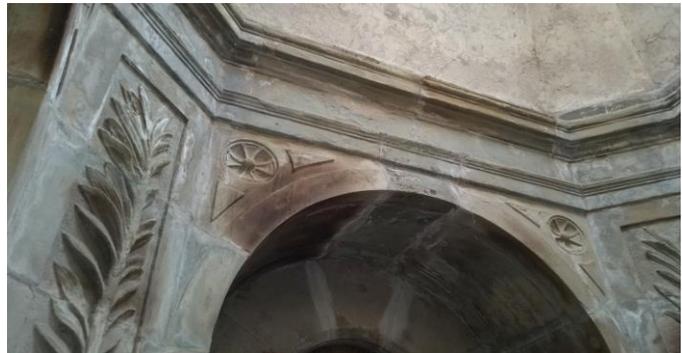
Interior Conditions

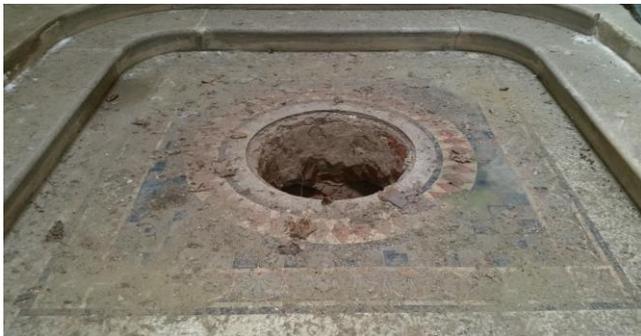
Ventilation pit (grate missing)

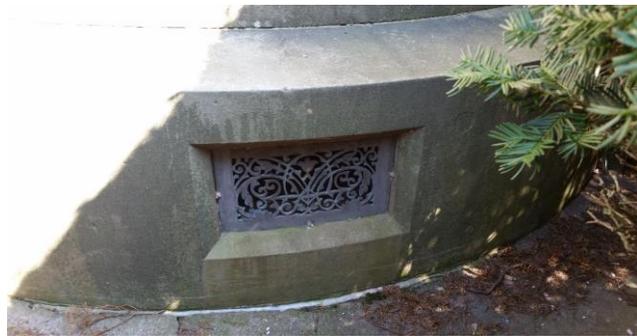
Exterior Ventilation Grate

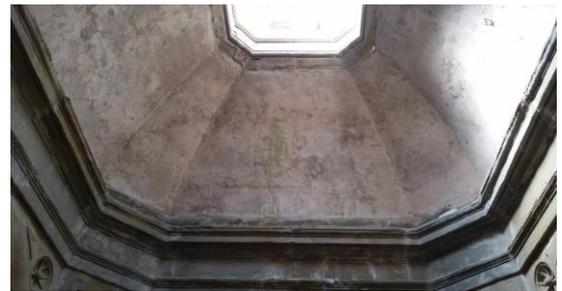
Interior Ceiling and Skylight

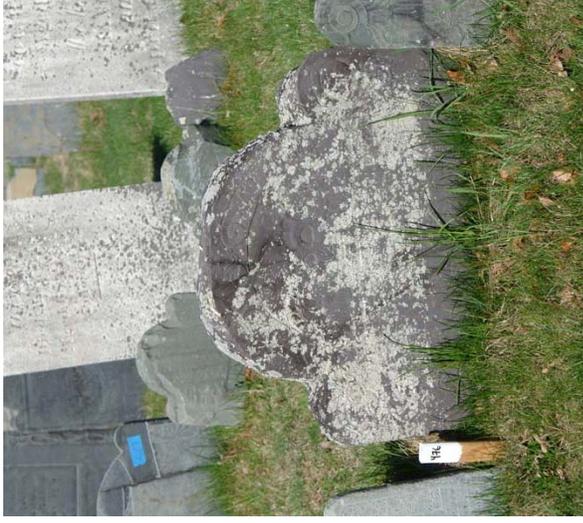
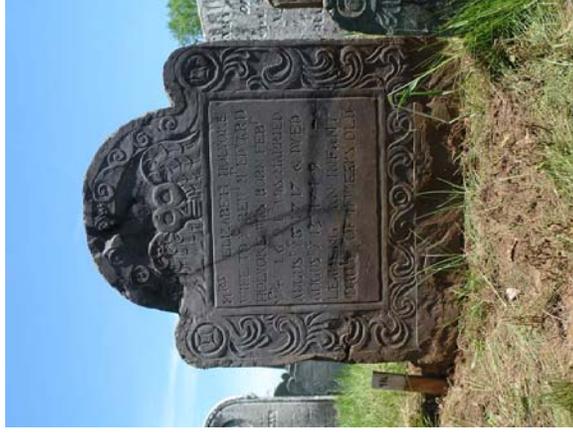
Typical slate marker, benefitting from cleaning

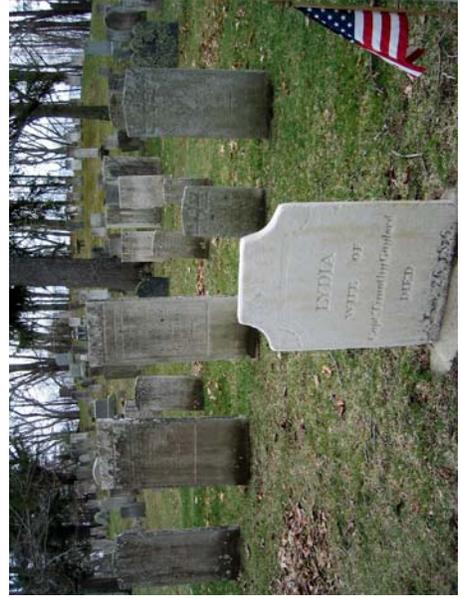
The cleaning of one marble inappropriately stands out; and cleaning all the stones would be historically incorrect.

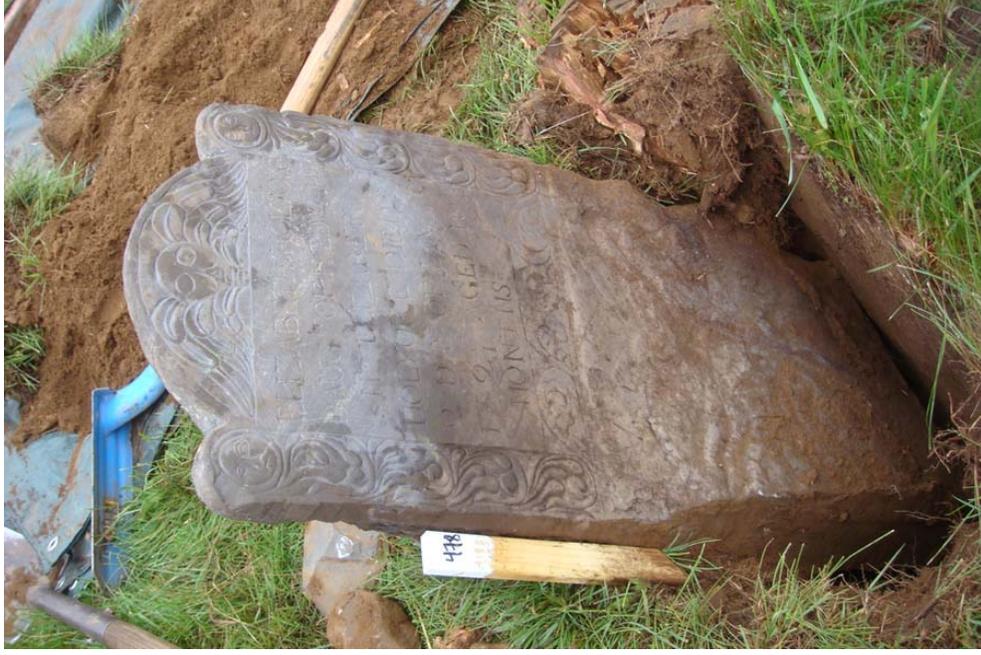
18th century markers often have as much below the ground as above. Only upon excavating this marker for resetting does the very massive below grade portion becomes apparent.

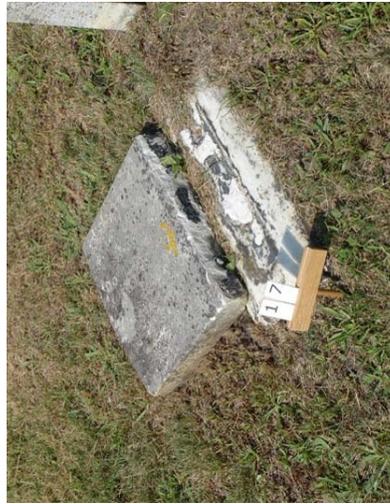
Example of marker broken just above existing base

When the gravestone has (typically) broken just above an existing slotted base, stone fragments may have to be removed from the slot and the bottom of the gravestone re-squared. Even with power tools, this is a time-consuming and arduous task.

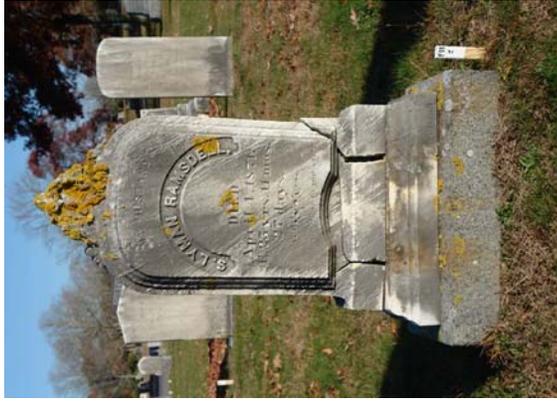
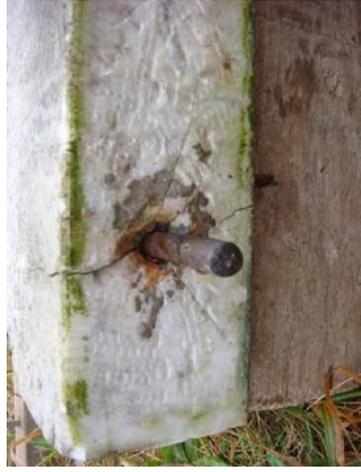
Above: Examples of cracking cause by rusted pins.

Inspect existing pins and if sound and made of copper or bronze can be re-used. Replace all iron pins. If missing or unsound carefully remove by drilling around them with a core drill and replace with stainless steel threaded rods. Setting holes were drilled to clean out debris.

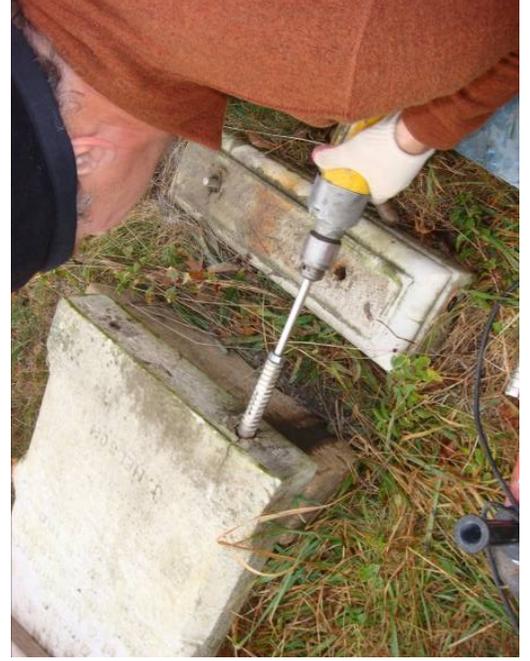
Example of removing iron pins with a core drill. These will be replaced with threaded stainless steel rods

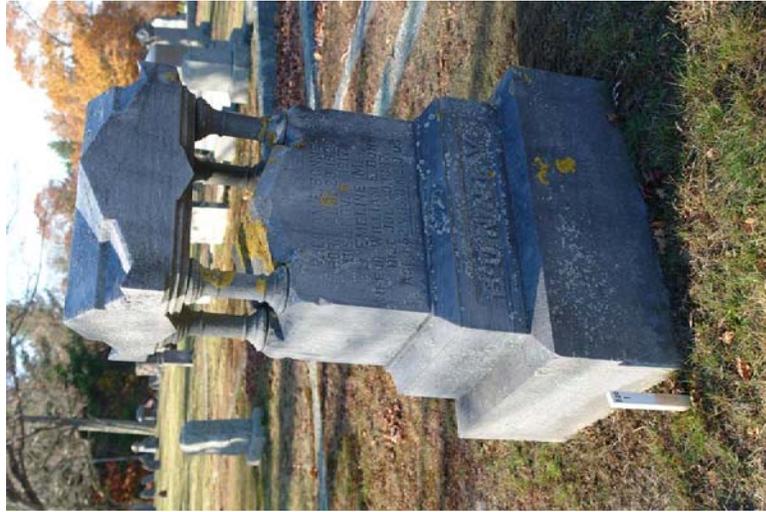
The large die (above) will require mechanical assistance to reset level. Resetting this monument after it falls is considerably more costly than stabilizing it now.

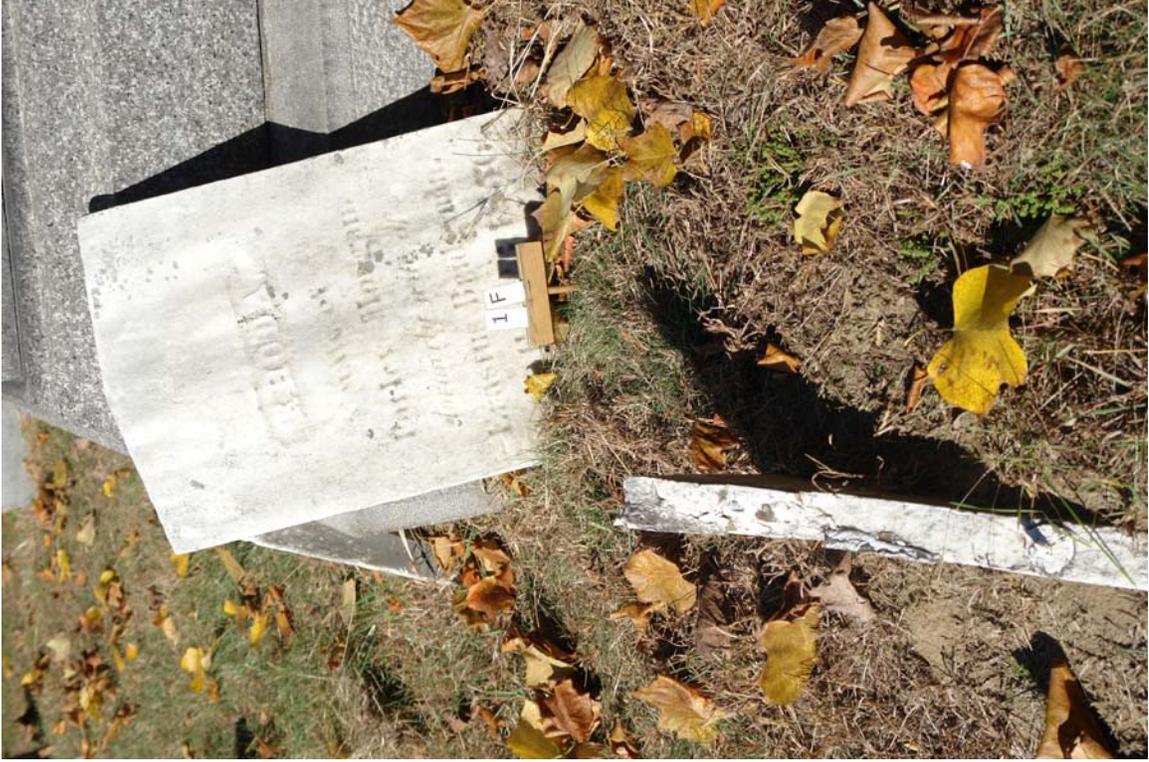
Marker# **1.F.3**

Failed adhesive **Reset level**
Marker leaning on adjacent monument **Attach fragments with structural adhesive**

CONSERVATION PRIORITY 3
 1) Hazardous, immediate action
 2) Unstable--asap
 3) Ongoing deterioration, treat 2-5 years

1. Old repair has completely failed. Remove any failed fills, pins and adhesives with hand tools and treat mating surfaces with D/2.
2. If lower in ground fragment or bases are tilted, excavate soil to a sufficient depth and re-set plumb at appropriate height and level onto gravel bed, and align with adjacent markers
3. Backfill area around marker with tamped sand and gravel
4. Attach fragments with structural adhesive (Abatron 55-22), clamp and brace until cured.
5. Remove excess epoxy with hand chisels within 24 hours
6. Fill cracks and losses with Voidspon PHLc or Jahn products
7. Mist filled areas with water and keep covered for 3 days min.
8. Treat filled surface areas with light acid wash and rinse thoroughly with water

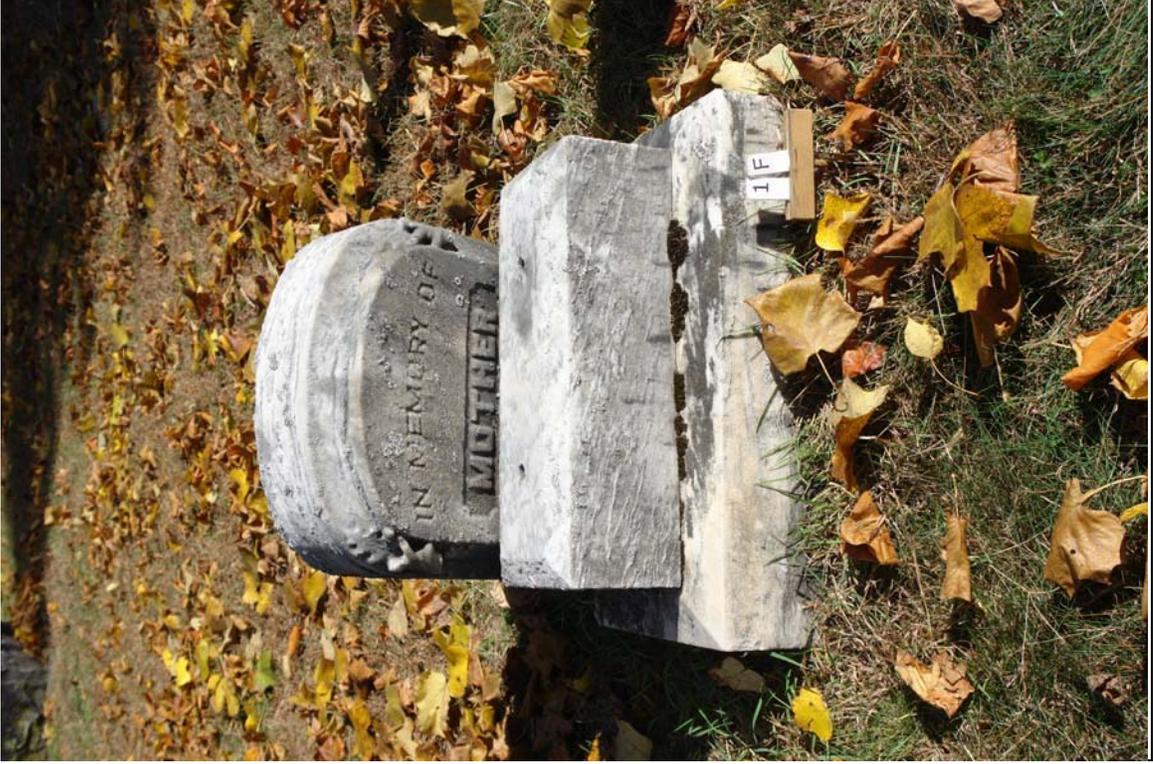
EXISTING CONDITIONS	CONSERVATION STRATEGY
Fallen, off base	Plumb bases and reset

CONSERVATION PRIORITY	2
<p>1) Hazardous, immediate action 2) Unstable--asap 3) Ongoing deterioration, treat 2-5 years</p> <p>RECOMMENDED TREATMENT</p> <ol style="list-style-type: none"> 1. Remove any failed setting material and pins from setting surfaces with hand tools 2. If required, excavate and align base with adjacent markers and re-set level. Backfill w/ tamped gravel 3. Prime setting surfaces with Acryl 60 diluted 1:3 with water and reset bases and marker with cement/lime mortar (3/2/9) with 000 sand. Use lead shims as necessary to level. Remove excess grout from joint. 4. Brace until partial cure.

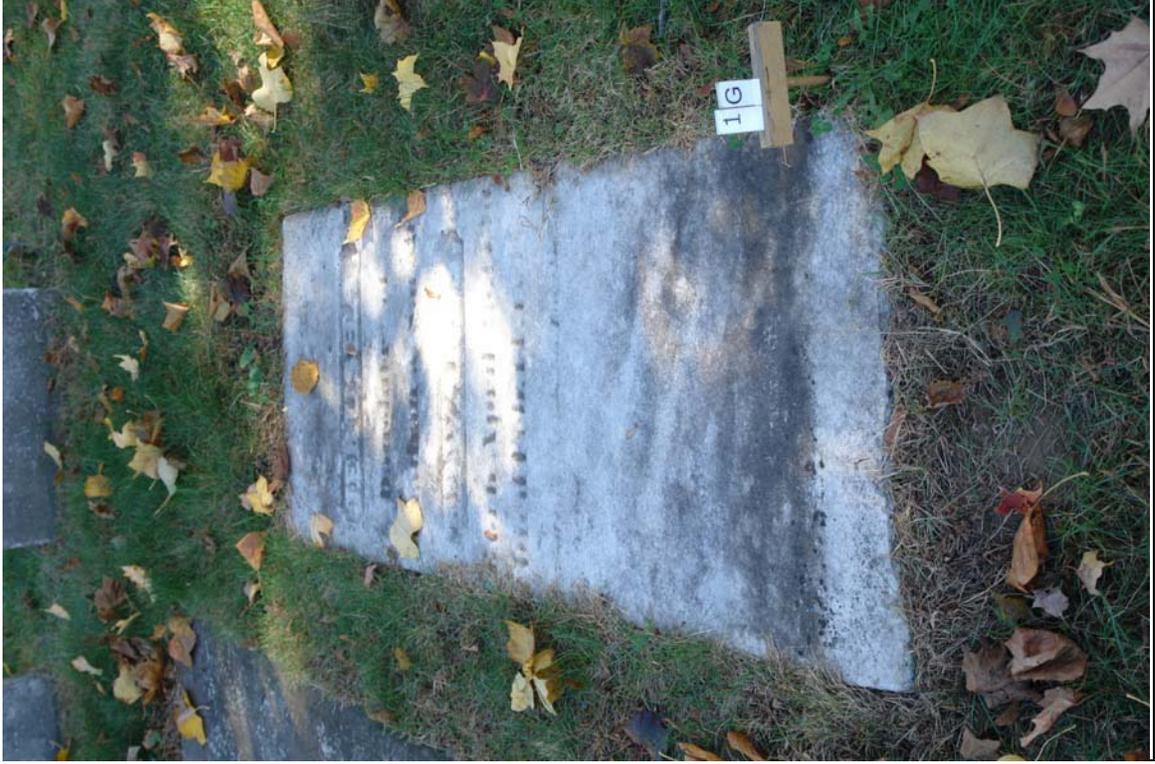
EXISTING CONDITIONS	CONSERVATION STRATEGY
Fallen	Reset into ground

CONSERVATION PRIORITY	3
<p>1) Hazardous, immediate action 2) Unstable--asap 3) Ongoing deterioration, treat 2-5 years</p> <p>RECOMMENDED TREATMENT</p> <ol style="list-style-type: none"> Carefully excavate marker; extremely tilted markers are hazardous. Inspect marker for soundness. If marker is tilted, remove soil around stone to an appropriate depth, if required, remove stone from ground. If marker has fallen, remove overgrowth and inspect for soundness. Remove soiling by light brushing with nylon brushes and water. Excavate setting area to sufficient depth and re-set stone plumb at appropriate height and level onto gravel bed, and align with adjacent markers Backfill area around marker with tamped sand and gravel Re-grade disturbed areas with existing topsoil.

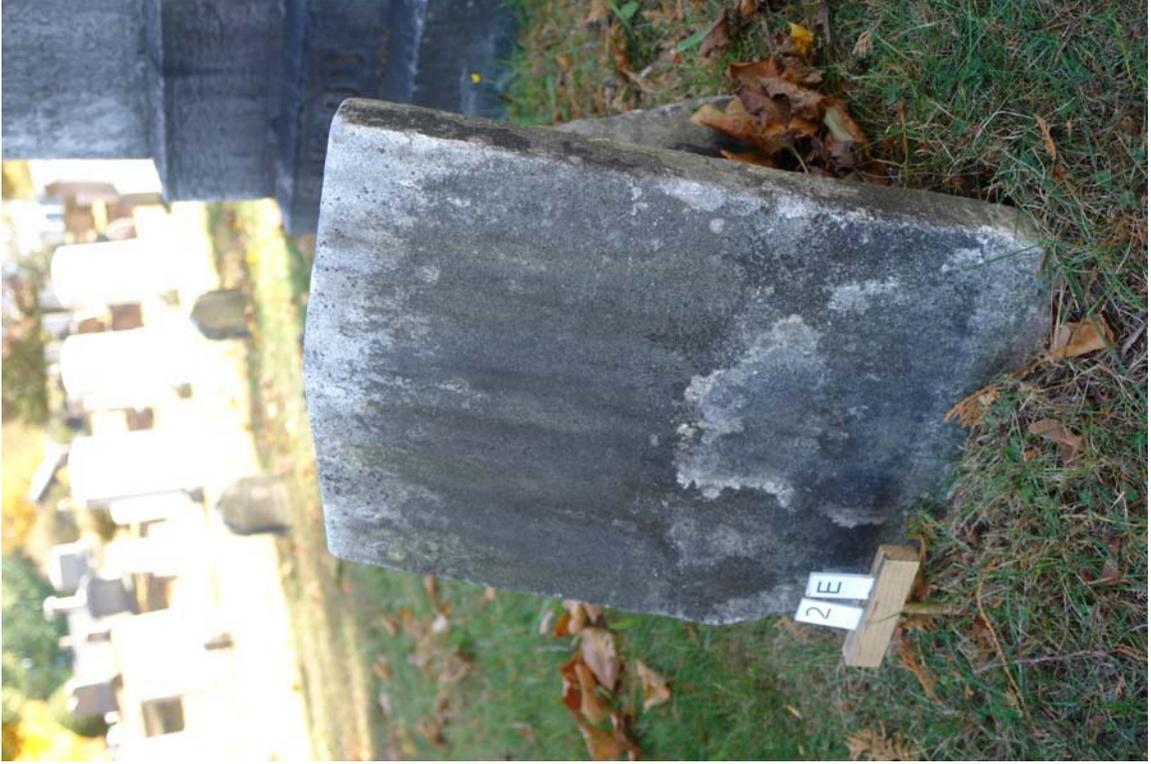
EXISTING CONDITIONS	CONSERVATION STRATEGY
Fractured	Attach fragments with structural adhesive Poss new base

CONSERVATION PRIORITY	2
<p>1) Hazardous, immediate action 2) Unstable--asap 3) Ongoing deterioration, treat 2-5 years</p> <p>RECOMMENDED TREATMENT</p> <ol style="list-style-type: none"> Excavate marker and fragments. Remove any previous failed repairs. If adequate below grade length is found for resetting (over 24"), ideally 30", reset lower marker fragment plumb. If unsound material or less than 24" is found, new below grade cast concrete base will be required for resetting. If required, re-square the lower edge of marker fragment w/ min. loss. After min 3 day cure, remove the setting form and reset lower marker fragment plumb and level into slot using a plasticized cement/lime grout (3/2/9) with 000 sand . Brace for minimum of 3 days. Backfill disturbed areas with tamped sand and gravel, and re-grade with existing topsoil. Attach fragments w/ structural adhesive, brace and clamp until cured. Fill cracks and losses with Voidspon PHLc or Jahn products. Mist filled areas with water and cover for 3 days minimum

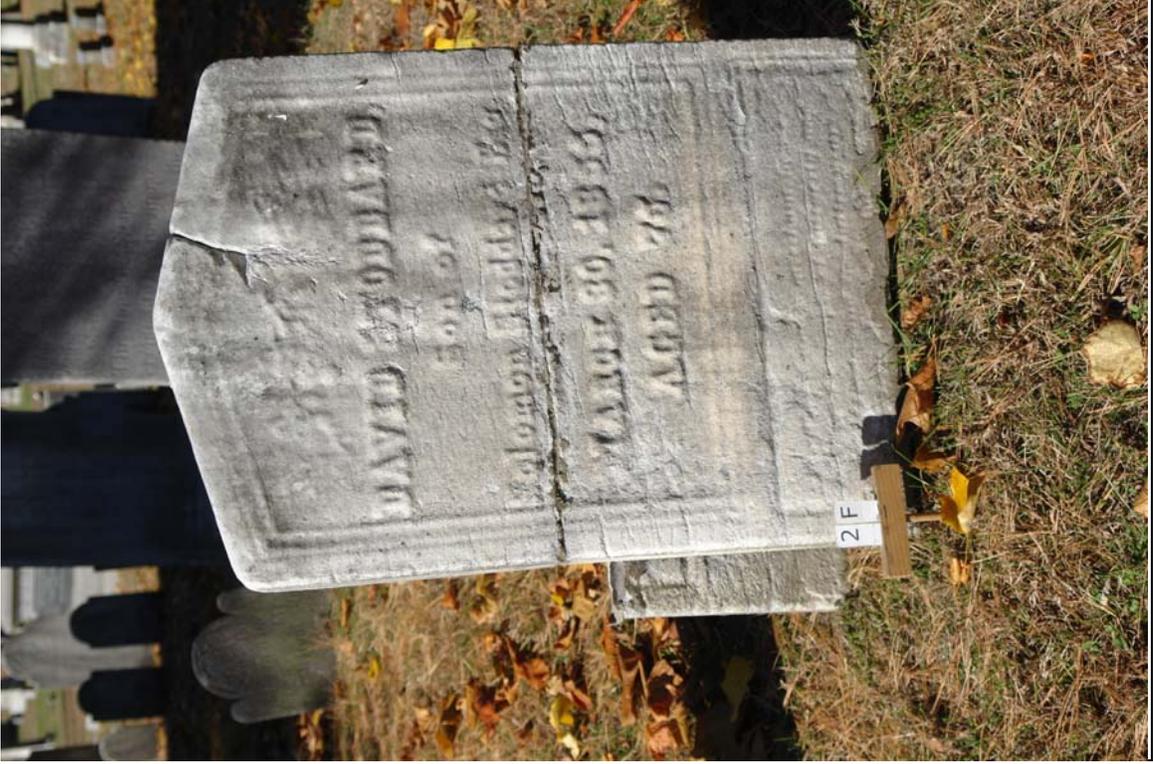
Marker# **2.F.1**

Fractured Evaluate condition of marker for
 Weathered restoration

Carefully excavate marker and fragments. Brush clean and inspect for soundness and extreme sugaring. Probe area for additional fragments. Evaluate if marker is restorable. If not, reset as found.

1. Clean mating surfaces and remove any failed adhesives or mortar
2. Attach fragments with structural adhesive, brace and clamp until cured.
3. Fill cracks and losses with Voidspon or Jahn products as required
4. Mist filled areas with water and cover for 3 days minimum
5. Treat filled surface areas with light acid wash and rinse thoroughly

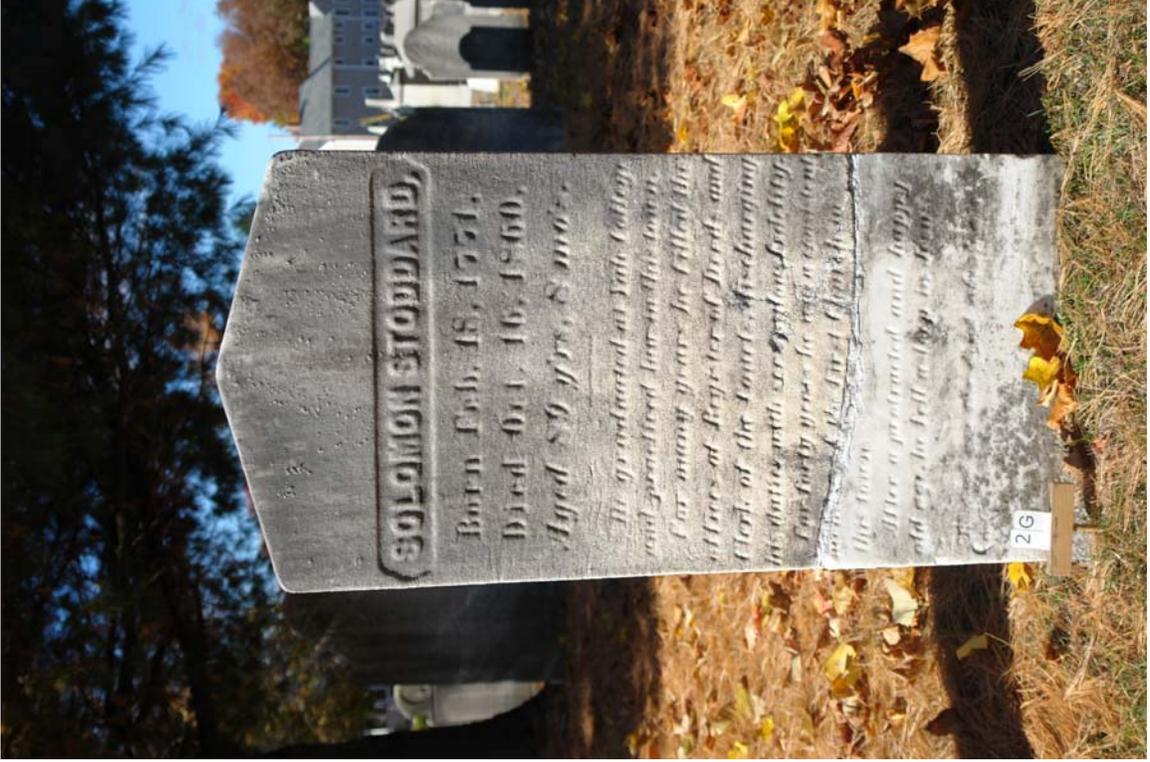
EXISTING CONDITIONS	CONSERVATION STRATEGY
Old repair failing– unstable	Reset level if required Re-attach fragments with structural adhesive Fills losses w/ cementitious fills

CONSERVATION PRIORITY	1
<p>RECOMMENDED TREATMENT</p> <p>1. Old repair has completely failed, top fragment is hazardous. Carefully take fragments apart and remove any failed pins. 2. If lower in ground fragment or bases are tilted, remove soil around the in ground fragment to an appropriate depth to sufficient depth and re-set stone fragment or bases plumb at appropriate height and level onto gravel bed, and align with adjacent markers 3. Backfill area around marker with tamped sand and gravel 4. Remove any failed fills and adhesives with hand tools and treat mating surfaces with D/2 5. Attach fragments with structural adhesive (Abatron 55-22), clamp and brace until cured. 6. Remove excess epoxy with hand chisels within 24 hours 7. Fill cracks and losses with Voidspan PHLc or Jahn products 8. Mist filled areas with water and keep covered for 3 days minimum 9. Treat filled surface areas with light acid wash and rinse thoroughly</p>

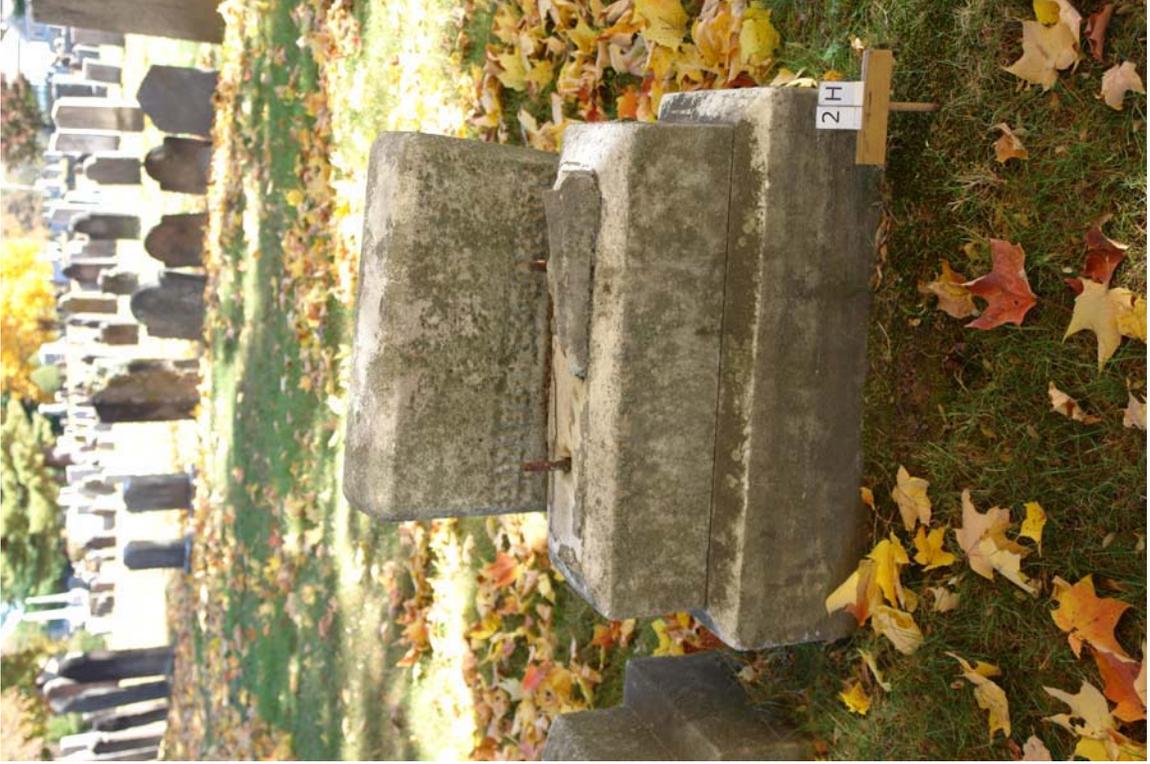
Fallen, off base Plumb base and reset marker

CONSERVATION PRIORITY	2	1) Hazardous, immediate action 2) Unstable--asap 3) Ongoing deterioration, treat 2-5 years
RECOMMENDED TREATMENT		
1. Remove any failed setting material and pins from setting surfaces with hand tools 2. If required, excavate and align base with adjacent markers and re-set level. Backfill w/ tamped gravel 3. Prime setting surfaces with Acryl 60 diluted 1:3 with water and reset bases and marker with cement/lime mortar (3/2/9) with 000 sand. Use lead shims as necessary to level. Remove excess grout from joint. 4. Brace until partial cure.

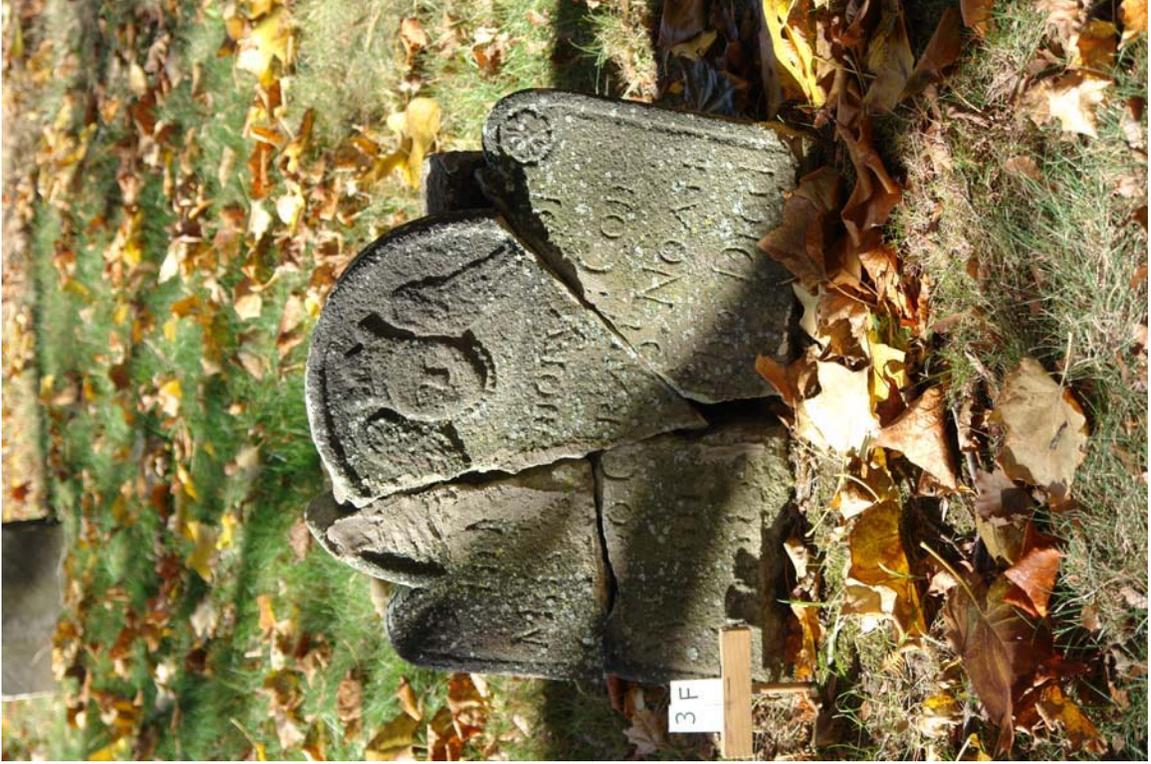
EXISTING CONDITIONS	CONSERVATION STRATEGY
Fragmented	Evaluate

CONSERVATION PRIORITY	3
<p>1) Hazardous, immediate action 2) Unstable--asap 3) Ongoing deterioration, treat 2-5 years</p> <p>RECOMMENDED TREATMENT</p> <p>Carefully excavate marker and fragments. Brush clean and inspect for soundness and extreme sugaring. Probe area for additional fragments. Evaluate if marker is restorable. If not, reset as found.</p> <ol style="list-style-type: none"> 1. Clean mating surfaces and remove any failed adhesives or mortar 2. Attach fragments with structural adhesive, brace and clamp until cured. 3. Fill cracks and losses with Voidspon or Jahn products as required 4. Mist filled areas with water and cover for 3 days minimum 5. Treat filled surface areas with light acid wash and rinse thoroughly 6. Reset as required- possible new base
