HISTORICAL CHRONOLOGY

The purpose of this report is to review the existing conditions of several significant structures within the Bridge Street Cemetery in the City of Northampton, Massachusetts.

Existing Conditions of Structures

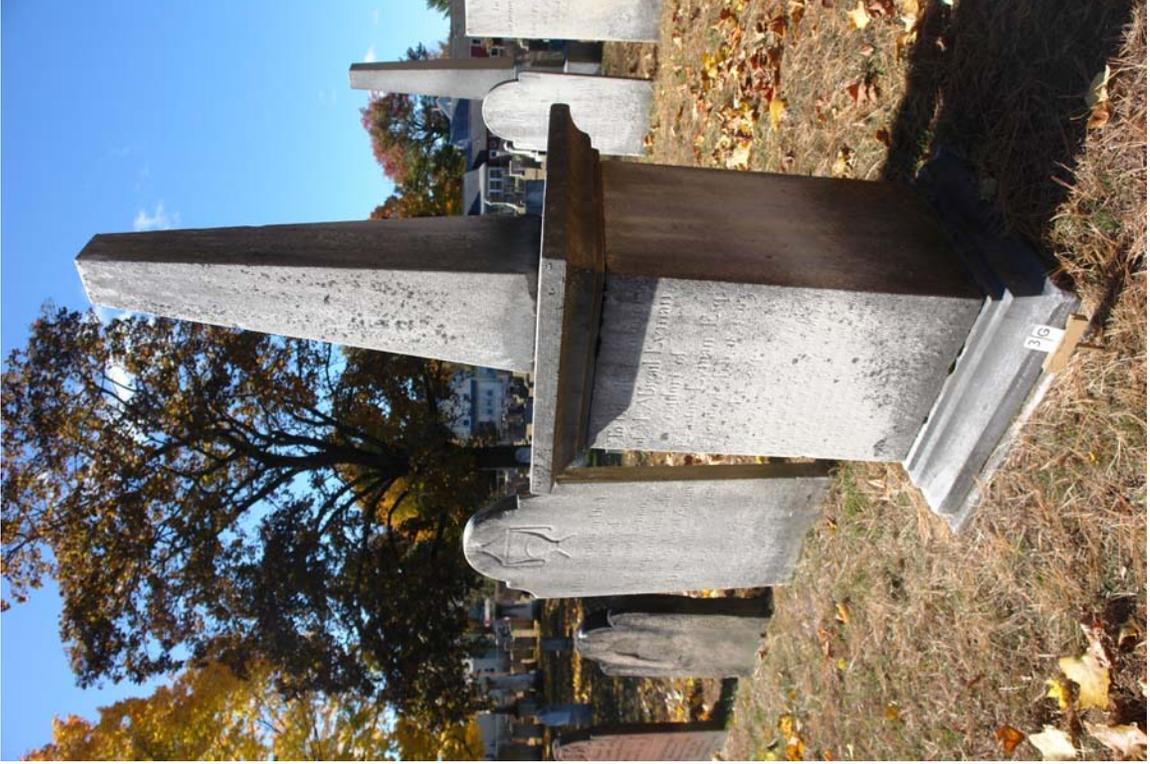
EXISTING CONDITIONS	CONSERVATION STRATEGY
Tilting	Reset plumb

CONSERVATION PRIORITY	RECOMMENDED TREATMENT
1) Hazardous, immediate action 2) Unstable--asap 3) Ongoing deterioration, treat 2-5 years	<ol style="list-style-type: none"> 1. Excavate around above ground base to depth of base. 2. Inspect loose stone foundation, remove unstable material. 3. Raise monument on one side with hydraulic jacks and remove loose stone rubble from setting area 4. Lower monument onto setting area, and repeat raising operation on opposite side as needed. 5. Monument leveled onto setting area, shimmed tightly with flat stones on all sides and re-grade area with existing topsoil. 6. If setting joints are unsound, remove failed setting mortar. 7. Prime setting surfaces with Acryl 60 diluted 1:3 with water. 8. Re-set elements plumb onto base/s with a cement/lime mortar (3/2/9) with 000 sand Use lead shims for leveling if required.

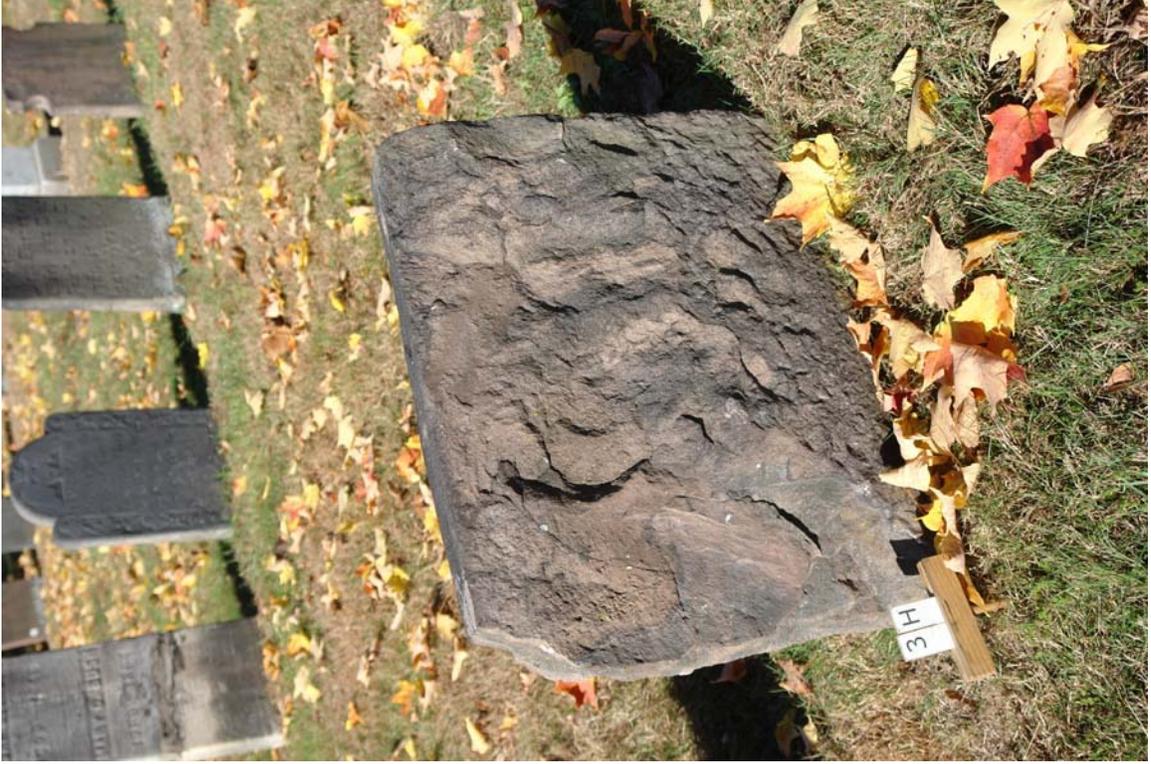
EXISTING CONDITIONS	CONSERVATION STRATEGY
Leaning on adjacent marker	Possible new base required

CONSERVATION PRIORITY	2
<p>1) Hazardous, immediate action 2) Unstable--asap 3) Ongoing deterioration, treat 2-5 years</p> <p>RECOMMENDED TREATMENT</p> <p>1. Probe area for possible existing below grade base or in ground fragmentation to determine location of resetting. 2. If base is found and stable, remove any failed material from setting slot and reset level as necessary. 3. If base is found to be unstable, or not found, a new below grade cast concrete base will be required. Sized minimum of 12 inches deep, 12 inches greater in thickness and 6 inches wider than the stone. The finished top to be entirely below grade. Align the 1" deep form for the setting slot (1/2" wider and thicker than the marker) with adjacent markers. 4. After min 3 day cure, remove the setting forms and backfill disturbed areas with tamped sand and gravel, and re-grade with existing topsoil 5. Re-square lower edge of marker fragment and reset plumb and level into slot using a flowable cement/lime grout (3/2/9) with 000 sand made fluid with a super plasticizer. Brace for minimum of 3 days.</p>

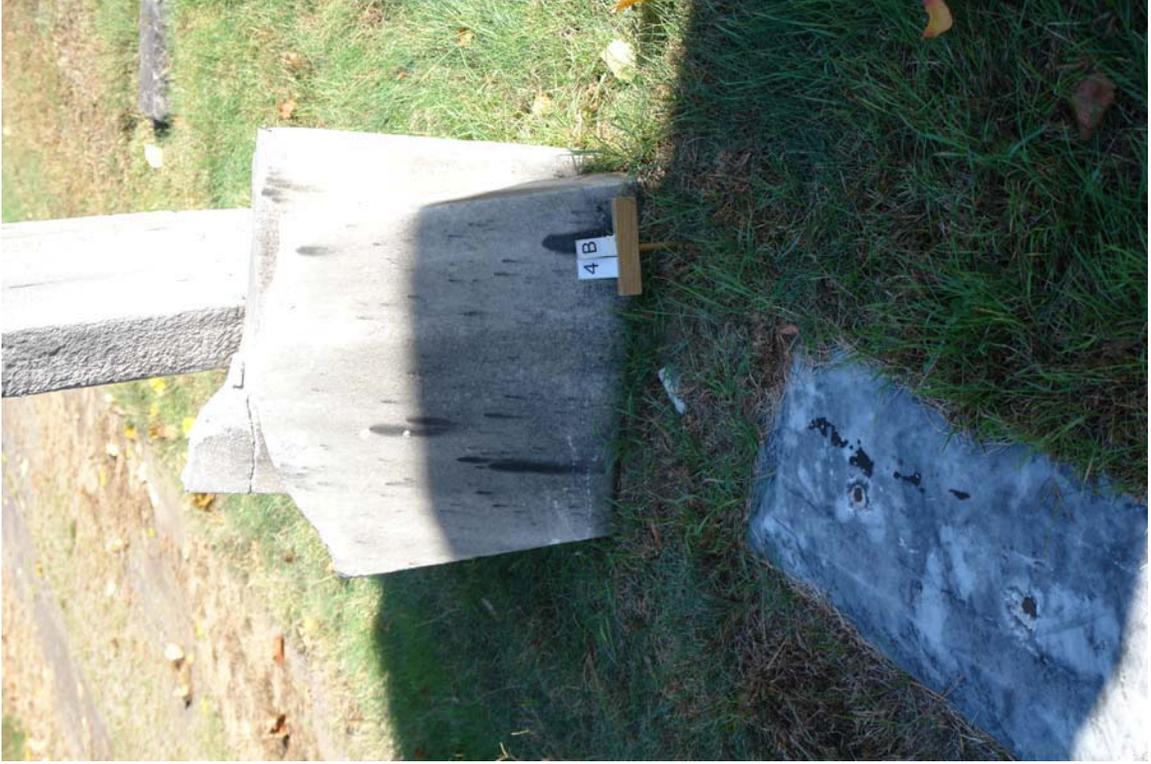
EXISTING CONDITIONS	CONSERVATION STRATEGY
Failed repair	Reset to base Attach fragments with structural adhesive Fill losses

CONSERVATION PRIORITY	2
1) Hazardous, immediate action 2) Unstable--asap 3) Ongoing deterioration, treat 2-5 years	
RECOMMENDED TREATMENT	
1. Old repair has completely failed, carefully take fragments apart and remove any failed fills and adhesives with hand tools. 2. Reset lower fragment plumb onto exiting base, repin if required. 3. Attach fragments with structural adhesive (Abatron 55-22), clamp and brace until cured. 4. Remove excess epoxy with hand chisels within 24 hours 5. Fill cracks and losses with Voidspan PHLc or Jahn products 6. Mist filled areas with water and keep covered for 3 days minimum 7. Treat filled surface areas with light acid wash and rinse thoroughly

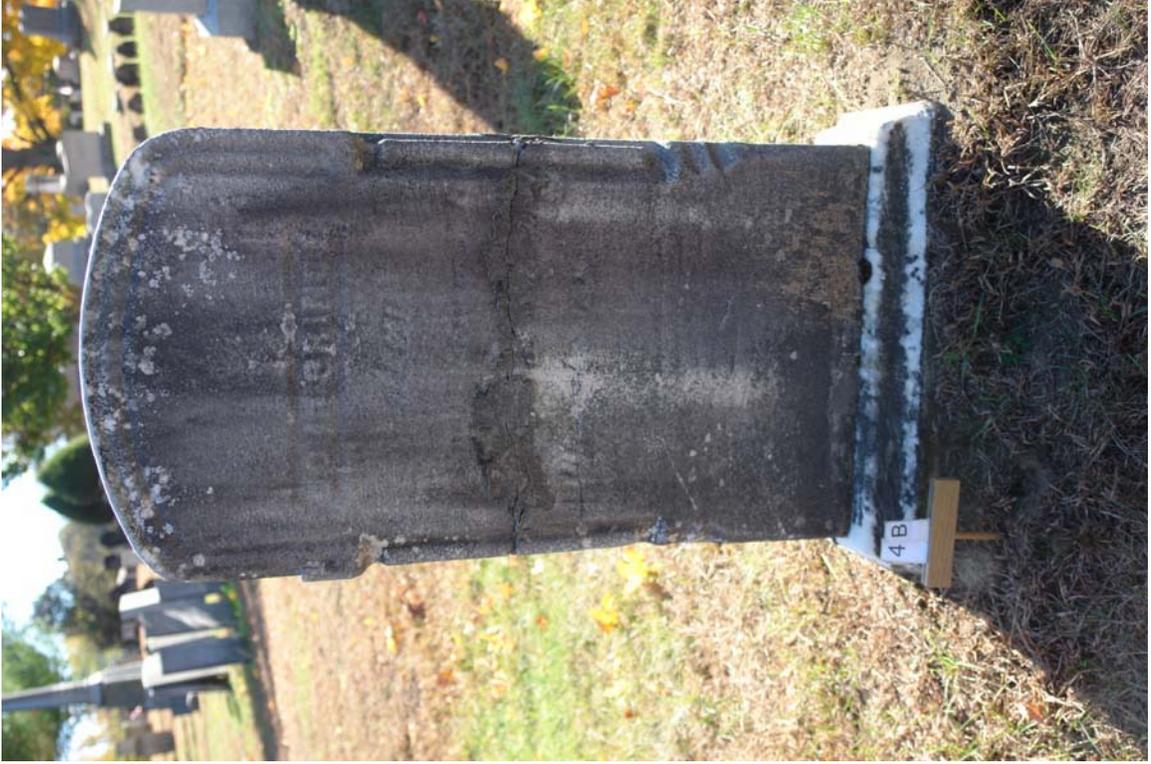
Marker# **4.B.3**

Old repair failing– unstable **Reset level if required**
Re-attach fragments with structural adhesive
Fills losses w/ cementitious fills

CONSERVATION PRIORITY 1
 1) Hazardous, immediate action
 2) Unstable--asap
 3) Ongoing deterioration, treat 2-5 years

1. Old repair has completely failed, top fragment is hazardous. Carefully take fragments apart and remove any failed pins.
2. If lower in ground fragment or bases are tilted, remove soil around the in ground fragment to an appropriate depth to sufficient depth and re-set stone fragment or bases plumb at appropriate height and level onto gravel bed, and align with adjacent markers
3. Backfill area around marker with tamped sand and gravel
4. Remove any failed fills and adhesives with hand tools and treat mating surfaces with D/2
5. Attach fragments with structural adhesive (Abatron 55-22), clamp and brace until cured.
6. Remove excess epoxy with hand chisels within 24 hours
7. Fill cracks and losses with Voidspan PHLc or Jahn products
8. Mist filled areas with water and keep covered for 3 days minimum
9. Treat filled surface areas with light acid wash and rinse thoroughly

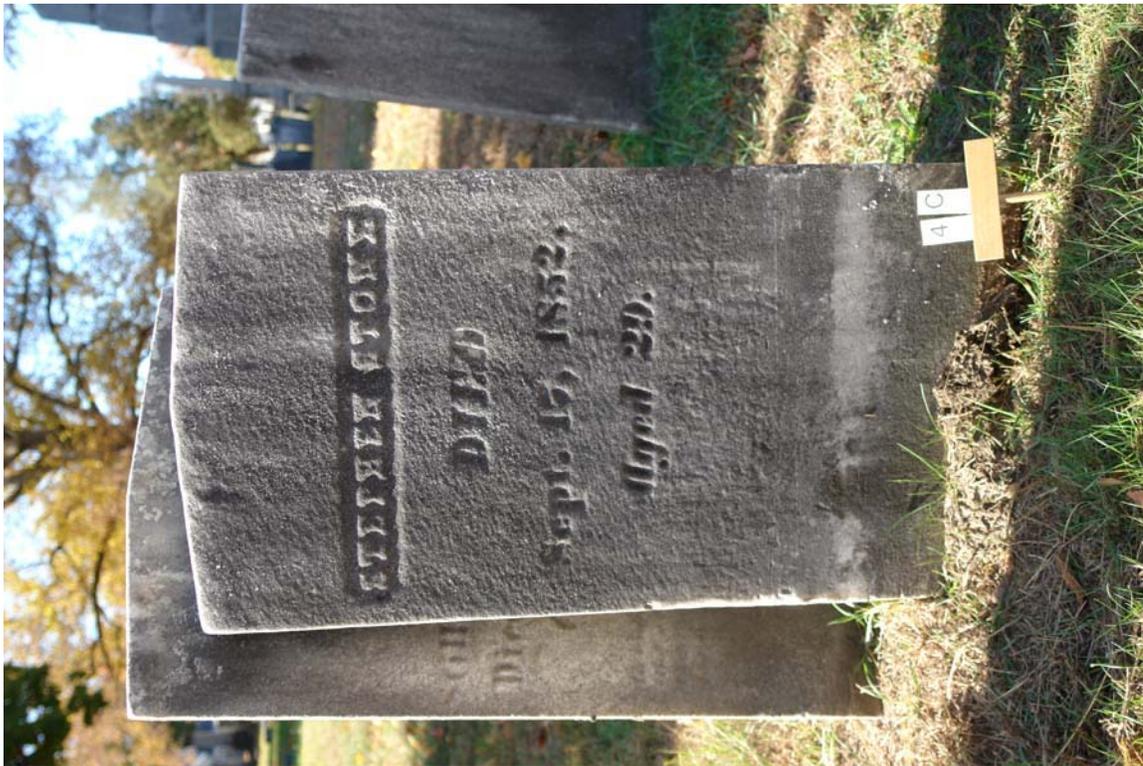
Marker# **4.C.1**

EXISTING CONDITIONS	CONSERVATION STRATEGY
Leaning on adjacent stone	Reset into new below grade base

CONSERVATION PRIORITY	2
<p>1) Hazardous, immediate action 2) Unstable--asap 3) Ongoing deterioration, treat 2-5 years</p> <p>RECOMMENDED TREATMENT</p> <ol style="list-style-type: none"> Carefully excavate marker and inspect marker for soundness. Excavate setting area for new below grade cast concrete base sized minimum of 12 inches deep, 12 inches greater in thickness and 6 inches wider than the stone. The finished top to be entirely below grade. Align the 1" deep form for the setting slot (1/2" wider and thicker than the marker) with adjacent markers. Remove soiling from marker by light brushing with nylon brushes and water. Inspect for soundness. If required, re-square the lower edge of marker with minimal loss. After min 3 day cure, remove the setting form and reset stone into slot using a cement/lime grout (3/2/9) with 000 sand Set marker plumb and level, brace for minimum of 5 days. Disturbed areas to be backfilled with tamped sand and gravel, and re-graded with existing topsoil.

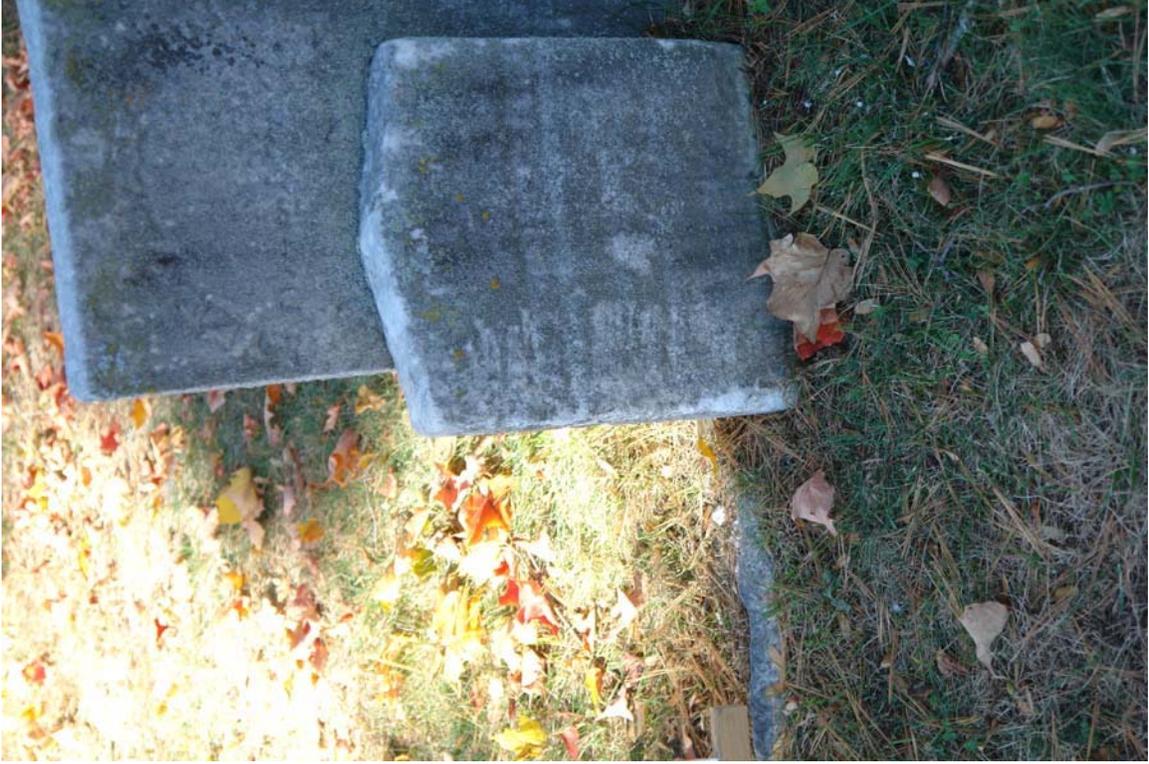
EXISTING CONDITIONS	CONSERVATION STRATEGY
Fractured at grade level	Reset into new below grade base

CONSERVATION PRIORITY	2
<p>1) Hazardous, immediate action 2) Unstable--asap 3) Ongoing deterioration, treat 2-5 years</p> <p>RECOMMENDED TREATMENT</p> <ol style="list-style-type: none"> Carefully excavate marker and inspect marker for soundness. Excavate setting area for new below grade cast concrete base sized minimum of 12 inches deep, 12 inches greater in thickness and 6 inches wider than the stone. The finished top to be entirely below grade. Align the 1" deep form for the setting slot (1/2" wider and thicker than the marker) with adjacent markers. Remove soiling from marker by light brushing with nylon brushes and water. Inspect for soundness. If required, re-square the lower edge of marker with minimal loss. After min 3 day cure, remove the setting form and reset stone into slot using a cement/lime grout (3/2/9) with 000 sand Set marker plumb and level, brace for minimum of 5 days. Disturbed areas to be backfilled with tamped sand and gravel, and re-graded with existing topsoil.

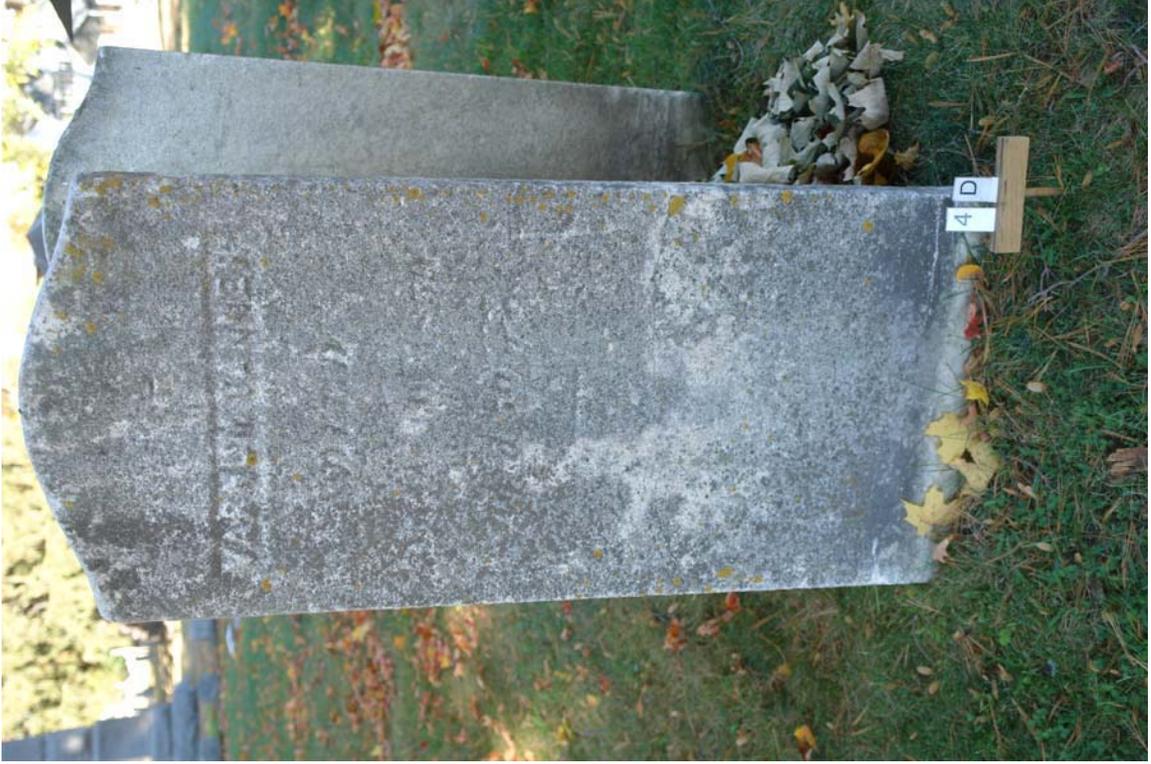
Marker# 4.D.2

EXISTING CONDITIONS	CONSERVATION STRATEGY
Unstable	Reset into new below grade base

<p>CONSERVATION PRIORITY 2</p> <p>1) Hazardous, immediate action 2) Unstable--asap 3) Ongoing deterioration, treat 2-5 years</p> <p>RECOMMENDED TREATMENT</p> <ol style="list-style-type: none"> Carefully excavate marker and inspect marker for soundness. Excavate setting area for new below grade cast concrete base sized minimum of 12 inches deep, 12 inches greater in thickness and 6 inches wider than the stone. The finished top to be entirely below grade. Align the 1" deep form for the setting slot (1/2" wider and thicker than the marker) with adjacent markers. Remove soiling from marker by light brushing with nylon brushes and water. Inspect for soundness. If required, re-square the lower edge of marker with minimal loss. After min 3 day cure, remove the setting form and reset stone into slot using a cement/lime grout (3/2/9) with 000 sand Set marker plumb and level, brace for minimum of 5 days. Disturbed areas to be backfilled with tamped sand and gravel, and re-graded with existing topsoil.

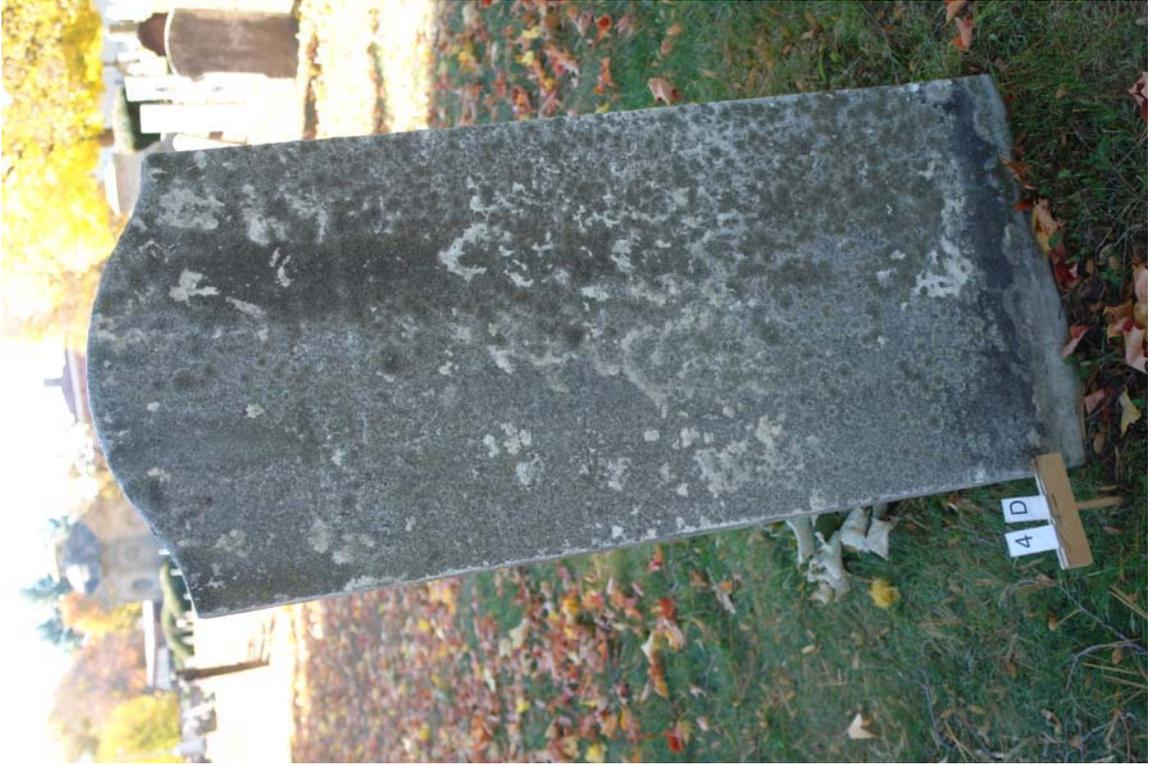
Marker# **4.D.3**

EXISTING CONDITIONS	CONSERVATION STRATEGY
Unstable	Reset into new below grade base

<p>CONSERVATION PRIORITY 2</p> <p>1) Hazardous, immediate action 2) Unstable--asap 3) Ongoing deterioration, treat 2-5 years</p> <p>RECOMMENDED TREATMENT</p> <ol style="list-style-type: none"> Carefully excavate marker and inspect marker for soundness. Excavate setting area for new below grade cast concrete base sized minimum of 12 inches deep, 12 inches greater in thickness and 6 inches wider than the stone. The finished top to be entirely below grade. Align the 1" deep form for the setting slot (1/2" wider and thicker than the marker) with adjacent markers. Remove soiling from marker by light brushing with nylon brushes and water. Inspect for soundness. If required, re-square the lower edge of marker with minimal loss. After min 3 day cure, remove the setting form and reset stone into slot using a cement/lime grout (3/2/9) with 000 sand Set marker plumb and level, brace for minimum of 5 days. Disturbed areas to be backfilled with tamped sand and gravel, and re-graded with existing topsoil.

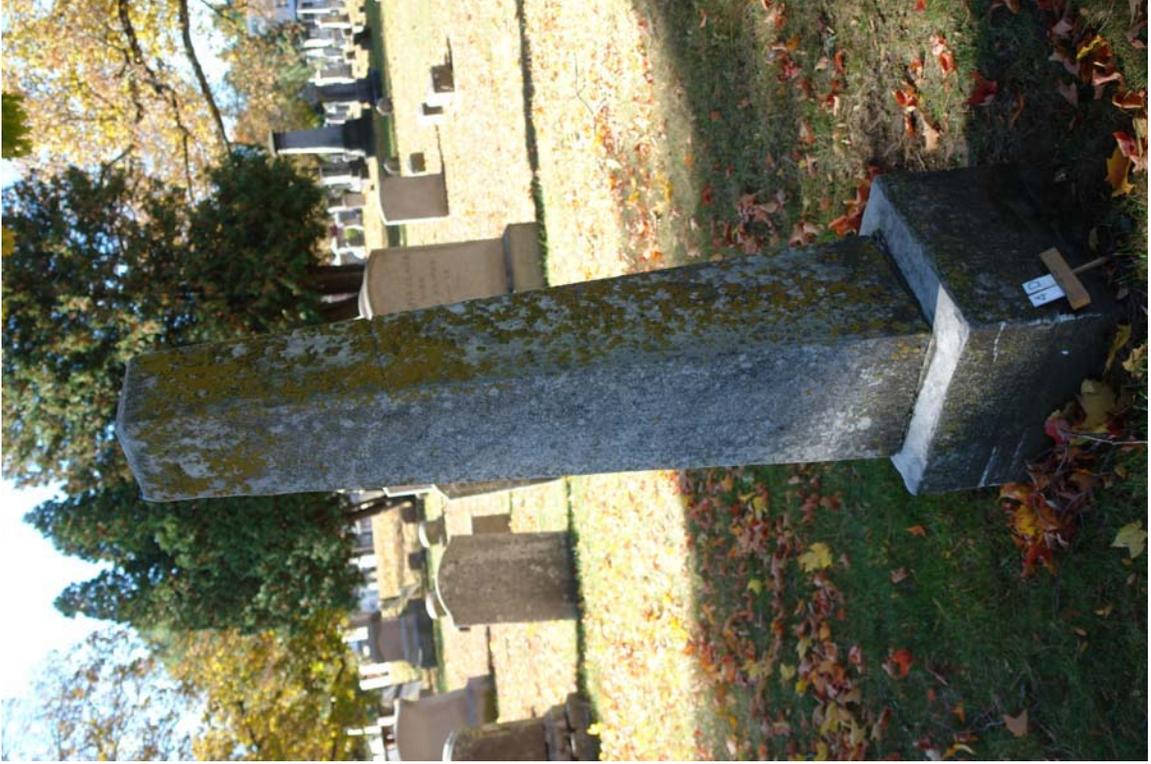
Marker# **4.D.4**

EXISTING CONDITIONS	CONSERVATION STRATEGY
Unstable	Level base Reset all elements

CONSERVATION PRIORITY	1
<p>RECOMMENDED TREATMENT</p> <ol style="list-style-type: none"> 1. Inspect soundness of setting joint of marker to base, if unstable, remove all units from in ground base. 2. Excavate area around existing base. 3. Align base with tamped gravel and re-grade with existing topsoil 4. Backfill with tamped gravel and re-grade with existing topsoil 5. If setting joint was unsound, remove failed setting mortar and, if required, replace setting pins with threaded stainless pins. 6. Prime setting surfaces with Acryl 60 diluted 1:3 with water. 7. Re-set marker plumb onto base/s with a cement/lime mortar (3/2/9) with 000 sand 8. Remove excess mortar and, if required, brace marker min 3 days .

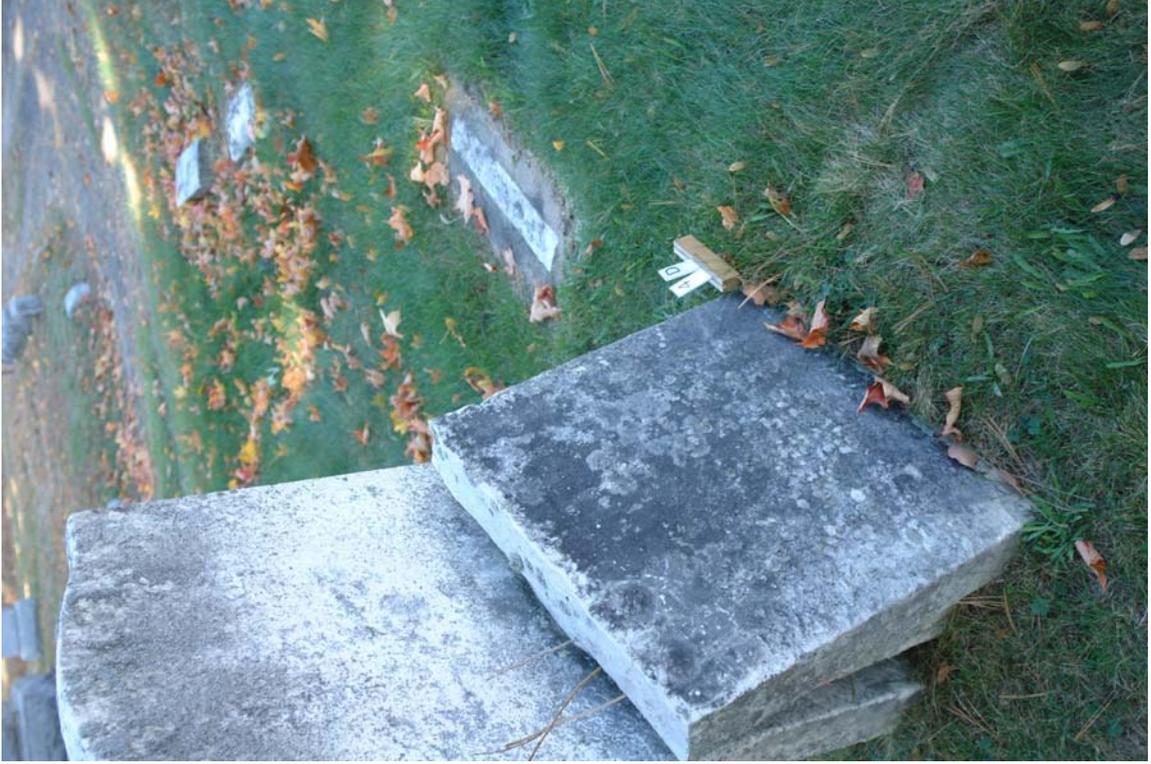
Marker# **4.D.5**

EXISTING CONDITIONS	CONSERVATION STRATEGY
Fractured Out of base	Reset to base Attach fragments with structural adhesive

CONSERVATION PRIORITY	3
<p>1) Hazardous, immediate action 2) Unstable--asap 3) Ongoing deterioration, treat 2-5 years</p> <p>RECOMMENDED TREATMENT</p> <ol style="list-style-type: none"> 1. If required, level existing base and align with adjacent markers. 2. Remove failed setting mortar from setting slot 3. If required, re-square the lower edge of marker fragment and reset into slot using a fluid cement/lime grout 4. Marker is set plumb and level, braced 5 days minimum. 5. Fragments attached with structural adhesive, Abatron 55-22, braced and clamped until cured. 6. Fill cracks and losses with Voidspan PHLC or Jahn products 7. Filled areas misted with water and covered for 3 days minimum 8. Treat filled surface areas with light acid wash and fully rinse with water

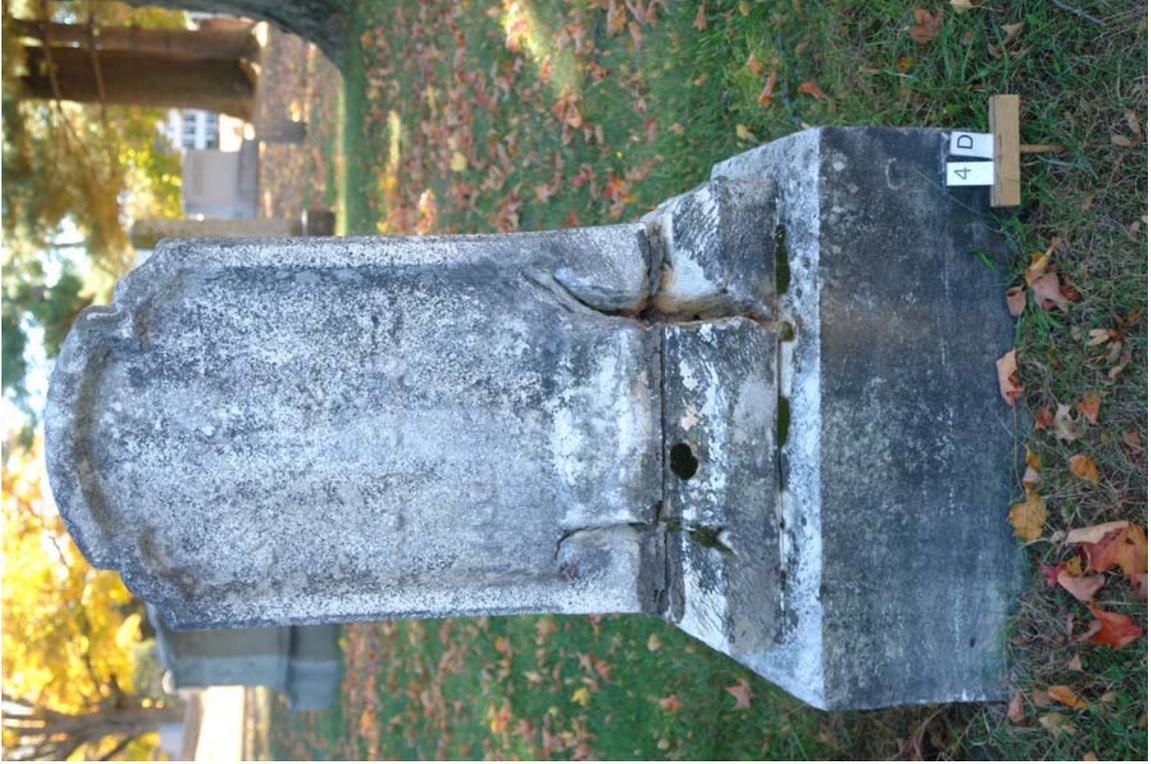
Marker# **4.D.6**

EXISTING CONDITIONS	CONSERVATION STRATEGY
Unstable	Level base Reset all elements Fill losses

CONSERVATION PRIORITY	1
RECOMMENDED TREATMENT	
<ol style="list-style-type: none"> 1) Hazardous, immediate action 2) Unstable--asap 3) Ongoing deterioration, treat 2-5 years <ol style="list-style-type: none"> 1. Inspect soundness of setting joint of marker to base, if unstable, remove all units from in ground base. 2. Excavate area around existing base. 3. Align base with adjacent markers and re-set level. 4. Backfill with tamped gravel and re-grade with existing topsoil 5. If setting joint was unsound, remove failed setting mortar and, if required, replace setting pins with threaded stainless pins. 6. Fill cracks and losses with Voidspan PHLC or Jahn products. 7. Mist filled areas with water and cover for 3 days minimum 8. Prime setting surfaces with Acryl 60 diluted 1:3 with water. 9. Re-set marker plumb onto base/s with a cement/lime mortar (3/2/9) with 000 sand 10. Remove excess mortar, if required, brace marker min 3 days .

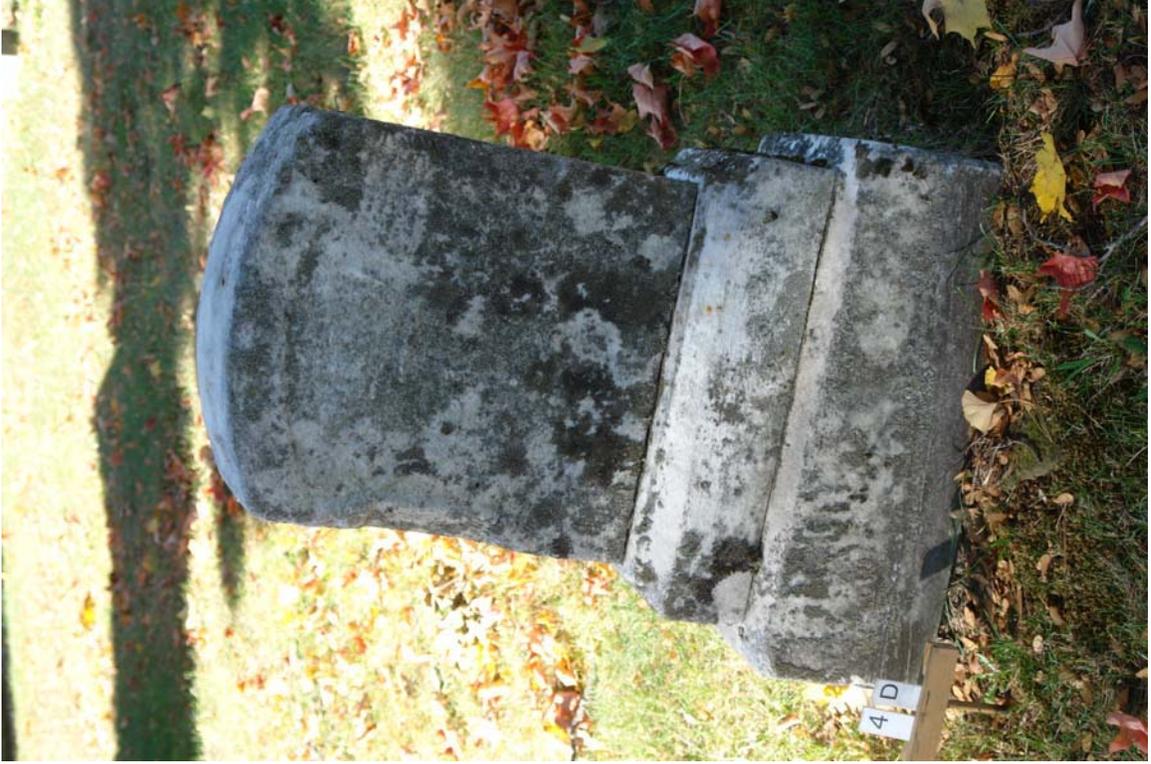
EXISTING CONDITIONS	CONSERVATION STRATEGY
Unstable	Level base Reset all elements

CONSERVATION PRIORITY	1	RECOMMENDED TREATMENT
	1) Hazardous, immediate action 2) Unstable--asap 3) Ongoing deterioration, treat 2-5 years	<ol style="list-style-type: none"> 1. Inspect soundness of setting joint of marker to base, if unstable, remove all units from in ground base. 2. Excavate area around existing base. 3. Align base with adjacent markers and re-set level. 4. Backfill with tamped gravel and re-grade with existing topsoil 5. If setting joint was unsound, remove failed setting mortar and, if required, replace setting pins with threaded stainless pins. 6. Prime setting surfaces with Acryl 60 diluted 1:3 with water. 7. Re-set marker plumb onto base/s with a cement/lime mortar (3/2/9) with 000 sand 8. Remove excess mortar and, if required, brace marker min 3 days .

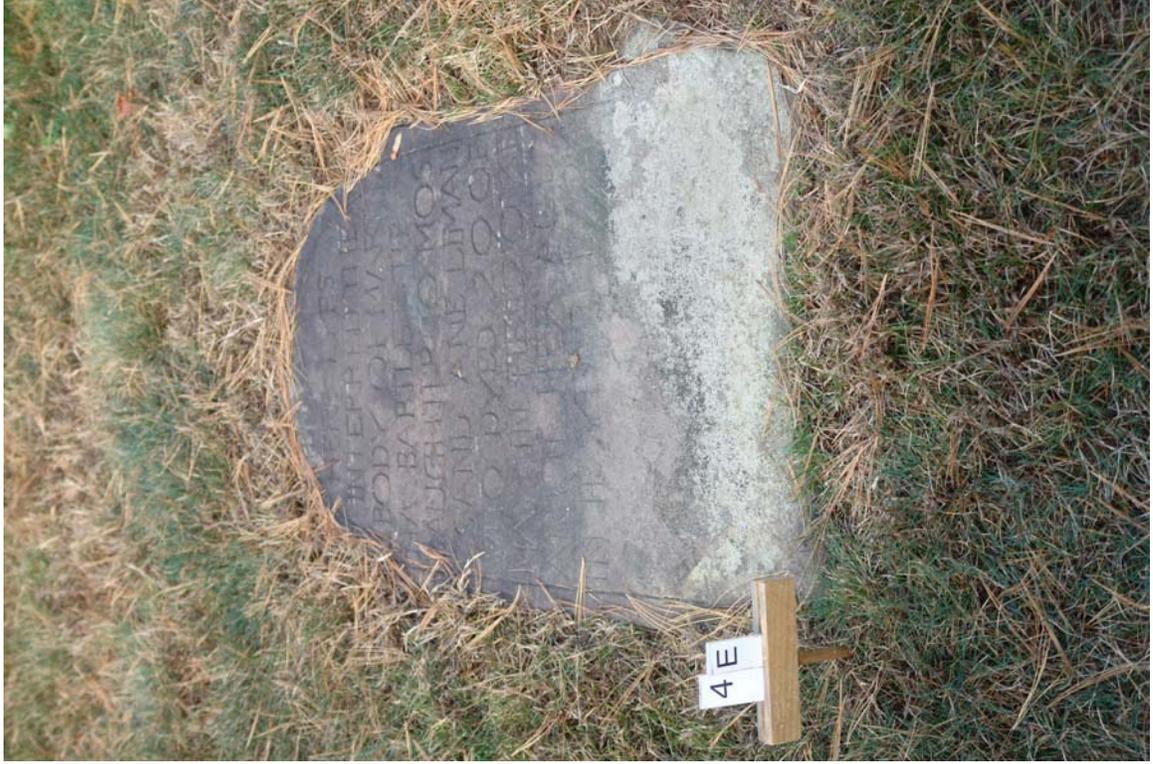
EXISTING CONDITIONS	CONSERVATION STRATEGY
Fallen	Reset into new below grade base

CONSERVATION PRIORITY	3
1) Hazardous, immediate action 2) Unstable--asap 3) Ongoing deterioration, treat 2-5 years	
RECOMMENDED TREATMENT	
1. Carefully excavate marker and inspect marker for soundness. 2. Excavate setting area for new below grade cast concrete base sized minimum of 12 inches deep, 12 inches greater in thickness and 6 inches wider than the stone. The finished top to be entirely below grade. Align the 1" deep form for the setting slot (1/2" wider and thicker than the marker) with adjacent markers. 3. Remove soiling from marker by light brushing with nylon brushes and water. Inspect for soundness. 4. If required, re-square the lower edge of marker with minimal loss. 5. After min 3 day cure, remove the setting form and reset stone into slot using a cement/lime grout (3/2/9) with 000 sand 6. Set marker plumb and level, brace for minimum of 5 days. 7. Disturbed areas to be backfilled with tamped sand and gravel, and re-graded with existing topsoil.

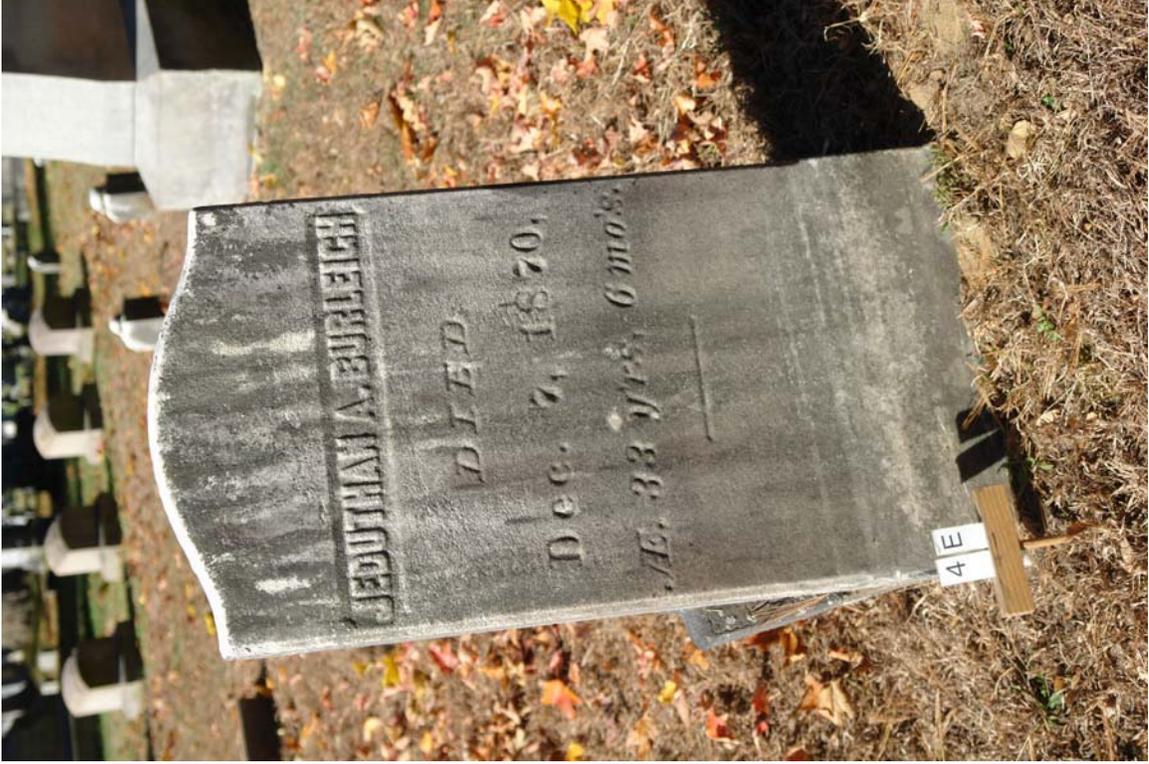
Marker# **4.E.2**

EXISTING CONDITIONS	CONSERVATION STRATEGY
Unstable	Reset into new below grade base

<p>CONSERVATION PRIORITY 2</p> <p>1) Hazardous, immediate action 2) Unstable--asap 3) Ongoing deterioration, treat 2-5 years</p> <p>RECOMMENDED TREATMENT</p> <ol style="list-style-type: none"> Carefully excavate marker and inspect marker for soundness. Excavate setting area for new below grade cast concrete base sized minimum of 12 inches deep, 12 inches greater in thickness and 6 inches wider than the stone. The finished top to be entirely below grade. Align the 1" deep form for the setting slot (1/2" wider and thicker than the marker) with adjacent markers. Remove soiling from marker by light brushing with nylon brushes and water. Inspect for soundness. If required, re-square the lower edge of marker with minimal loss. After min 3 day cure, remove the setting form and reset stone into slot using a cement/lime grout (3/2/9) with 000 sand Set marker plumb and level, brace for minimum of 5 days. Disturbed areas to be backfilled with tamped sand and gravel, and re-graded with existing topsoil.

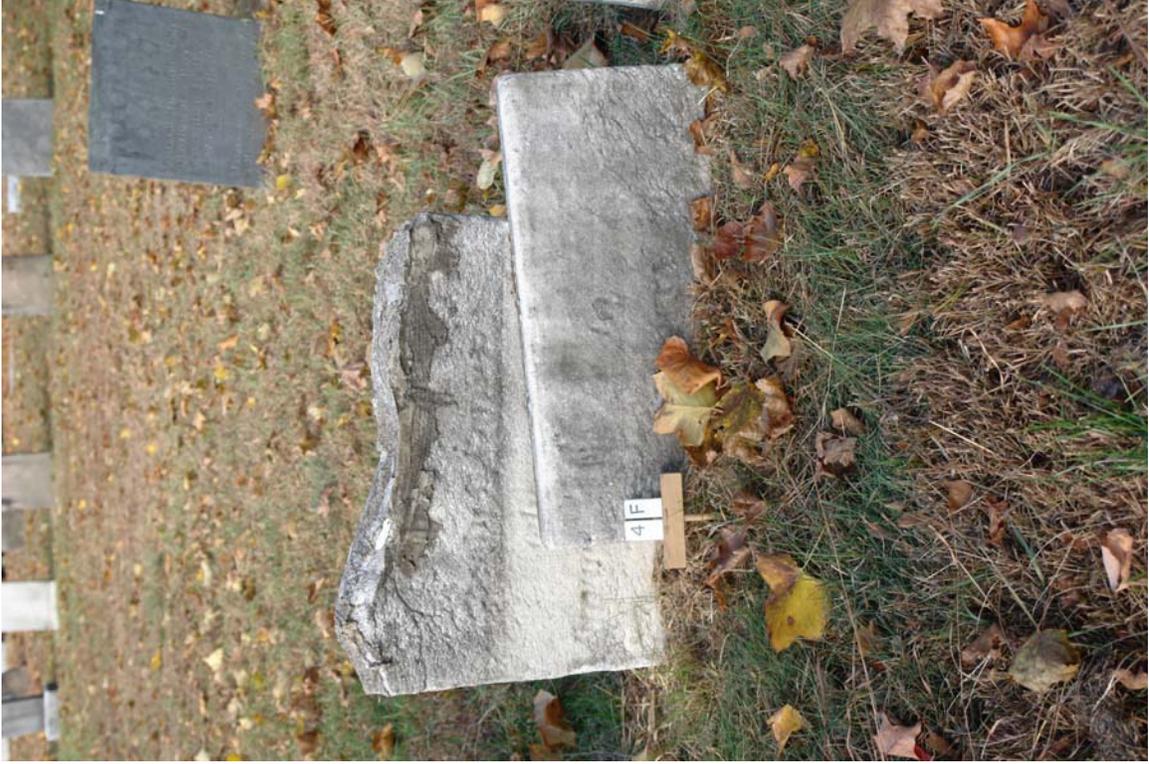
EXISTING CONDITIONS	CONSERVATION STRATEGY
Fractured Weathered	Evaluate condition of marker for restoration

CONSERVATION PRIORITY	3
<p>1) Hazardous, immediate action 2) Unstable--asap 3) Ongoing deterioration, treat 2-5 years</p> <p>RECOMMENDED TREATMENT</p> <p>Carefully excavate marker and fragments. Brush clean and inspect for soundness and extreme sugaring. Probe area for additional fragments. Evaluate if marker is restorable. If not, reset as found.</p> <ol style="list-style-type: none"> 1. Clean mating surfaces and remove any failed adhesives or mortar 2. Attach fragments with structural adhesive, brace and clamp until cured. 3. Fill cracks and losses with Voidspon or Jahn products as required 4. Mist filled areas with water and cover for 3 days minimum 5. Treat filled surface areas with light acid wash and rinse thoroughly

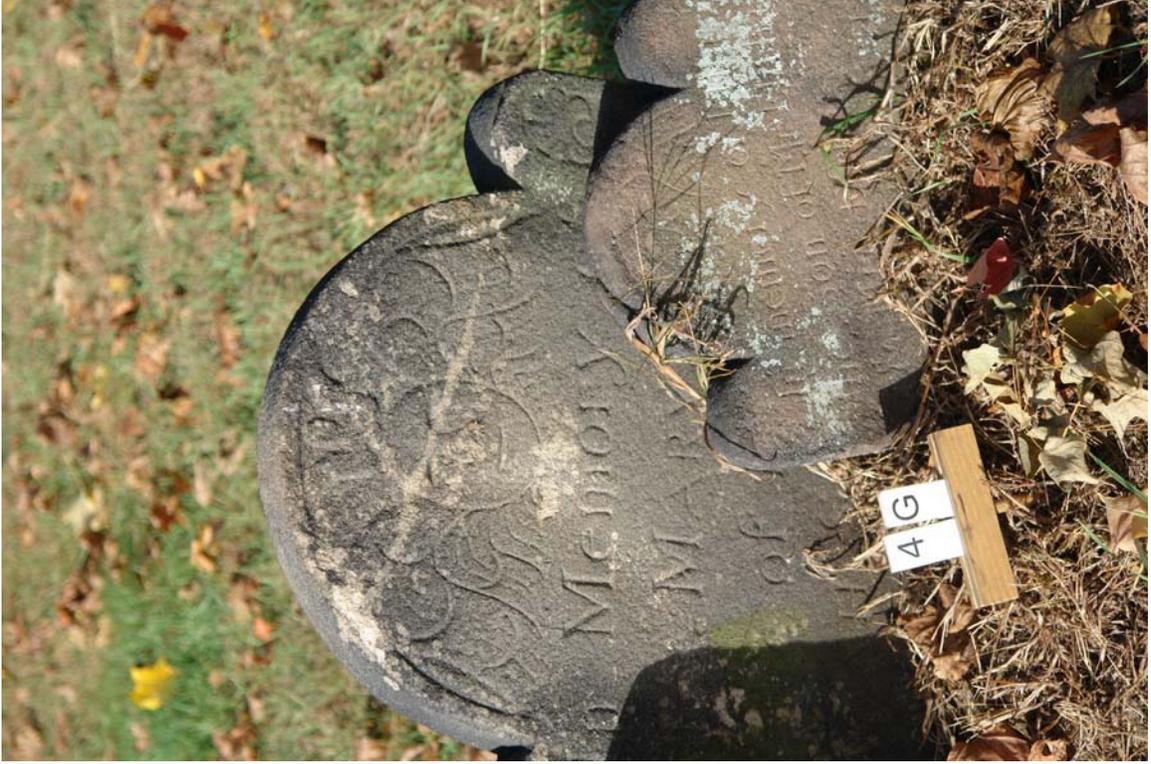
Marker# **4.G.1**

EXISTING CONDITIONS	CONSERVATION STRATEGY
Leaning on adjacent marker	Reset into new below grade base

<p>CONSERVATION PRIORITY 2</p> <p>1) Hazardous, immediate action 2) Unstable--asap 3) Ongoing deterioration, treat 2-5 years</p> <p>RECOMMENDED TREATMENT</p> <ol style="list-style-type: none"> Carefully excavate marker and inspect marker for soundness. Excavate setting area for new below grade cast concrete base sized minimum of 12 inches deep, 12 inches greater in thickness and 6 inches wider than the stone. The finished top to be entirely below grade. Align the 1" deep form for the setting slot (1/2" wider and thicker than the marker) with adjacent markers. Remove soiling from marker by light brushing with nylon brushes and water. Inspect for soundness. If required, re-square the lower edge of marker with minimal loss. After min 3 day cure, remove the setting form and reset stone into slot using a cement/lime grout (3/2/9) with 000 sand Set marker plumb and level, brace for minimum of 5 days. Disturbed areas to be backfilled with tamped sand and gravel, and re-graded with existing topsoil.

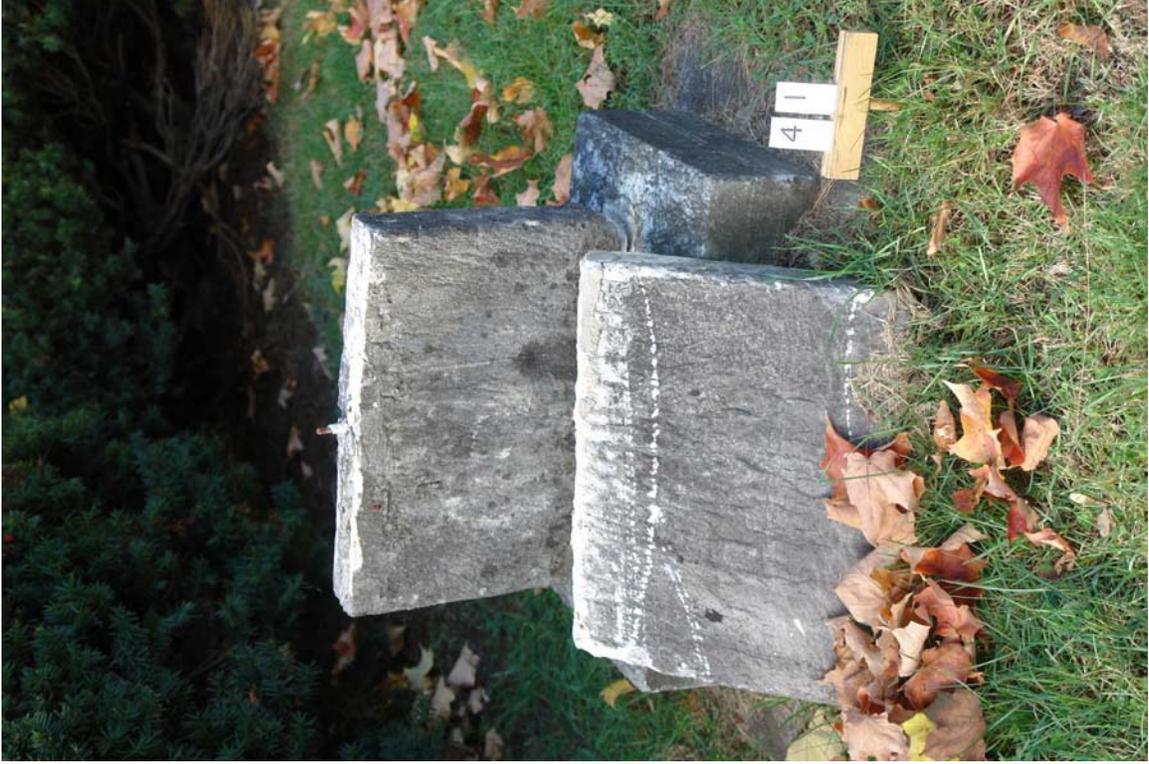
EXISTING CONDITIONS	CONSERVATION STRATEGY
Fractured Tilted	Reset level Attach fragments with structural adhesive

CONSERVATION PRIORITY	2
<p>1) Hazardous, immediate action 2) Unstable--asap 3) Ongoing deterioration, treat 2-5 years</p> <p>RECOMMENDED TREATMENT</p> <p>1. Old repair has completely failed. Remove any failed fills, pins and adhesives with hand tools and treat mating surfaces with D/2. 2. If lower in ground fragment or bases are tilted, excavate soil to a sufficient depth and re-set plumb at appropriate height and level onto gravel bed, and align with adjacent markers 3. Backfill area around marker with tamped sand and gravel 4. Attach fragments with structural adhesive (Abatron 55-22), clamp and brace until cured. 5. Remove excess epoxy with hand chisels within 24 hours 6. Fill cracks and losses with Voidspan PHLc or Jahn products 7. Mist filled areas with water and keep covered for 3 days min. 8. Treat filled surface areas with light acid wash and rinse thoroughly with water</p>

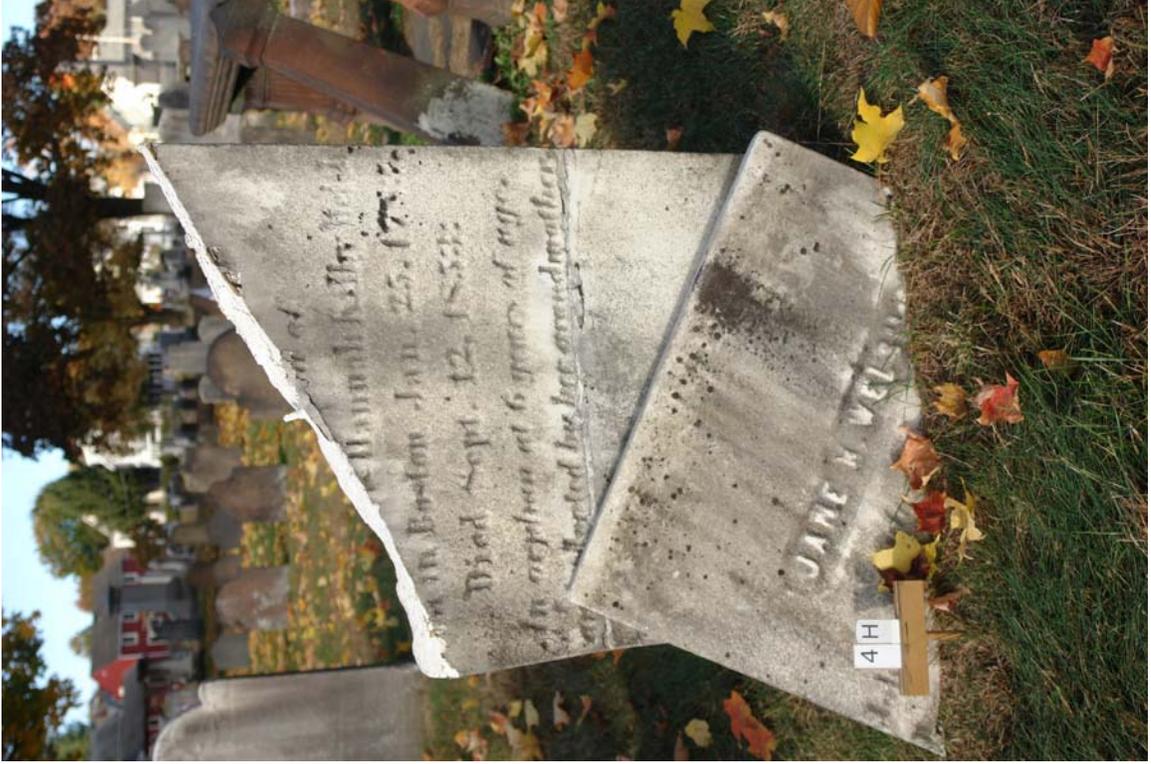
EXISTING CONDITIONS	CONSERVATION STRATEGY
Tilted Failed repair	Reset plumb Attach fragments with structural adhesive

CONSERVATION PRIORITY	3
<p>1) Hazardous, immediate action 2) Unstable--asap 3) Ongoing deterioration, treat 2-5 years</p> <p>RECOMMENDED TREATMENT</p> <ol style="list-style-type: none"> Carefully remove soil around the in ground fragment to an appropriate depth, if required, remove stone from ground. Excavate setting area to sufficient depth and re-set stone fragment plumb at appropriate height and level onto gravel bed, and align with adjacent markers Backfill area around marker with tamped sand and gravel Carefully excavate overgrown fragments and inspect for soundness. Clean all mating edges of fragments with water and remove any failed adhesives, pins, and fills with hand tools Attach fragments with structural adhesive (Abatron 55-22), clamp and brace until cured. Remove excess epoxy with hand chisels within 24 hours Fill cracks and losses with Voidspan PHLc or Jahn products Mist filled areas with water and keep covered for 3 days minimum Treat filled surface areas with light acid wash and rinse thoroughly.

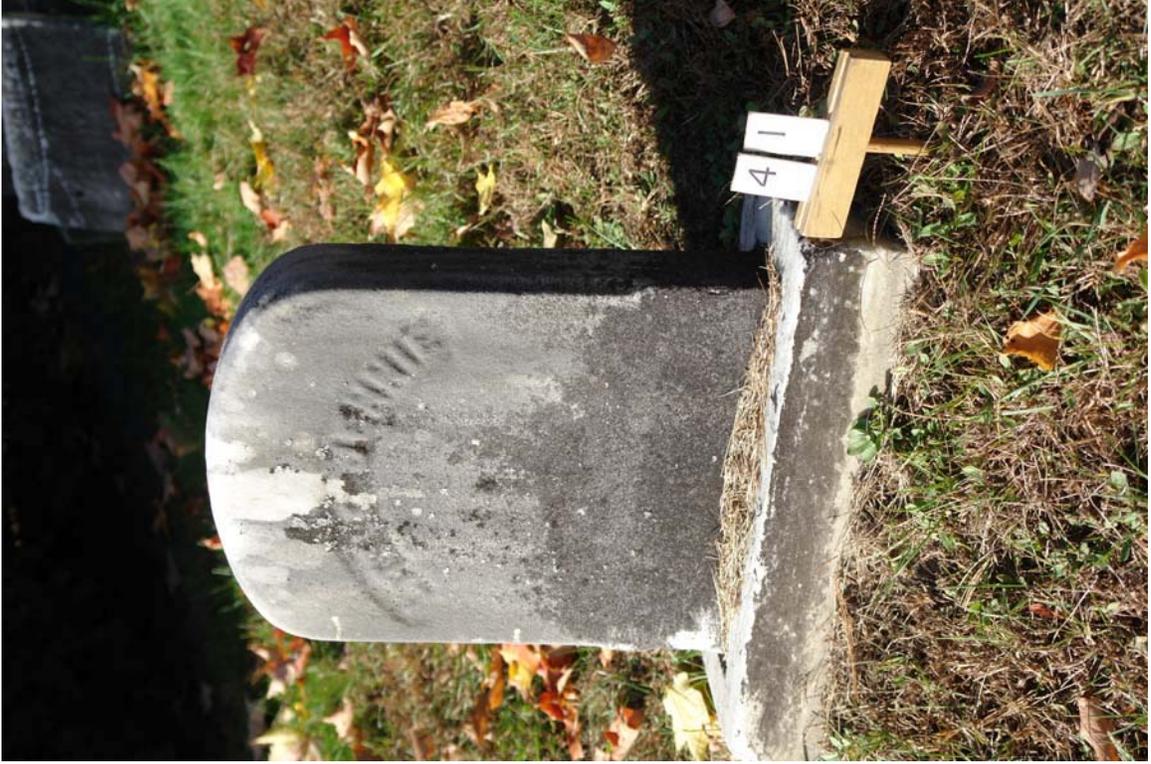
Marker# **4.I.2**

EXISTING CONDITIONS	CONSERVATION STRATEGY
Unstable	Level base Reset all elements

CONSERVATION PRIORITY	1
<p>RECOMMENDED TREATMENT</p> <ol style="list-style-type: none"> 1. Inspect soundness of setting joint of marker to base, if unstable, remove all units from in ground base. 2. Excavate area around existing base. 3. Align base with tamped gravel and re-grade with existing topsoil 4. Backfill with tamped gravel and re-grade with existing topsoil 5. If setting joint was unsound, remove failed setting mortar and, if required, replace setting pins with threaded stainless pins. 6. Prime setting surfaces with Acryl 60 diluted 1:3 with water. 7. Re-set marker plumb onto base/s with a cement/lime mortar (3/2/9) with 000 sand 8. Remove excess mortar and, if required, brace marker min 3 days .
