HISTORICAL CHRONOLOGY

The purpose of this report is to review the existing conditions of several significant structures within the Bridge Street Cemetery in the City of Northampton, Massachusetts.

Existing Conditions of Structures

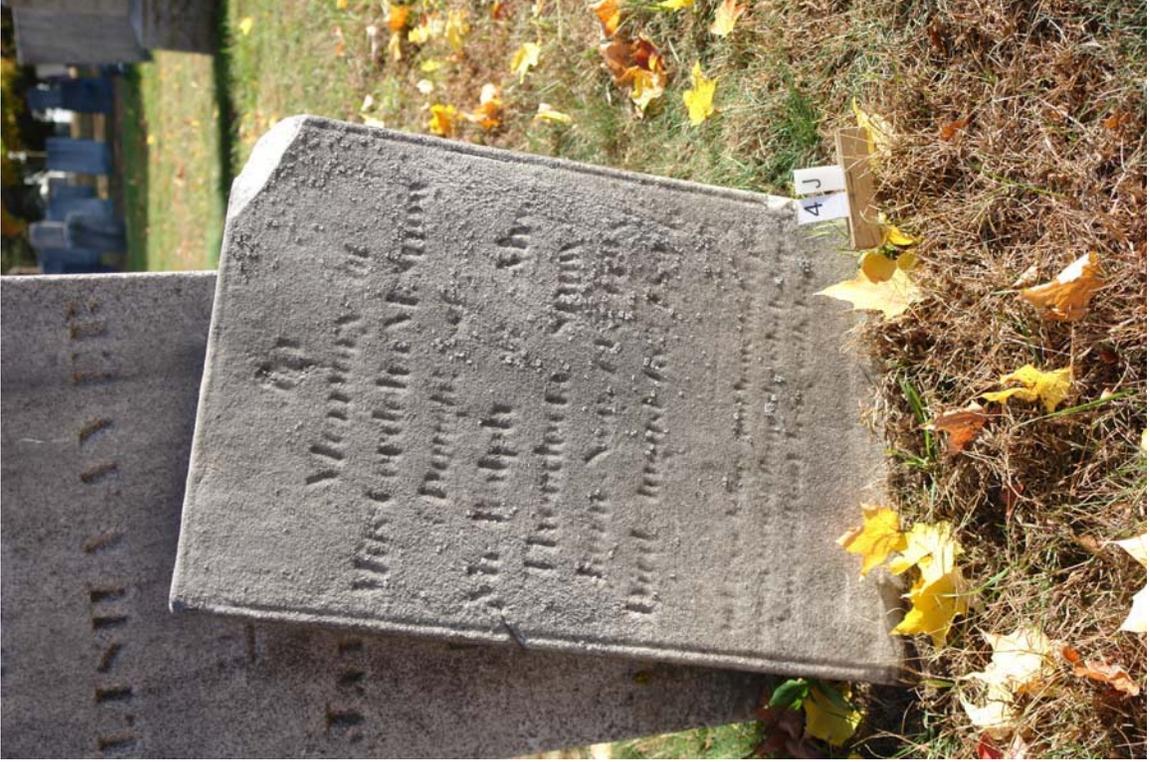
Marker# **4.J.1**

EXISTING CONDITIONS CONSERVATION STRATEGY
 Leaning on adjacent marker Reset into new below grade base

CONSERVATION PRIORITY 2
 1) Hazardous, immediate action
 2) Unstable--asap
 3) Ongoing deterioration, treat 2-5 years

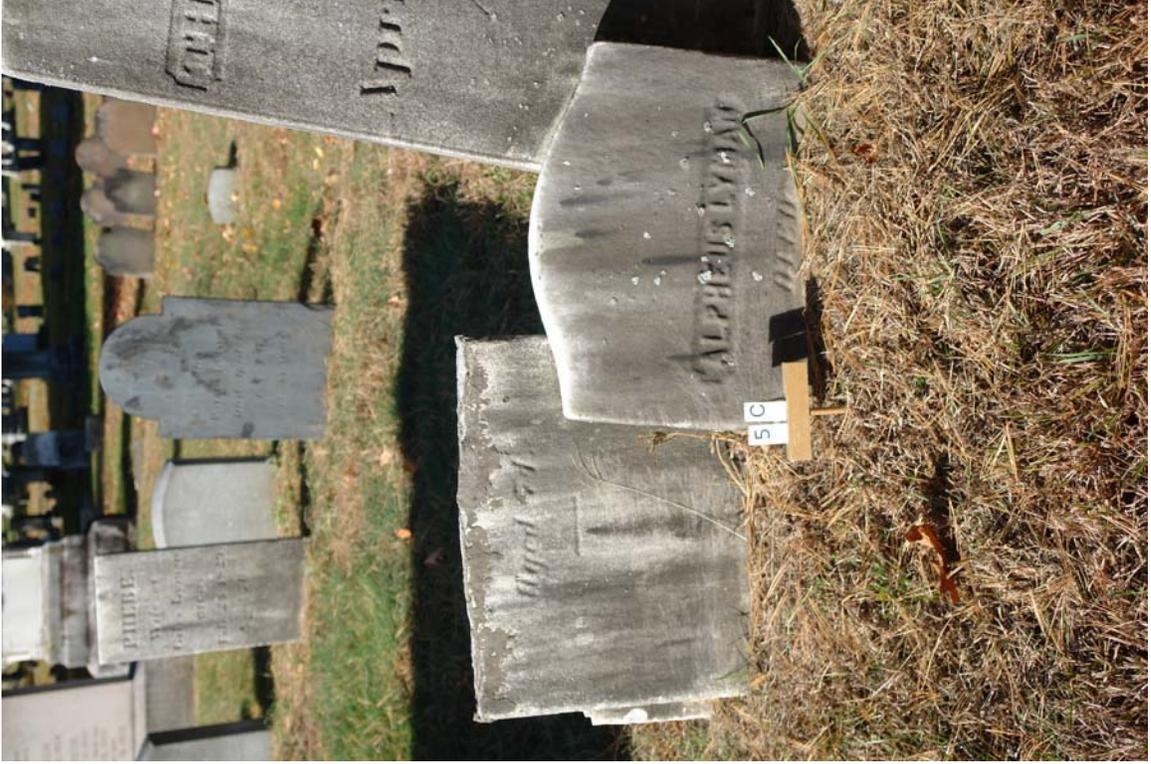
EXISTING CONDITIONS	CONSERVATION STRATEGY
Tilted Failed repair	Reset plumb Attach fragments with structural adhesive

CONSERVATION PRIORITY	3
<p>1) Hazardous, immediate action 2) Unstable--asap 3) Ongoing deterioration, treat 2-5 years</p> <p>RECOMMENDED TREATMENT</p> <ol style="list-style-type: none"> Carefully remove soil around the in ground fragment to an appropriate depth, if required, remove stone from ground. Excavate setting area to sufficient depth and re-set stone fragment plumb at appropriate height and level onto gravel bed, and align with adjacent markers Backfill area around marker with tamped sand and gravel Carefully excavate overgrown fragments and inspect for soundness. Clean all mating edges of fragments with water and remove any failed adhesives, pins, and fills with hand tools Attach fragments with structural adhesive (Abatron 55-22), clamp and brace until cured. Remove excess epoxy with hand chisels within 24 hours Fill cracks and losses with Voidspan PHLc or Jahn products Mist filled areas with water and keep covered for 3 days minimum Treat filled surface areas with light acid wash and rinse thoroughly.

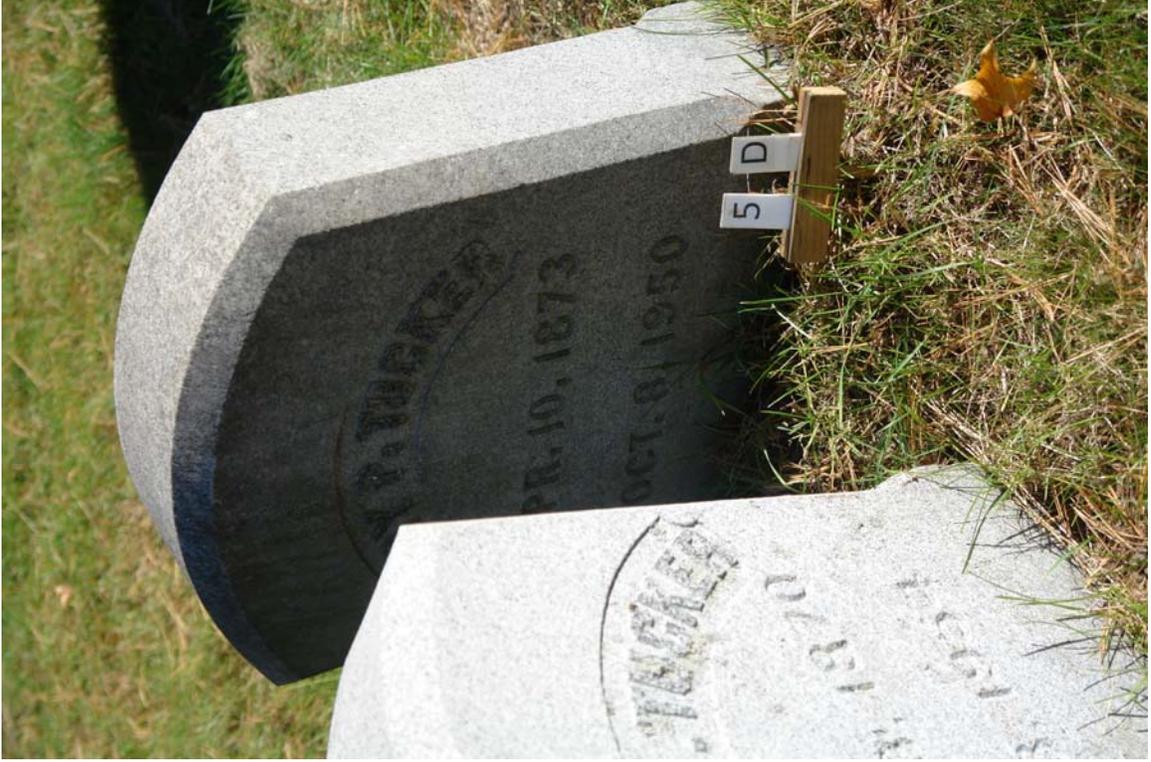
EXISTING CONDITIONS	CONSERVATION STRATEGY
Unstable	Locate existing base and reset

CONSERVATION PRIORITY	2
1) Hazardous, immediate action 2) Unstable--asap 3) Ongoing deterioration, treat 2-5 years	
RECOMMENDED TREATMENT	
1. Locate buried, original base by probing. Remove any failed setting material and pins from setting surfaces with hand tools 2. If required, excavate and align base with adjacent markers and re-set level. Backfill w/ tamped gravel 3. Prime setting surfaces with Acryl 60 diluted 1:3 with water and reset marker with cement/lime mortar (3/2/9) with 000 sand. Use lead shims as necessary to level. Remove excess grout from joint. 4. Brace until partial cure.

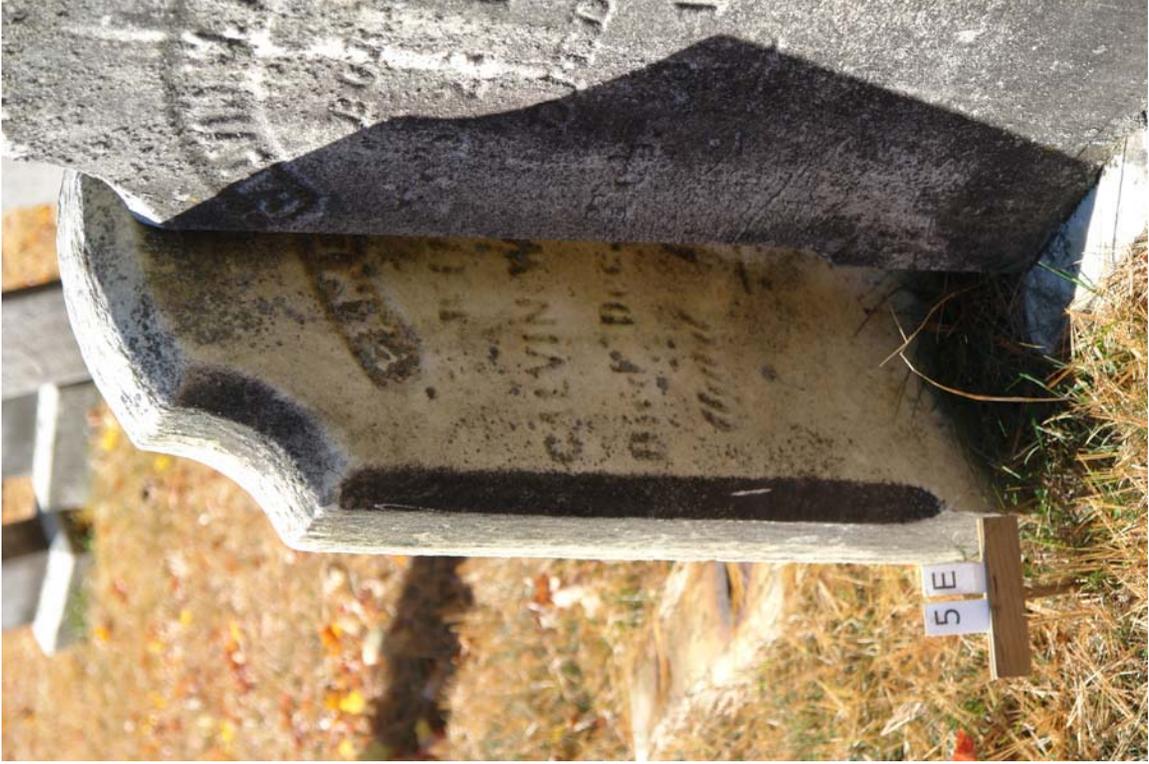
Marker# **5.E.1**

EXISTING CONDITIONS	CONSERVATION STRATEGY
Unstable	Level base Reset all elements

CONSERVATION PRIORITY	1	RECOMMENDED TREATMENT
	1) Hazardous, immediate action 2) Unstable--asap 3) Ongoing deterioration, treat 2-5 years	<ol style="list-style-type: none"> 1. Inspect soundness of setting joint of marker to base, if unstable, remove all units from in ground base. 2. Excavate area around existing base. 3. Align base with adjacent markers and re-set level. 4. Backfill with tamped gravel and re-grade with existing topsoil 5. If setting joint was unsound, remove failed setting mortar and, if required, replace setting pins with threaded stainless pins. 6. Prime setting surfaces with Acryl 60 diluted 1:3 with water. 7. Re-set marker plumb onto base/s with a cement/lime mortar (3/2/9) with 000 sand 8. Remove excess mortar and, if required, brace marker min 3 days .

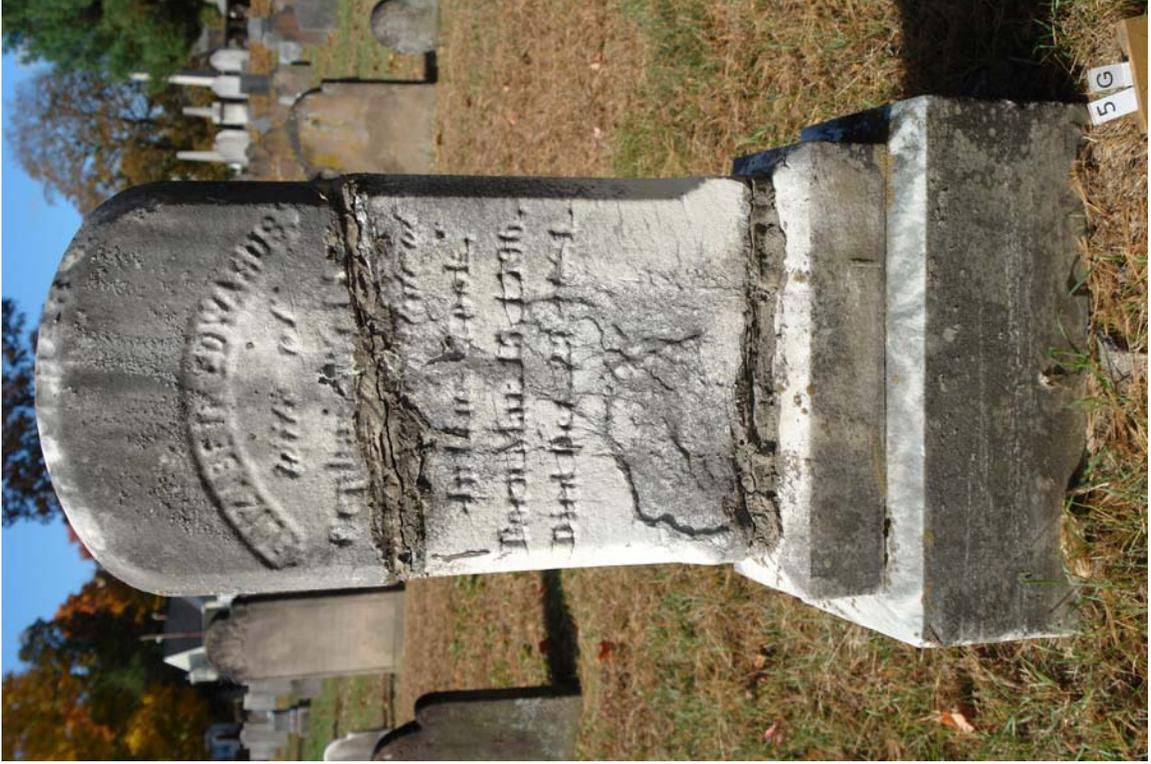
Marker# **5.G.2**

EXISTING CONDITIONS	CONSERVATION STRATEGY
Fractured at grade Fallen	Reset into new below grade base

CONSERVATION PRIORITY	2
<p>1) Hazardous, immediate action 2) Unstable--asap 3) Ongoing deterioration, treat 2-5 years</p> <p>RECOMMENDED TREATMENT</p> <ol style="list-style-type: none"> Carefully excavate marker and inspect marker for soundness. Excavate setting area for new below grade cast concrete base sized minimum of 12 inches deep, 12 inches greater in thickness and 6 inches wider than the stone. The finished top to be entirely below grade. Align the 1" deep form for the setting slot (1/2" wider and thicker than the marker) with adjacent markers. Remove soiling from marker by light brushing with nylon brushes and water. Inspect for soundness. If required, re-square the lower edge of marker with minimal loss. After min 3 day cure, remove the setting form and reset stone into slot using a cement/lime grout (3/2/9) with 000 sand Set marker plumb and level, brace for minimum of 5 days. Disturbed areas to be backfilled with tamped sand and gravel, and re-graded with existing topsoil.

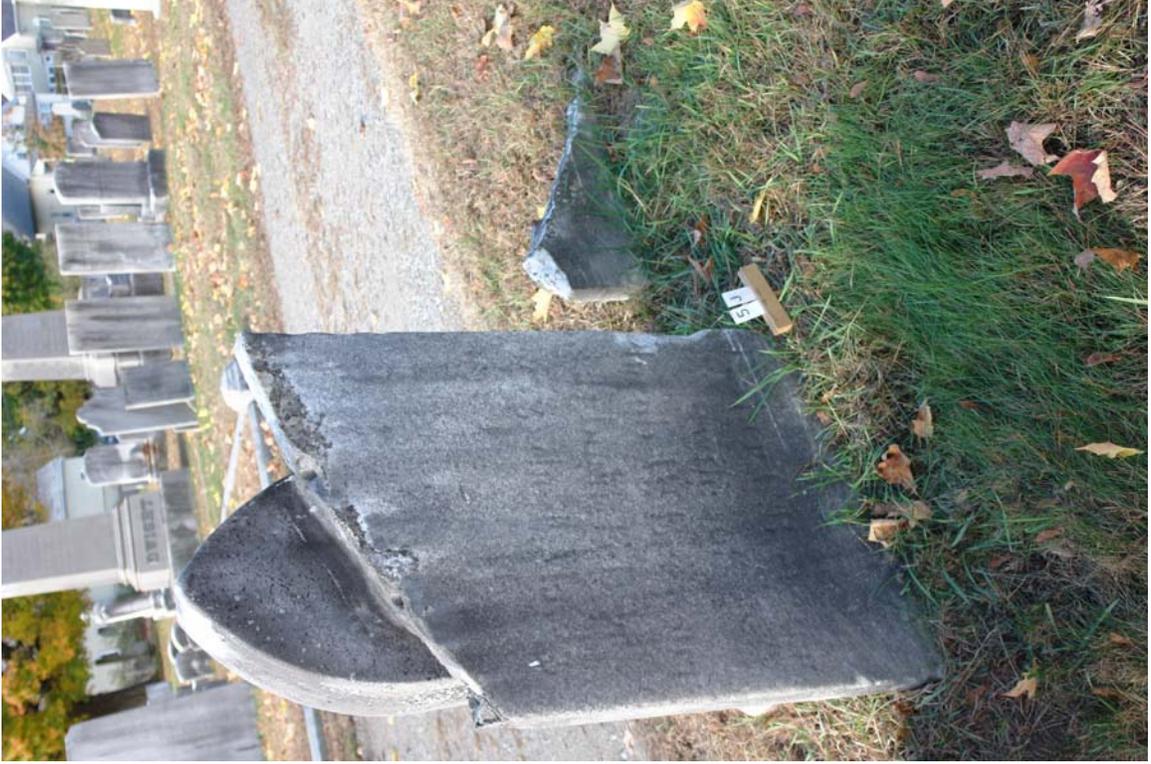
Marker# **5.J.3**

EXISTING CONDITIONS	CONSERVATION STRATEGY
Unstable	Level base Reset all elements

CONSERVATION PRIORITY	1
RECOMMENDED TREATMENT	
<ol style="list-style-type: none"> 1. Inspect soundness of setting joint of marker to base, if unstable, remove all units from in ground base. 2. Excavate area around existing base. 3. Align base with adjacent markers and re-set level. 4. Backfill with tamped gravel and re-grade with existing topsoil 5. If setting joint was unsound, remove failed setting mortar and, if required, replace setting pins with threaded stainless pins. 6. Prime setting surfaces with Acryl 60 diluted 1:3 with water. 7. Re-set marker plumb onto base/s with a cement/lime mortar (3/2/9) with 000 sand 8. Remove excess mortar and, if required, brace marker min 3 days .

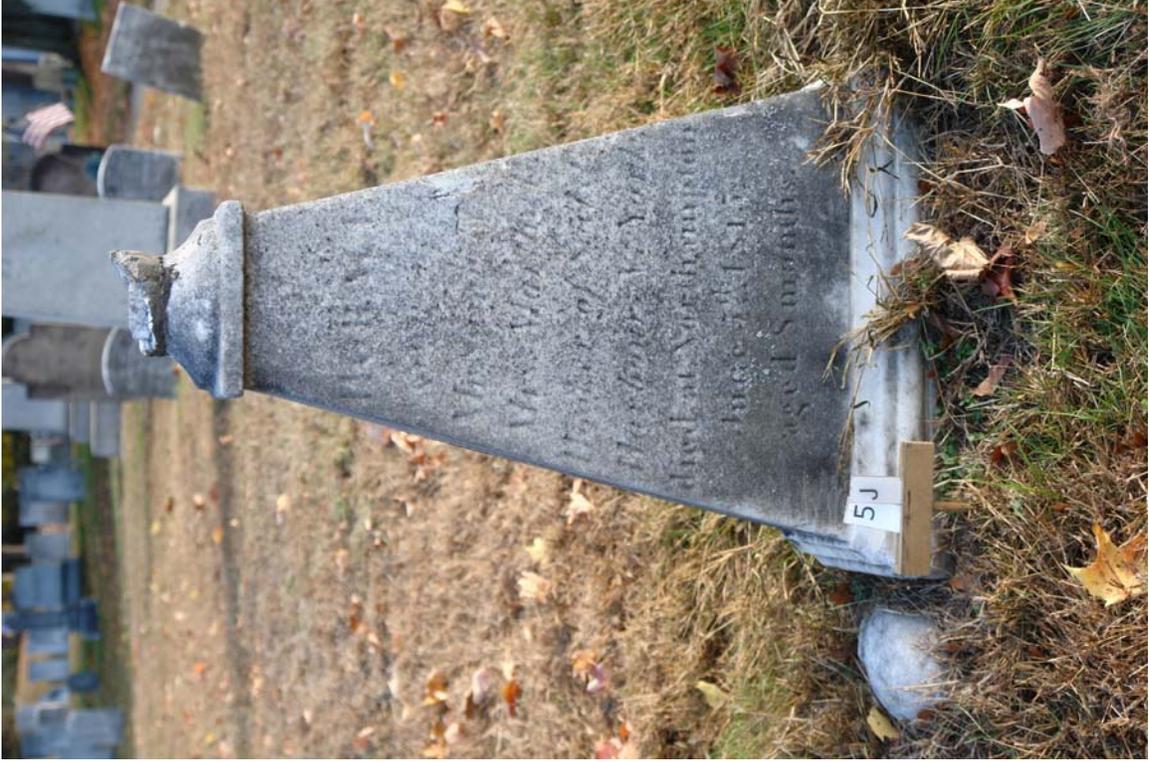
Marker# **5.J.5**

EXISTING CONDITIONS	CONSERVATION STRATEGY
Tilted	Reset plumb

<p>CONSERVATION PRIORITY 2</p> <p>1) Hazardous, immediate action 2) Unstable--asap 3) Ongoing deterioration, treat 2-5 years</p> <p>RECOMMENDED TREATMENT</p> <ol style="list-style-type: none"> Carefully excavate marker; extremely tilted markers are hazardous. Inspect marker for soundness. If marker is tilted, remove soil around stone to an appropriate depth, if required, remove stone from ground. If marker has fallen, remove overgrowth and inspect for soundness. Remove soiling by light brushing with nylon brushes and water. Excavate setting area to sufficient depth and re-set stone plumb at appropriate height and level onto gravel bed, and align with adjacent markers Backfill area around marker with tamped sand and gravel Re-grade disturbed areas with existing topsoil.
--

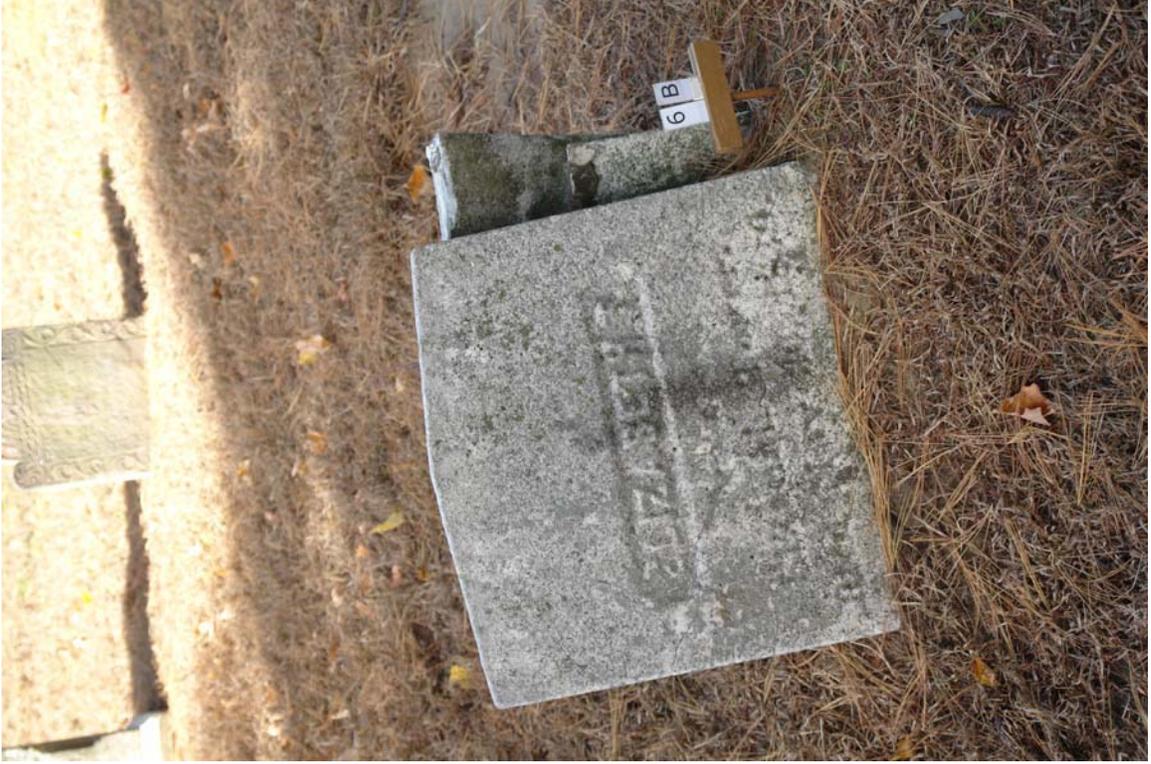
Marker# **6.B.5**

EXISTING CONDITIONS	CONSERVATION STRATEGY
Tilted, out of ground	Reset into ground

CONSERVATION PRIORITY	3
<p>1) Hazardous, immediate action 2) Unstable--asap 3) Ongoing deterioration, treat 2-5 years</p> <p>RECOMMENDED TREATMENT</p> <ol style="list-style-type: none"> Carefully excavate marker; extremely tilted markers are hazardous. Inspect marker for soundness. If marker is tilted, remove soil around stone to an appropriate depth, if required, remove stone from ground. If marker has fallen, remove overgrowth and inspect for soundness. Remove soiling by light brushing with nylon brushes and water. Excavate setting area to sufficient depth and re-set stone plumb at appropriate height and level onto gravel bed, and align with adjacent markers Backfill area around marker with tamped sand and gravel Re-grade disturbed areas with existing topsoil.

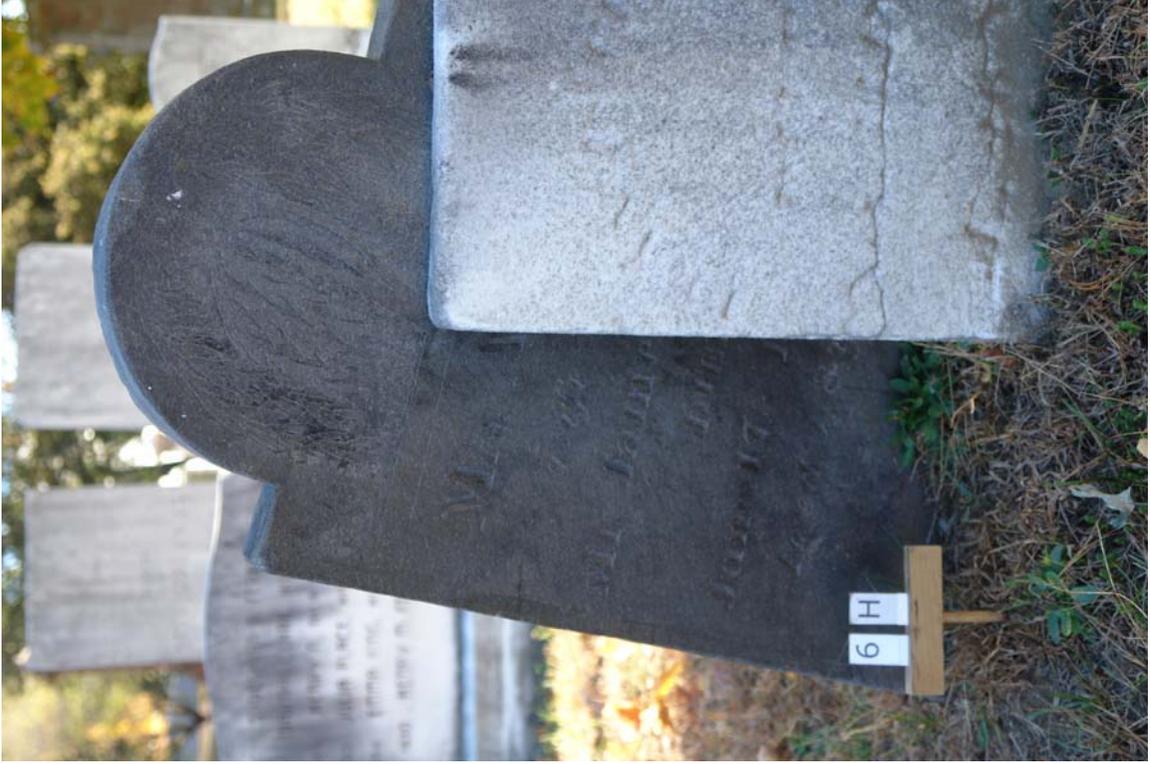
Marker# **6.H.1**

EXISTING CONDITIONS	CONSERVATION STRATEGY
Leaning on adjacent marker	Reset into new below grade base

CONSERVATION PRIORITY	2
<p>1) Hazardous, immediate action 2) Unstable--asap 3) Ongoing deterioration, treat 2-5 years</p> <p>RECOMMENDED TREATMENT</p> <ol style="list-style-type: none"> Carefully excavate marker and inspect marker for soundness. Excavate setting area for new below grade cast concrete base sized minimum of 12 inches deep, 12 inches greater in thickness and 6 inches wider than the stone. The finished top to be entirely below grade. Align the 1" deep form for the setting slot (1/2" wider and thicker than the marker) with adjacent markers. Remove soiling from marker by light brushing with nylon brushes and water. Inspect for soundness. If required, re-square the lower edge of marker with minimal loss. After min 3 day cure, remove the setting form and reset stone into slot using a cement/lime grout (3/2/9) with 000 sand Set marker plumb and level, brace for minimum of 5 days. Disturbed areas to be backfilled with tamped sand and gravel, and re-graded with existing topsoil.

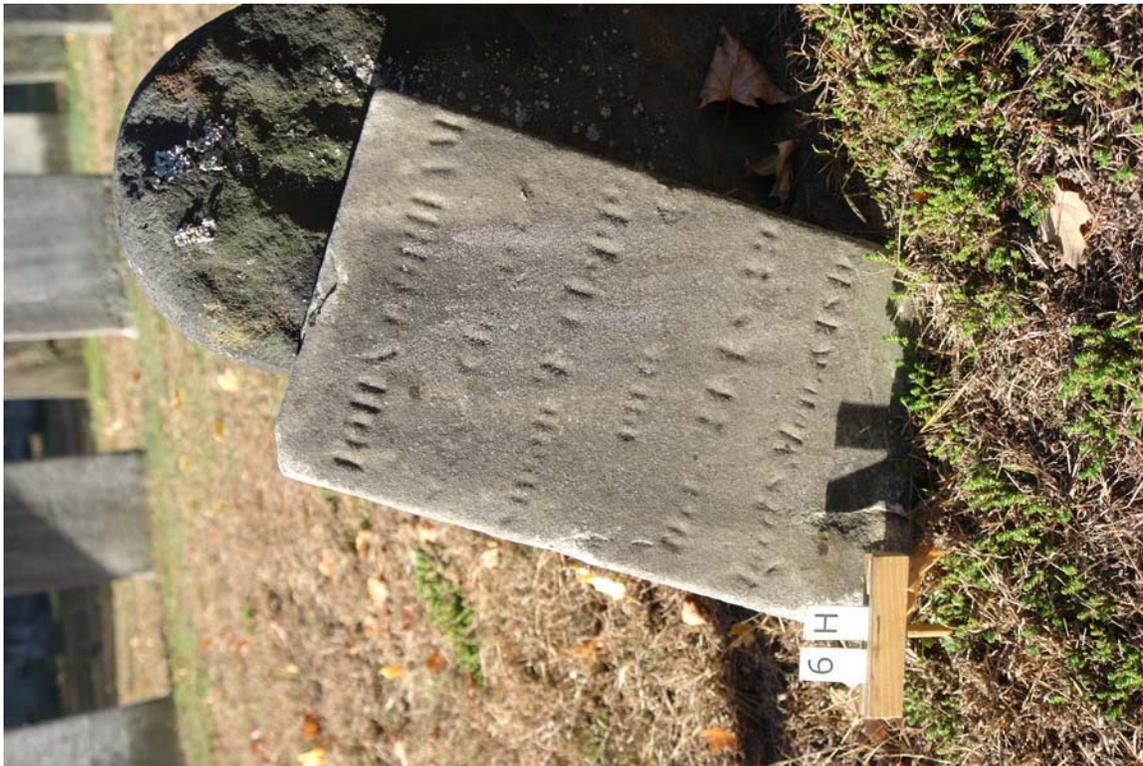
Marker# **6.H.2**

Fractured Leaning on adjacent marker **Reset into new base Attach fragments with structural adhesive**

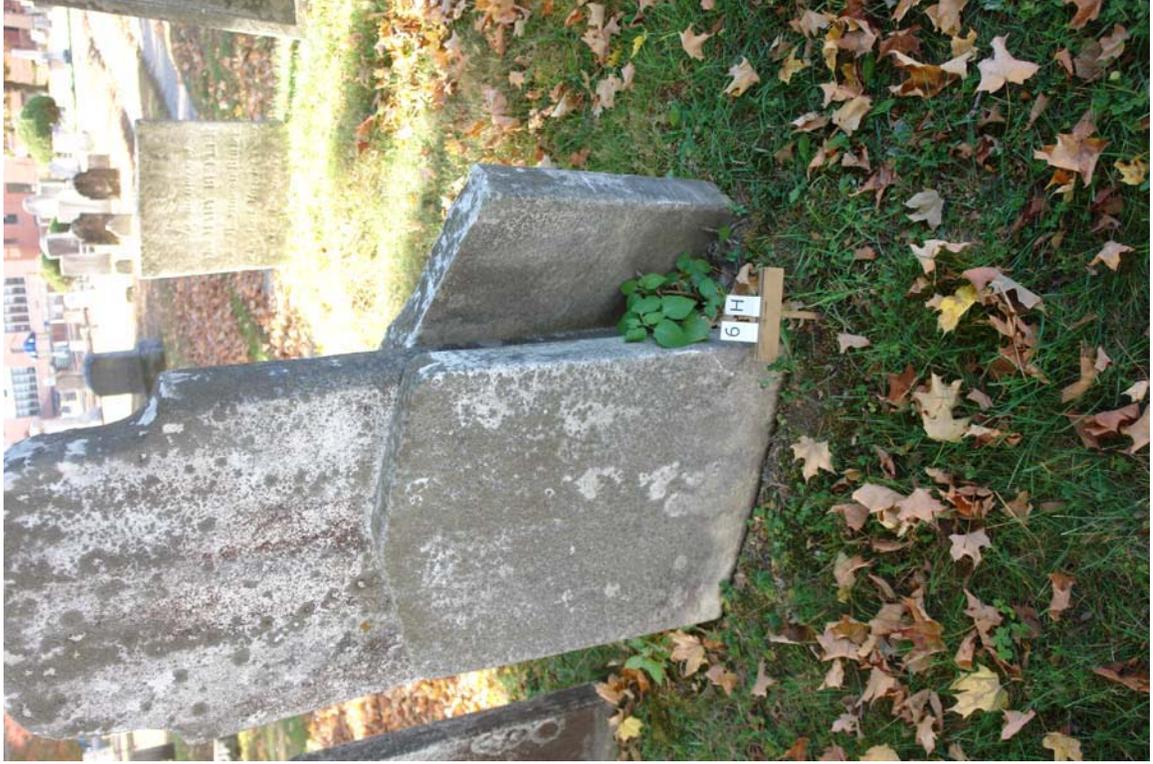
Marker# **6.H.3**

EXISTING CONDITIONS	CONSERVATION STRATEGY
Leaning on adjacent marker	Reset into new below grade base

CONSERVATION PRIORITY	2
<p>1) Hazardous, immediate action 2) Unstable--asap 3) Ongoing deterioration, treat 2-5 years</p> <p>RECOMMENDED TREATMENT</p> <ol style="list-style-type: none"> Carefully excavate marker and inspect marker for soundness. Excavate setting area for new below grade cast concrete base sized minimum of 12 inches deep, 12 inches greater in thickness and 6 inches wider than the stone. The finished top to be entirely below grade. Align the 1" deep form for the setting slot (1/2" wider and thicker than the marker) with adjacent markers. Remove soiling from marker by light brushing with nylon brushes and water. Inspect for soundness. If required, re-square the lower edge of marker with minimal loss. After min 3 day cure, remove the setting form and reset stone into slot using a cement/lime grout (3/2/9) with 000 sand Set marker plumb and level, brace for minimum of 5 days. Disturbed areas to be backfilled with tamped sand and gravel, and re-graded with existing topsoil.

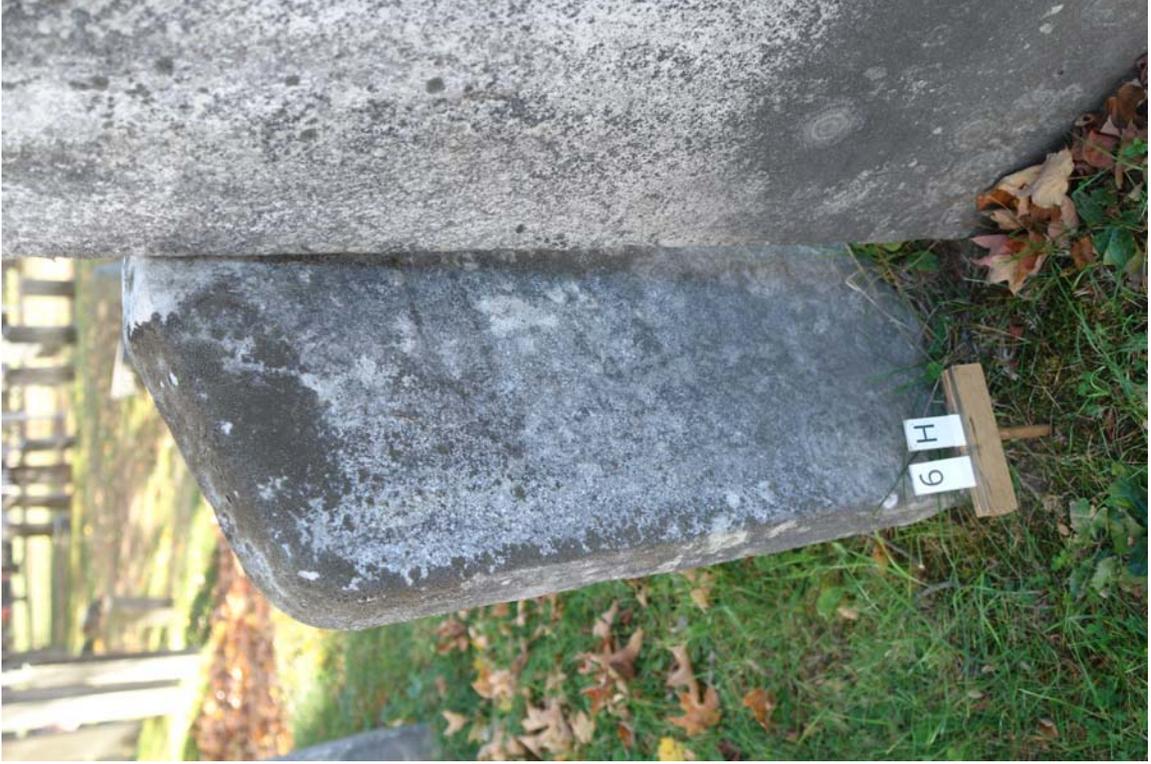
Marker# **6.H.4**

EXISTING CONDITIONS	CONSERVATION STRATEGY
Finial unstable	Remove finial Replace pin and reset with structural adhesive

CONSERVATION PRIORITY	1
1) Hazardous, immediate action 2) Unstable--asap 3) Ongoing deterioration, treat 2-5 years	
RECOMMENDED TREATMENT	
1. Carefully remove urn finial and existing pin 2. Base of urn is missing. Replace exiting pin and attach urn directly to top of monument with structural adhesive (Abatron 55-22), clamp and brace as required until cured. 3. Remove excess epoxy with hand chisels within 24 hours

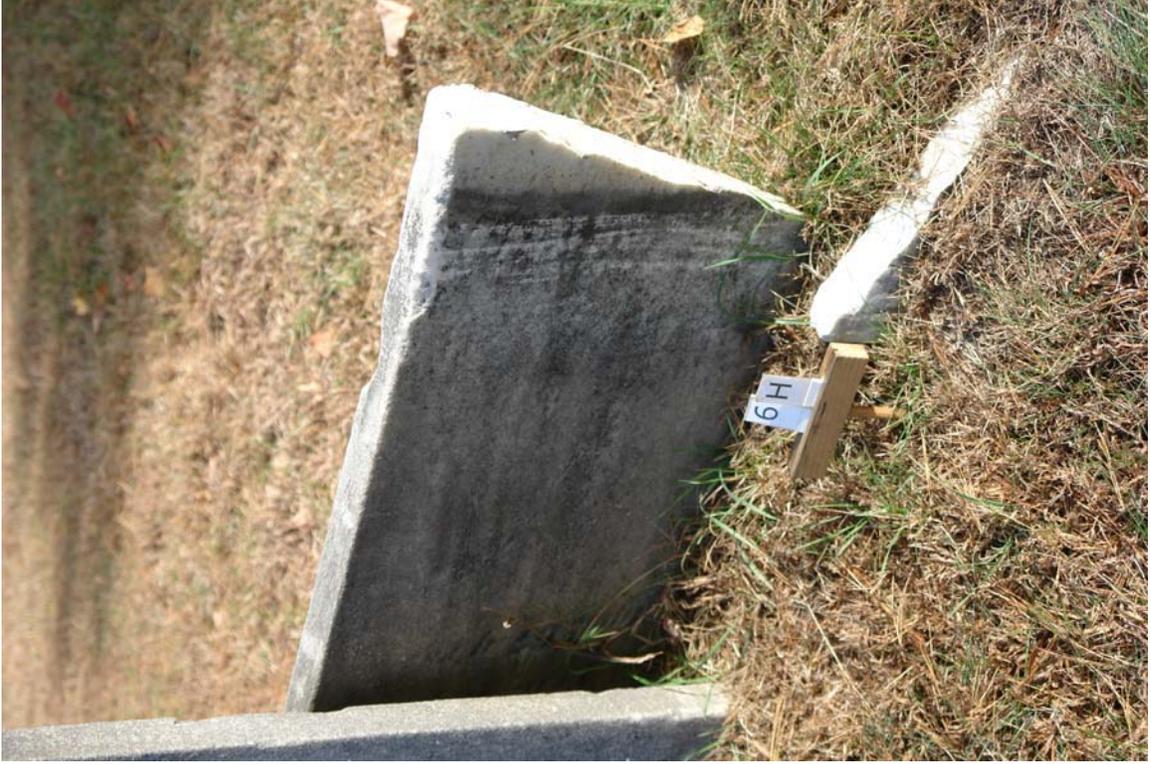
Marker# **6.H.9**

EXISTING CONDITIONS	CONSERVATION STRATEGY
Unstable	Reset into new below grade base

CONSERVATION PRIORITY	2
<p>1) Hazardous, immediate action 2) Unstable--asap 3) Ongoing deterioration, treat 2-5 years</p> <p>RECOMMENDED TREATMENT</p> <ol style="list-style-type: none"> Carefully excavate marker and inspect marker for soundness. Excavate setting area for new below grade cast concrete base sized minimum of 12 inches deep, 12 inches greater in thickness and 6 inches wider than the stone. The finished top to be entirely below grade. Align the 1" deep form for the setting slot (1/2" wider and thicker than the marker) with adjacent markers. Remove soiling from marker by light brushing with nylon brushes and water. Inspect for soundness. If required, re-square the lower edge of marker with minimal loss. After min 3 day cure, remove the setting form and reset stone into slot using a cement/lime grout (3/2/9) with 000 sand Set marker plumb and level, brace for minimum of 5 days. Disturbed areas to be backfilled with tamped sand and gravel, and re-graded with existing topsoil.

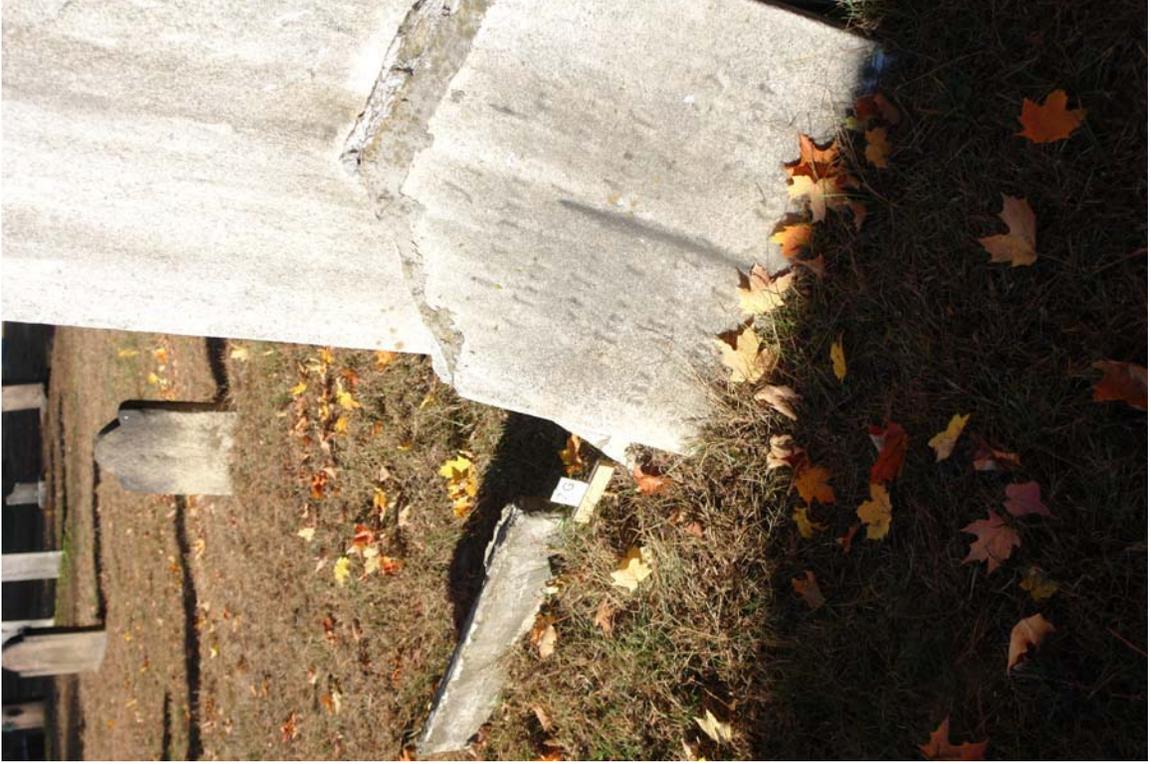
EXISTING CONDITIONS	CONSERVATION STRATEGY
Fractured Weathered	Evaluate condition of marker for restoration Poss. new base

CONSERVATION PRIORITY	3
<p>1) Hazardous, immediate action 2) Unstable--asap 3) Ongoing deterioration, treat 2-5 years</p> <p>RECOMMENDED TREATMENT</p> <p>Carefully excavate marker and fragments. Brush clean and inspect for soundness and extreme sugaring. Probe area for additional fragments. Evaluate if marker is restorable. If not, reset as found.</p> <ol style="list-style-type: none"> 1. If marker is sound and adequate fragments are found a new below grade cast concrete base will be required. Sized minimum of 12 inches deep, 12 inches greater in thickness and 6 inches wider than the stone. Align the slot setting form with adjacent markers. 2. After min 3 day cure, remove the setting form and reset lower marker fragment plumb and level into slot using a cement/lime grout (3/2/9) with 000 sand. Brace for minimum of 5 days. 3. Backfill disturbed areas with tamped sand and gravel, and re-grade with existing topsoil. 4. Attach fragments w structural adhesive, brace and clamp until cured. 5. Fill cracks and losses with Voidspon or Jahn products as required 6. Mist filled areas with water and cover for 3 days minimum

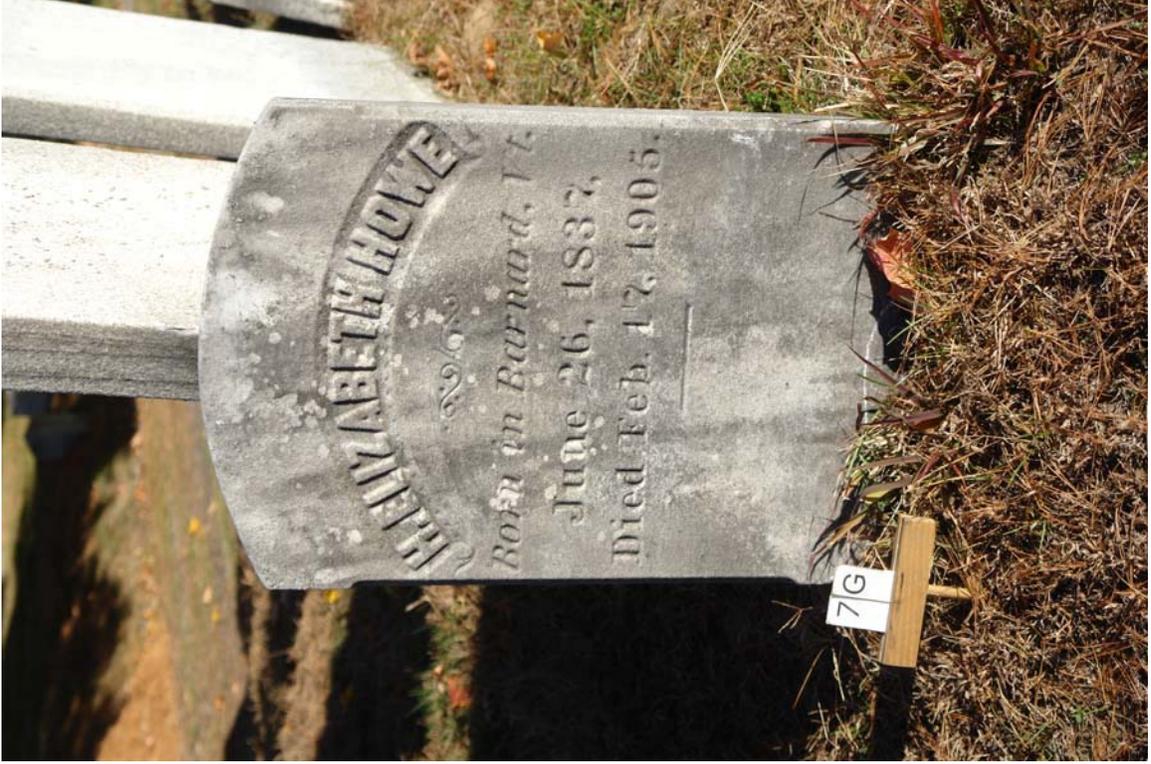
Marker# **7.G.2**

EXISTING CONDITIONS	CONSERVATION STRATEGY
Leaning on adjacent marker	Possible new base required

CONSERVATION PRIORITY	2
<p>1) Hazardous, immediate action 2) Unstable--asap 3) Ongoing deterioration, treat 2-5 years</p> <p>RECOMMENDED TREATMENT</p> <p>1. Probe area for possible existing below grade base or in ground fragment to determine location of resetting. 2. If base is found and stable, remove any failed material from setting slot and reset level as necessary. 3. If base is found to be unstable, or not found, a new below grade cast concrete base will be required. Sized minimum of 12 inches deep, 12 inches greater in thickness and 6 inches wider than the stone. The finished top to be entirely below grade. Align the 1" deep form for the setting slot (1/2" wider and thicker than the marker) with adjacent markers. 4. After min 3 day cure, remove the setting forms and backfill disturbed areas with tamped sand and gravel, and re-grade with existing topsoil 5. Re-square lower edge of marker fragment and reset plumb and level into slot using a flowable cement/lime grout (3/2/9) with 000 sand made fluid with a super plasticizer. Brace for minimum of 3 days.</p>

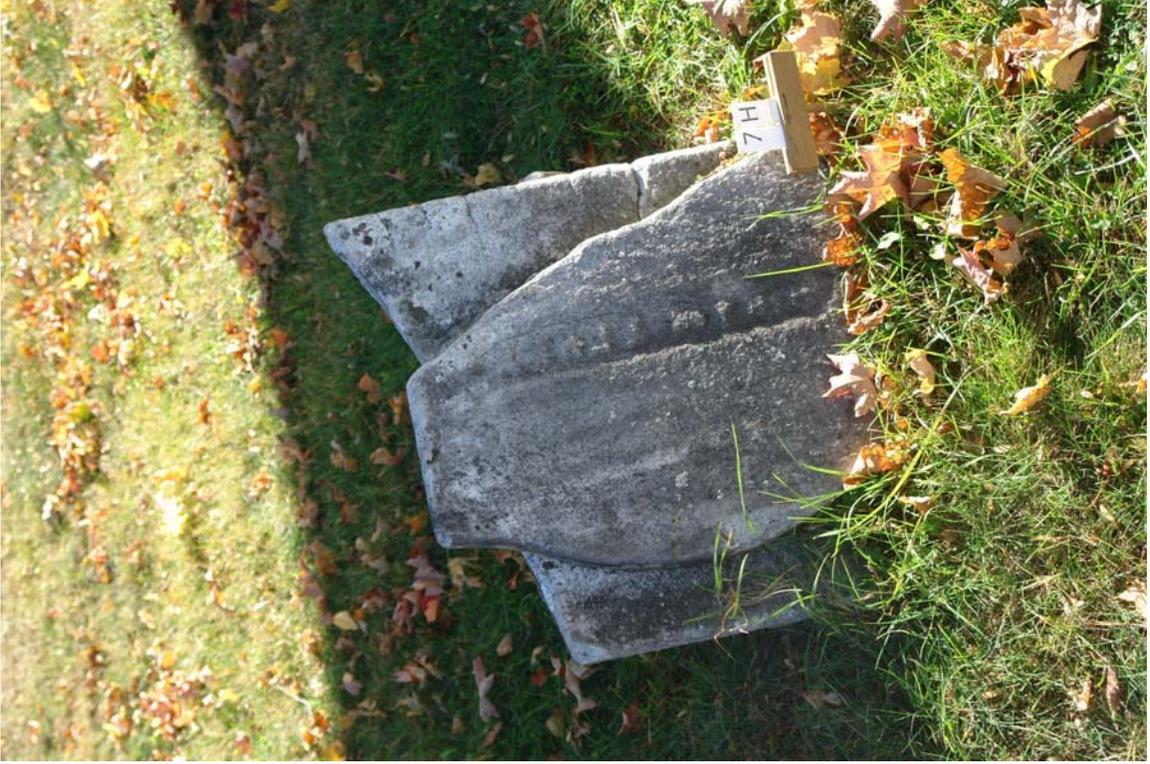
EXISTING CONDITIONS	CONSERVATION STRATEGY
Fragmented	Evaluate

CONSERVATION PRIORITY	3
<p>1) Hazardous, immediate action 2) Unstable--asap 3) Ongoing deterioration, treat 2-5 years</p> <p>RECOMMENDED TREATMENT</p> <p>Carefully excavate marker and fragments. Brush clean and inspect for soundness and extreme sugaring. Probe area for additional fragments. Evaluate if marker is restorable. If not, reset as found.</p> <ol style="list-style-type: none"> 1. Clean mating surfaces and remove any failed adhesives or mortar 2. Attach fragments with structural adhesive, brace and clamp until cured. 3. Fill cracks and losses with Voidspon or Jahn products as required 4. Mist filled areas with water and cover for 3 days minimum 5. Treat filled surface areas with light acid wash and rinse thoroughly 6. Reset as required- possible new base

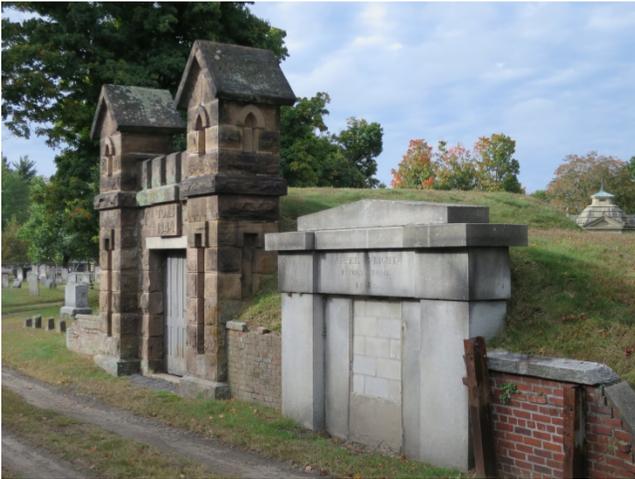
The brownstone façade-d town receiving tomb and adjacent Ansel Wright tomb, both constructed in the 1840s, are both in good condition with some repairs needed to their wing walls. The steel doors on the town tomb appear to be original.

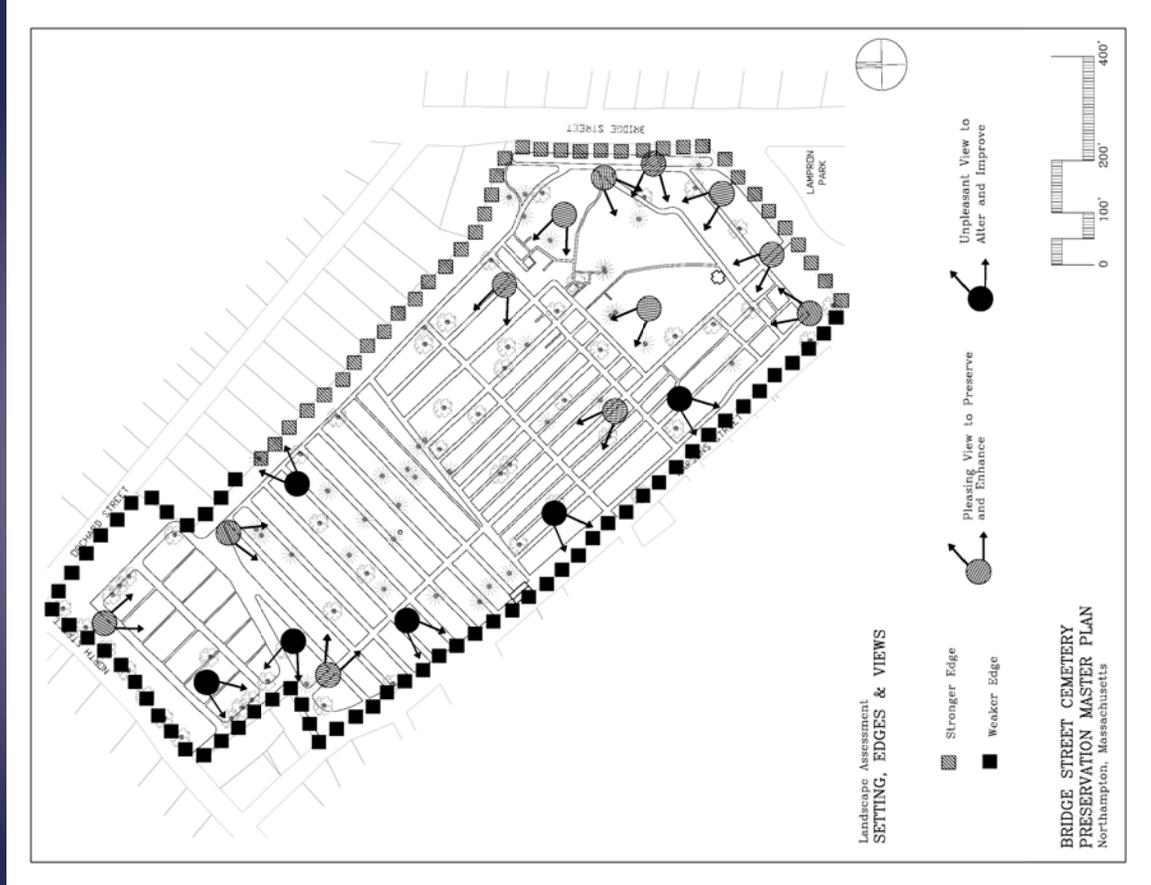
- The existing chain link is in fair condition and conflicts with historic character
- Parsons Street closely abuts graves on the cemetery's western side
- The cemetery lacks a formal entrance and the existing entrance is difficult to find
- The roads and paths lack hierarchy and some are in poor condition
- Lack of signs sends an unwelcoming message to visitors
- The tree population is aging; Maples dominate

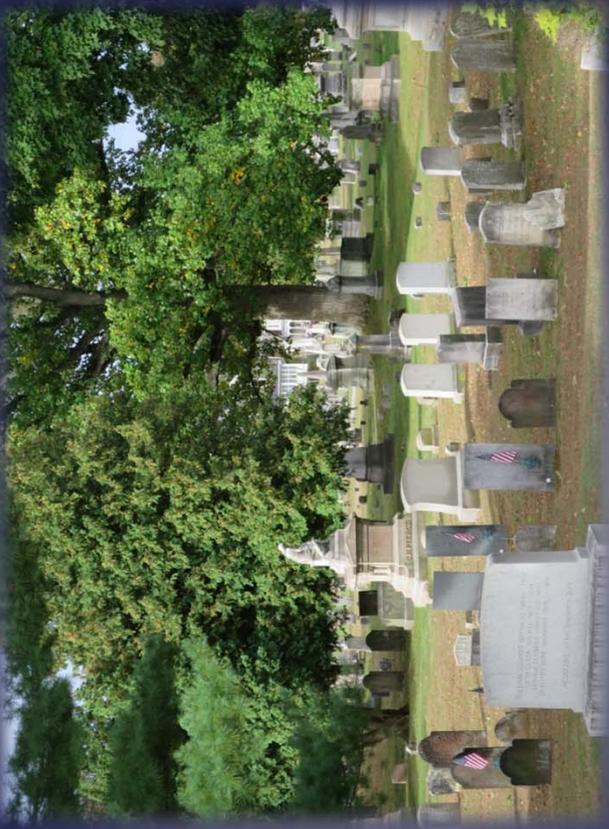
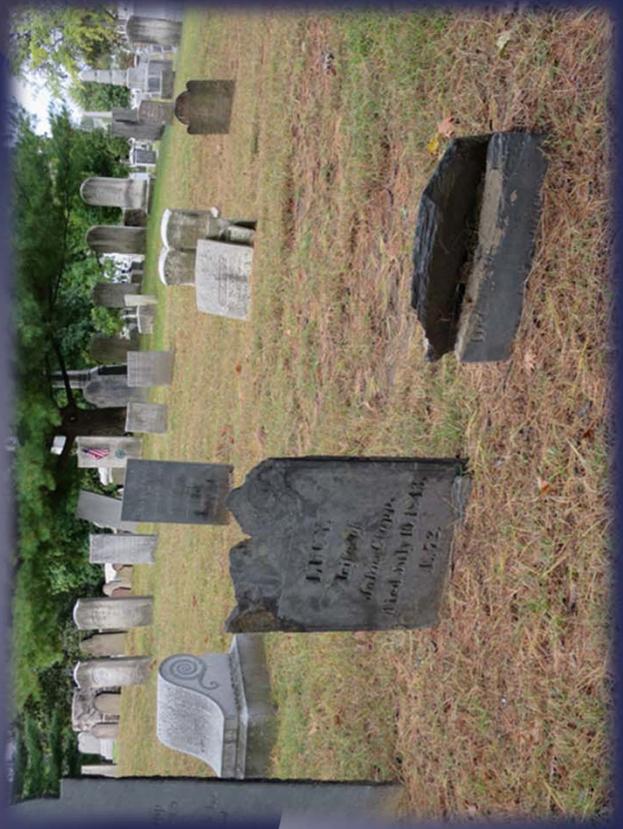
PROJECT #5: PRIORITY #2 GRAVESTONES

- In unstable condition
- Located throughout the cemetery
- 84 stones
- Will require the services of a professional stone conservator

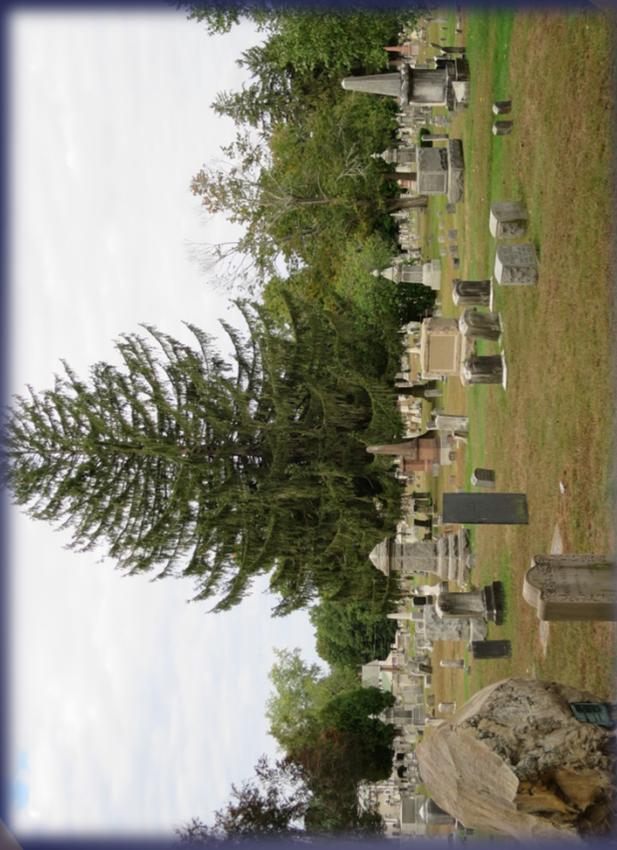
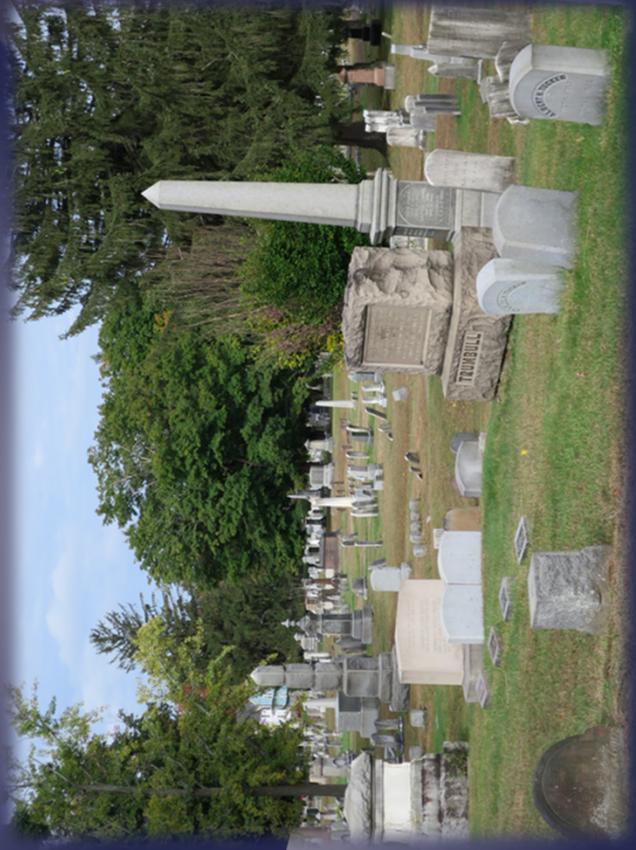
PRIORITY #3 GRAVESTONES

- Suffering from ongoing deterioration
- Located throughout the cemetery
- 51 stones
- Will evaluation of a professional stone conservator, and treatment if necessary
